# Structural Assessment of S.P.S Library

Zahid Bashir Bhat<sup>1</sup>, Danish Iqbal<sup>2</sup>

**Abstract:** In general structural assessment is a process to determine the capacity of an existing structure to carry current and future loads and to fulfill its task for a given time period. The paper presents the assessment of the Library under construction from last 13 years, submerged upto first story during September 2014 kashmir floods. Considering the high importance of the building an attempt is made to understand the condition of the building, identify critical areas to repair and suggest corrective measures to ensure safety and serviceability of the existing building and thus save human life. Method of visual Inspection is adopted for the assessment of the building.

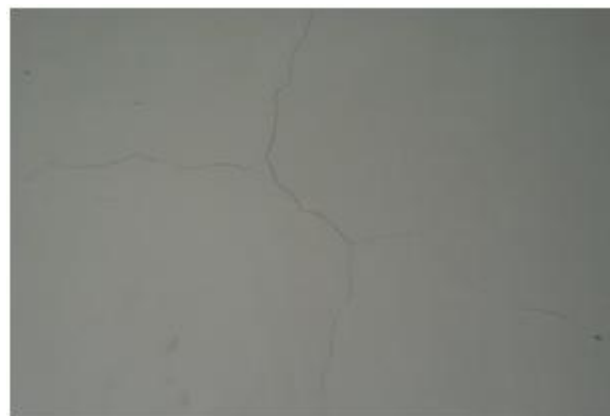
**Figure 1:** Plaster crack

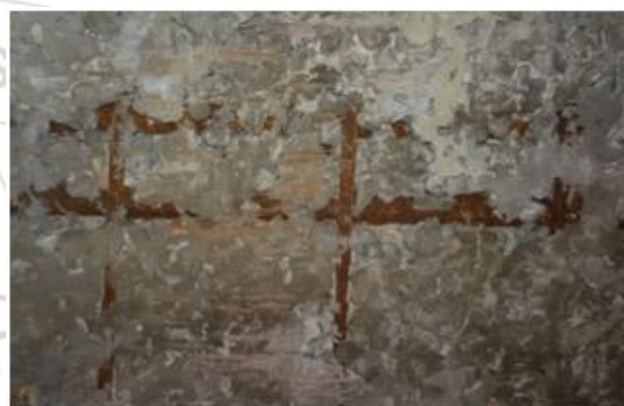
- weight of the structure.
- 5) Concrete disintegration and exposed steel reinforcements observed in some beams. .
  - 6) Leakages & dampness in in third floor bathroom wall resulting into cracks and swelling.

**Figure 2:** Corrosion in RCC due to insufficient cover

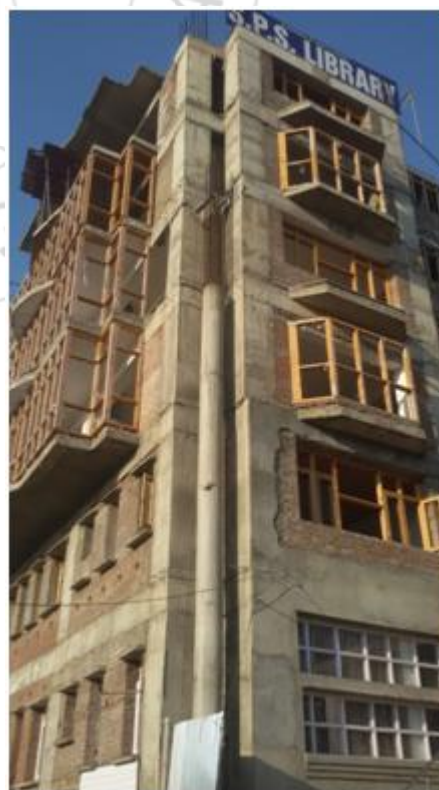
**Figure 3:** Slender columns at building corner

The round columns are provided at the corners in the front elevation of the building for the sole purpose of providing architectural aesthetics. However, the said columns have been casted upto a height of 40 feet without any intermediate lateral support. Large lateral displacement of said columns is observed on giving a slight horizontal push at the top. The

effective length of such a column fixed at one end and free at the other becomes 4 times the length of the column. Since the buckling load is inversely proportional to the square of the effective length this implies a slight load will cause considerable deflections in the column. The said columns will also cause knocking effect on the structure even during a low magnitude earthquake and are therefore a severe hazard for the health of the structure, besides being threat to human life. It is therefore recommended, that the columns should be anchored into the slab at the top into the slab with the help of structural steel. This will reduce the effective length of the column to one fourth i.e 10 feet and the columns will behave as part of the structure itself. The cavity walls have been provided without any horizontal and vertical bands. This may result in severe cracks particularly at the place of windows even under moderate shaking during earthquake.

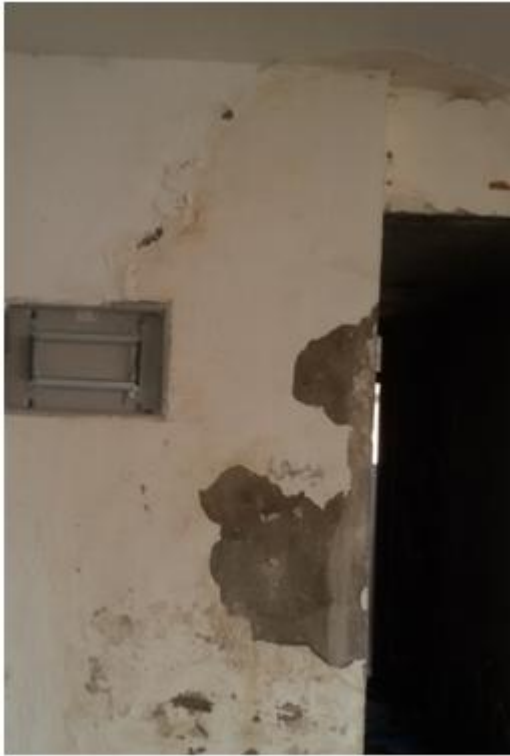
Figure 4: Dampness in wall adjacent to bathroom

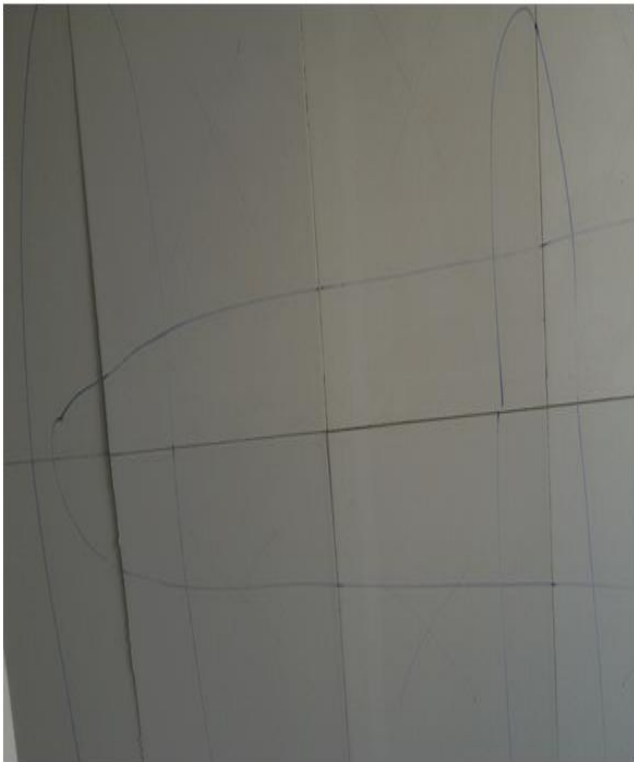
Figure 5: Swelling of plaster and tiles in third floor bathroom
