# Structural Assessment of S.P.S Library

**Abstract:** *In general structural assessment is a process to determine the capacity of an existing structure to carry current and future loads and to fulfill its task for a given time period. The paper presents the assessment of the Library under construction from last 13 years, submerged upto first story during September 2014 kashmir floods. Considering the high importance of the building an attempt is made to understand the condition of the building, identify critical areas to repair and suggest corrective measures to ensure safety and serviceability of the existing building and thus save human life. Method of visual Inspection is adopted for the assessment of the building.*

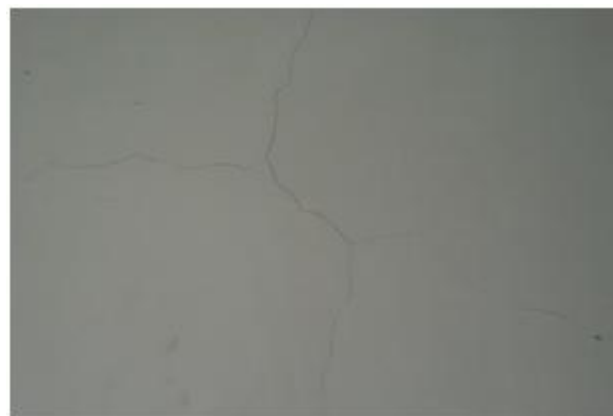
**Figure 1:** Plaster crack

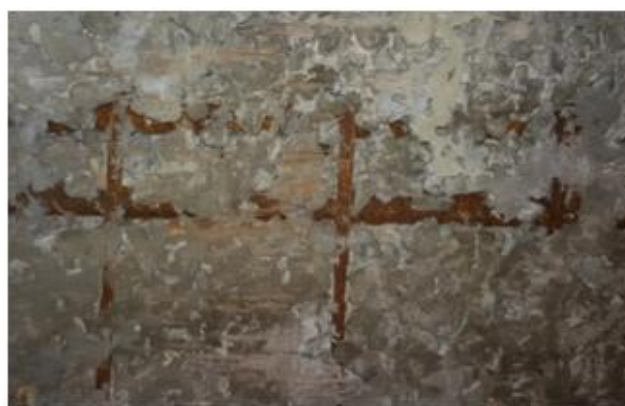
- weight of the structure.
- 5) Concrete disintegration and exposed steel reinforcements observed in some beams. .
  - 6) Leakages & dampness in in third floor bathroom wall resulting into cracks and swelling.

**Figure 2:** Corrosion in RCC due to insufficient cover

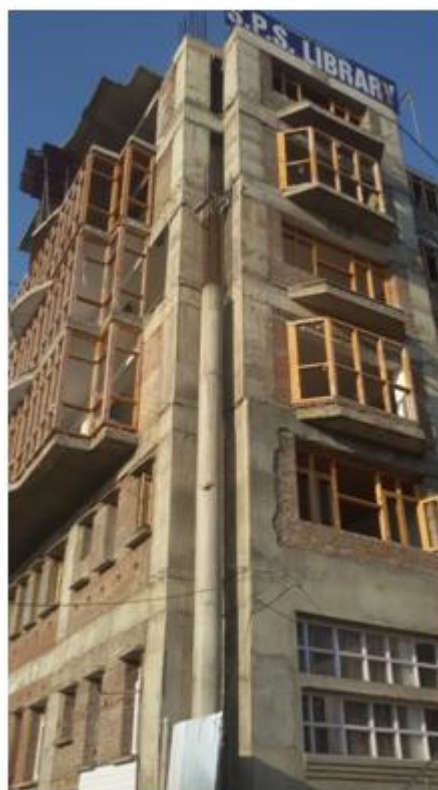
**Figure 3:** Slender columns at building corner

The round columns are provided at the corners in the front elevation of the building for the sole purpose of providing architectural aesthetics. However, the said columns have been casted upto a height of 40 feet without any intermediate lateral support. Large lateral displacement of said columns is observed on giving a slight horizontal push at the top. The

effective length of such a column fixed at one end and free at the other becomes 4 times the length of the column. Since the buckling load is inversely proportional to the square of the effective length this implies a slight load will cause considerable deflections in the column. The said columns will also cause knocking effect on the structure even during a low magnitude earthquake and are therefore a severe hazard for the health of the structure, besides being threat to human life. It is therefore recommended, that the columns should be anchored into the slab at the top into the slab with the help of structural steel. This will reduce the effective length of the column to one fourth i.e 10 feet and the columns will behave as part of the structure itself. The cavity walls have been provided without any horizontal and vertical bands. This may result in severe cracks particularly at the place of windows even under moderate shaking during earthquake.

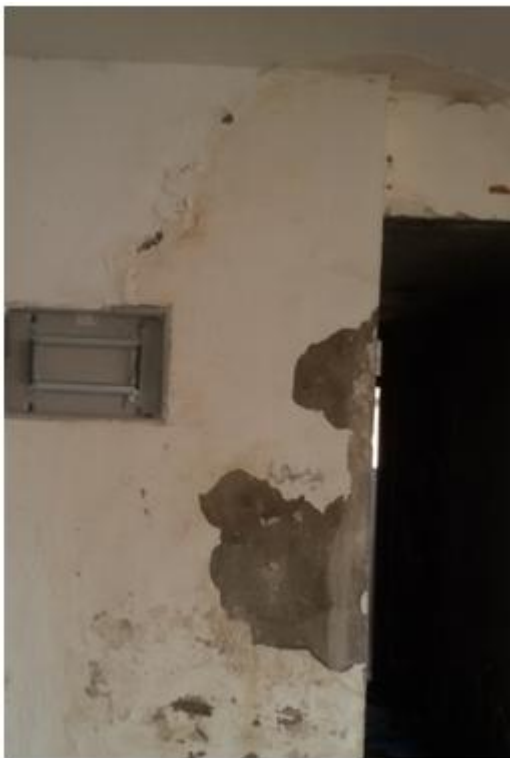
Figure 4: Dampness in wall adjacent to bathroom

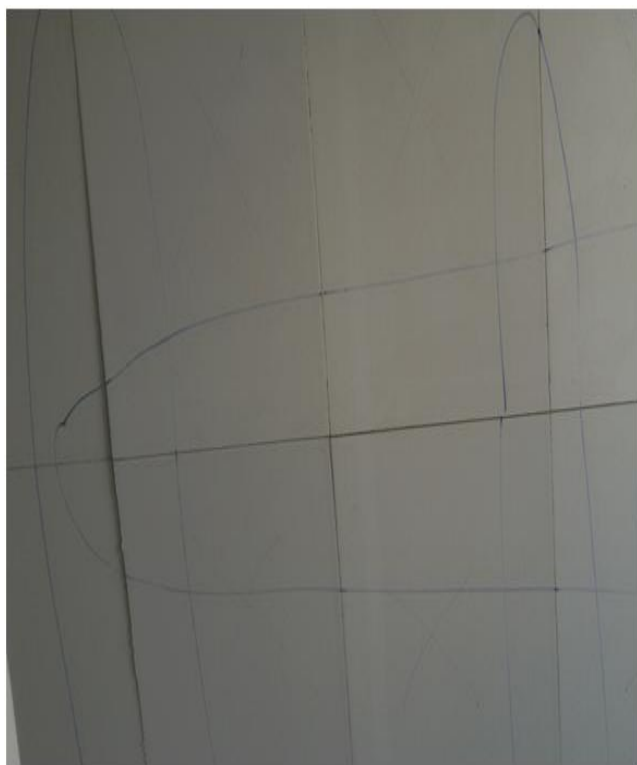
Figure 5: Swelling of plaster and tiles in third floor bathroom
