Failure Analysis for High Speed Gears

Abstract: *In this paper, the failure analysis of high speed gears driving air blowers in starch manufacturing processes was investigated in order to find the failure reasons and so over coming them in the future. The gear velocity was 21000 rpm and manufactured from carburized steel (18CrNiMo7-6) DIN No. (1.6587). The gear module was 2 mm and number of teeth was 23 teeth. The gear has failed within 3 weeks of first time operation. Visual investigation has carried out and a set of photos was taken. The teeth of the gear have undergone a bending deflection accompanied with surface wear. The operating conditions (environmental effects, lubrication, loads, assembly and alignment) were revised. The design data was reviewed according to the standard gear design recommendations and also the manufacturing data were checked according to the design data. Additionally, the material analysis; micro hardness measurements and micro structure were investigated. A set of errors were found. The analysis showed that the gear material selection was wrong because the carburization is not suitable for small gear modules. Also, the carburizing depth is not suitabl

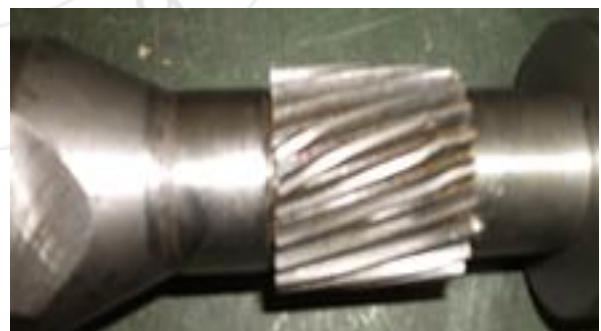
The present case failure had not complete fracture of the gear teeth a deflection occurred at the pinion gear which resulted from the applied stress producing a deflection shape of teeth as shown in figures (1, 2). It was observed that the teeth had a high deflection at the most of teeth and along their width. The investigation procedure were surveying the assembly, operation and maintenance of the gearbox. Also the environment was surveyed looking for dust, heat or corrosion sources. The operating conditions also reviewed for finding any overloads or back pressure loads to the impeller back to the gearbox. Material selection was considered and heat treatment specifications of the design were reviewed. The heat treatment cycle parameters were checked. The micro hardness measurements survey for the teeth section and also at the teeth root at the area between teeth was surveyed. The microstructure investigations were applied to the teeth and the area between teeth. The results of the previous steps were discussed and a conclusion was drawn

When the gear was put in operation, a severe deformation in the gear teeth was observed during the first 15 days of starting up the gear box unit as shown in figures (1), (2).

Figure 1: The gear after failure

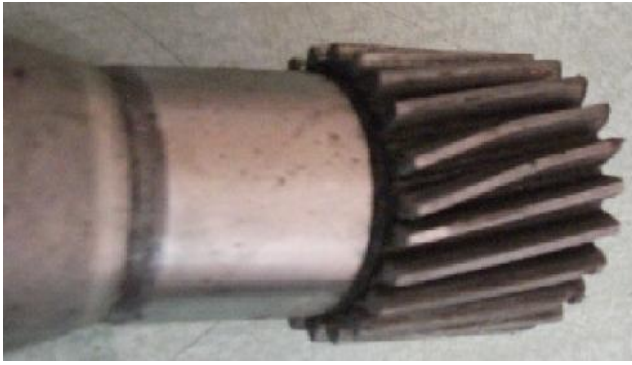
Figure 2: The gear after cut off for investigation

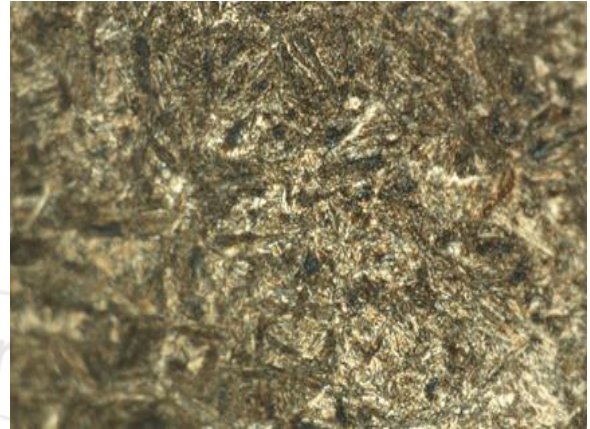
Figure 3: Carburizing case tooth microstructure (excessive retained austenite) Nital 5%, 1000X

The presence of Bainite which decreases the fatigue strength, especially contact fatigue strength, where (the ideal structure of the case would be fine tempered martensite with very little or no presence of other transformation products. The presence of the excessive retained austenite (figures 3, 4) due to incorrect quenching after the carburizing process, as shown in figure (8), where (retained austenite is more critical with steel containing increased Nickel and chromium).

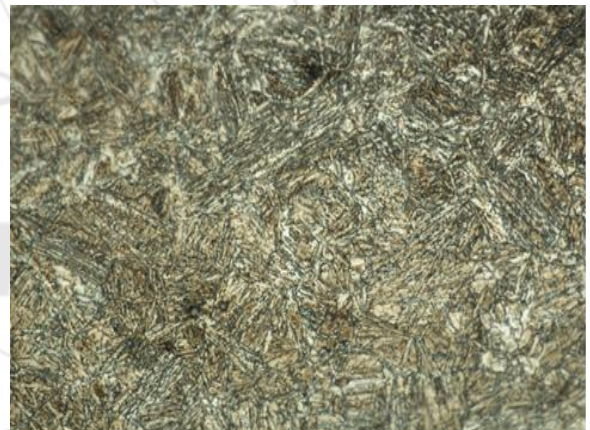
Figure 4: Tooth core micro-structure (excessive retained austenite) +coarse martensite Nital 5% , 1000X

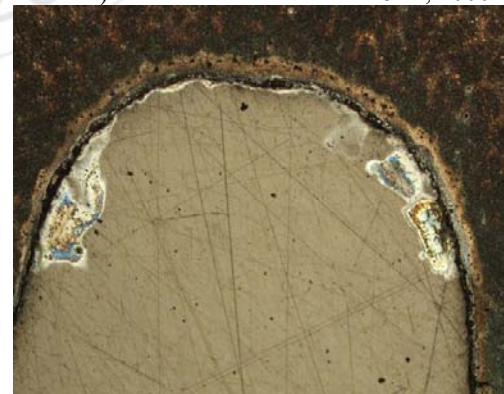
Figure 5: Decarburization depth (white area) between teeth

The micro hardness drop in the case which is an indirect means of the low quality of carburization process (it reveals partial decarburization 50-80 Micron, figures (5, 7)).

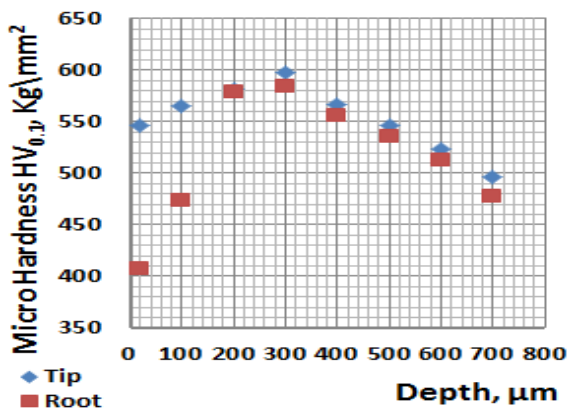
Case surface hardness is the most important parameter which influence the quality and service performance of case carburized of gears which are required to sustain high surface stresses (contact and sliding), the hardness is normally specified > 56 HRC (HV=613) minimum [10,11] to overcome the applied loads but the surface hardness of the delivered gear = 547 HV maximum on the teeth and not homogeneous and this is the main problem, and 408 HV between teeth. The hardness is graphically represented in figure (6) which shows a decarburizing at the surface which reduces the resistance Hertzian stress.

Figure 6: Micro-hardness against case depth

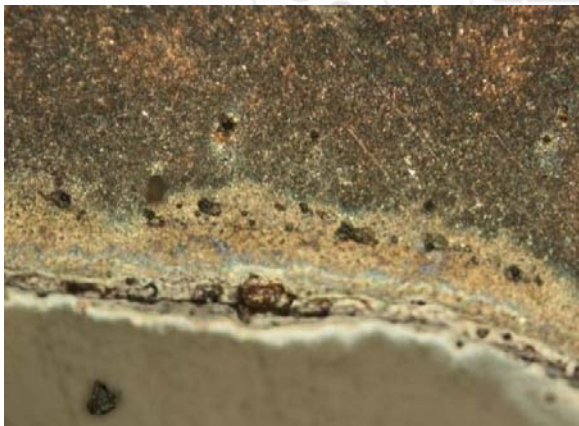
Figure 7: Decarburization at the tooth root Nital 5%, 200X
