Failure Analysis for High Speed Gears

Abstract: *In this paper, the failure analysis of high speed gears driving air blowers in starch manufacturing processes was investigated in order to find the failure reasons and so over coming them in the future. The gear velocity was 21000 rpm and manufactured from carburized steel (18CrNiMo7-6) DIN No. (1.6587). The gear module was 2 mm and number of teeth was 23 teeth. The gear has failed within 3 weeks of first time operation. Visual investigation has carried out and a set of photos was taken. The teeth of the gear have undergone a bending deflection accompanied with surface wear. The operating conditions (environmental effects, lubrication, loads, assembly and alignment) were revised. The design data was reviewed according to the standard gear design recommendations and also the manufacturing data were checked according to the design data. Additionally, the material analysis; micro hardness measurements and micro structure were investigated. A set of errors were found. The analysis showed that the gear material selection was wrong because the carburization is not suitable for small gear modules. Also, the carburizing depth is not suitabl

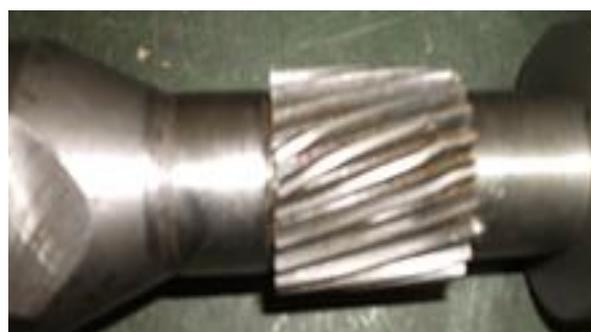
The present case failure had not complete fracture of the gear teeth a deflection occurred at the pinion gear which resulted from the applied stress producing a deflection shape of teeth as shown in figures (1, 2). It was observed that the teeth had a high deflection at the most of teeth and along their width. The investigation procedure were surveying the assembly, operation and maintenance of the gearbox. Also the environment was surveyed looking for dust, heat or corrosion sources. The operating conditions also reviewed for finding any overloads or back pressure loads to the impeller back to the gearbox. Material selection was considered and heat treatment specifications of the design were reviewed. The heat treatment cycle parameters were checked. The micro hardness measurements survey for the teeth section and also at the teeth root at the area between teeth was surveyed. The microstructure investigations were applied to the teeth and the area between teeth. The results of the previous steps were discussed and a conclusion was drawn

When the gear was put in operation, a severe deformation in the gear teeth was observed during the first 15 days of starting up the gear box unit as shown in figures (1), (2).

Figure 1: The gear after failure

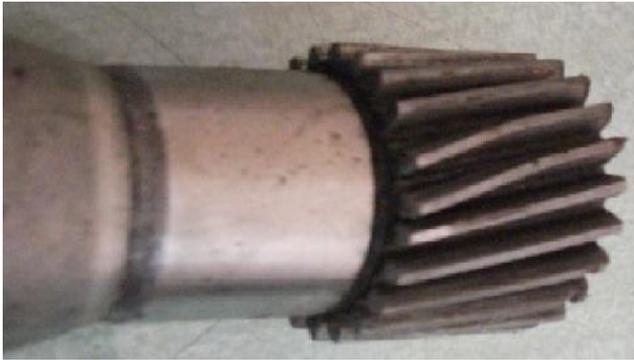
Figure 2: The gear after cut off for investigation

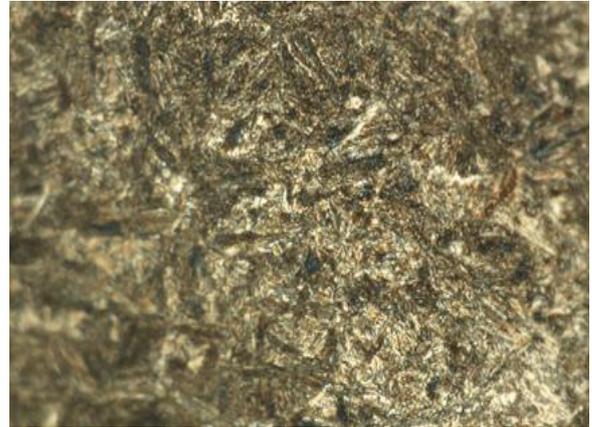
Figure 3: Carburizing case tooth microstructure (excessive retained austenite) Nital 5%, 1000X

The presence of Bainite which decreases the fatigue strength, especially contact fatigue strength, where (the ideal structure of the case would be fine tempered martensite with very little or no presence of other transformation products). The presence of the excessive retained austenite (figures 3, 4) due to incorrect quenching after the carburizing process, as shown in figure (8), where (retained austenite is more critical with steel containing increased Nickel and chromium).

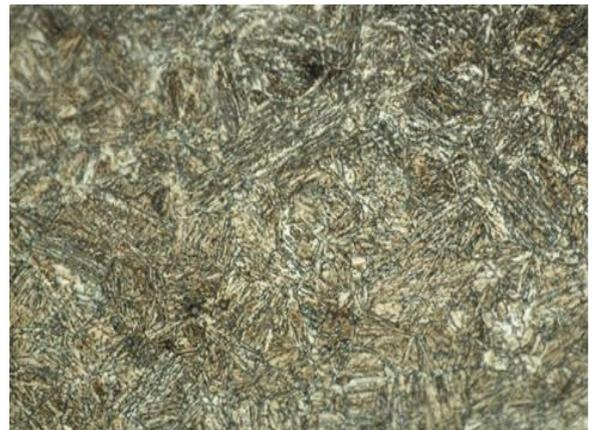
Figure 4: Tooth core micro-structure (excessive retained austenite) +coarse martensite Nital 5% , 1000X

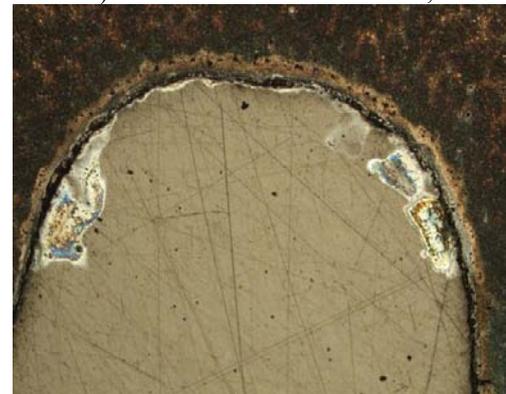
Figure 5: Decarburization depth (white area) between teeth

The micro hardness drop in the case which is an indirect means of the low quality of carburization process (it reveals partial decarburization 50-80 Micron, figures (5, 7)).

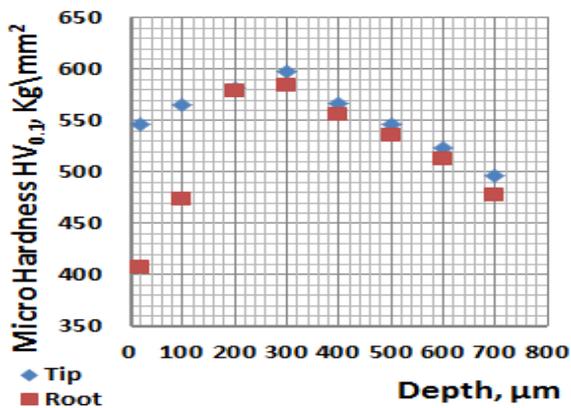
Case surface hardness is the most important parameter which influence the quality and service performance of case carburized of gears which are required to sustain high surface stresses (contact and sliding), the hardness is normally specified > 56 HRC (HV=613) minimum [10,11] to overcome the applied loads but the surface hardness of the delivered gear = 547 HV maximum on the teeth and not homogeneous and this is the main problem, and 408 HV between teeth. The hardness is graphically represented in figure (6) which shows a decarburizing at the surface which reduces the resistance Hertzian stress.

Figure 6: Micro-hardness against case depth

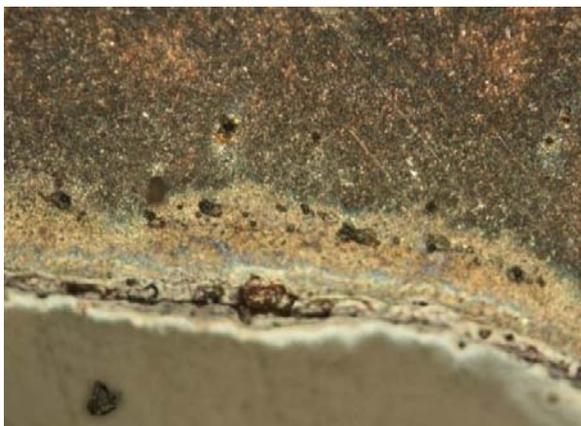
Figure 7: Decarburization at the tooth root Nital 5%, 200X
