Study on Radiation Protection Infrastructure of Diagnostic X-Ray Facilities at Habiganj District in Bangladesh

L. Begum, M. Nahar

Radiation, Transport and Waste Safety Division, Bangladesh Atomic Energy Regulatory Authority, Agargaon, Dhaka-1207, Bangladesh

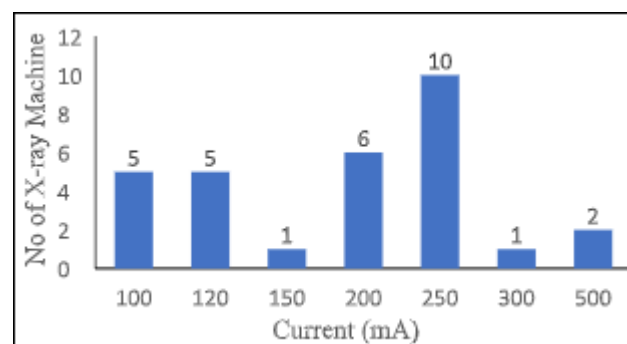
Figure 1: Quantity of X-ray machine with mA

Figure.01 shows a graphical illustration of number of X-ray machine with different current level (mA). Most of the installations use lead and brick as shielding material for control panel of X-ray room. The area of the X-ray room in most of the facilities lies below the standard size ≥ 21 sq. m or 225ft², it is a matter of concern from shielding point of view. For X-ray facilities shielding analysis of some areas are essential, especially in control panel, outside of the entrance door, where a group of radiation worker may be exposed to a considerable amount of radiation [6]. Due to inadequate room size, it does not permit optimum mobility of the equipment and the staff during radiological examination. In several cases, X-ray rooms are not well planned and designed with the regulatory standards for radiation safety in mind. Because of these, the undesirable exposures of occupational workers, patients and the general public are unavoidable.

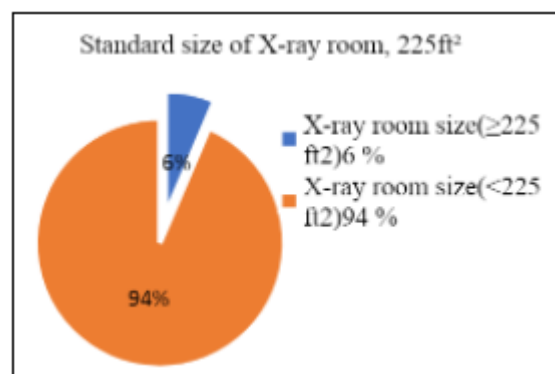
Figure 2: X-ray room size status of Habiganj district

Fig.2 shows the X-ray room size status of Habiganj district where only 6% are standard size and 94% are below standard which requires huge improvement to fulfill the regulatory demand. All X-ray rooms except one have 10" brick wall, which are effective in the protection of X-rays. Most of the facilities radiation dose level was within regulatory limit (10µSv/hr for occupational worker) because the entrance door and control panel barrier were lead and brick shielded.

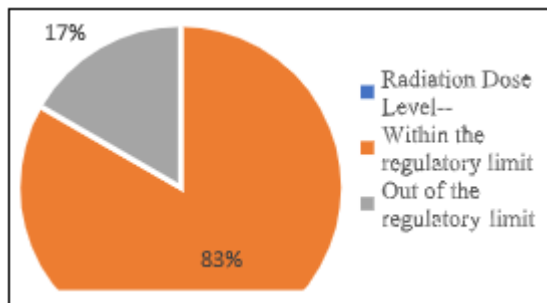
Figure 3: Dose level status of X-ray installations at Habiganj district

Fig.3 shows in 83% facilities radiation doses are within regulatory limit where 17% are out of regulatory limit.

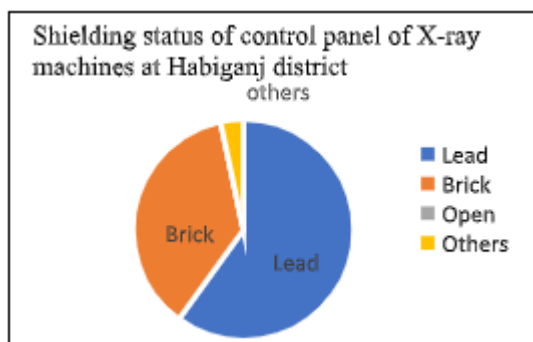
Figure 4: Shielding status of control panel of X-ray machines

Fig.4 indicates the shielding condition of the secondary barrier (Control Panel); lead is most commonly used shielding material in control panels, covering 60% of all

installations, while brick is the second most commonly used shielding material in control panel barriers.

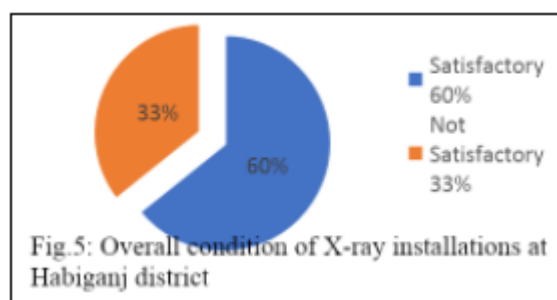
Fig.5: Overall condition of X-ray installations at Habiganj district

Among all inspected installations in Habiganj district, 18 (60%) installations have been found satisfactory performance from radiological safety point of view (Table.1 and Fig.5). The results show that the overall performance of the radiographic X-ray systems is merely satisfactory since only 60% of them have satisfactory performance in compliance with the regulatory requirements. However, the monitoring and surveillance is needed to more improvement of the equipment performance and operational safety in diagnostic X-ray installations. The dose rates observed at some points of interest around the X-ray machines are tabulated in Table 1.
