Radiation Safety Assessment of Medical X-Ray Installations at Gazipur District City in Bangladesh

L. Begum, M. Nahar

Radiation, Transport and Waste Safety Division, Bangladesh Atomic Energy Regulatory Authority, Agargaon, Dhaka-1207, Bangladesh

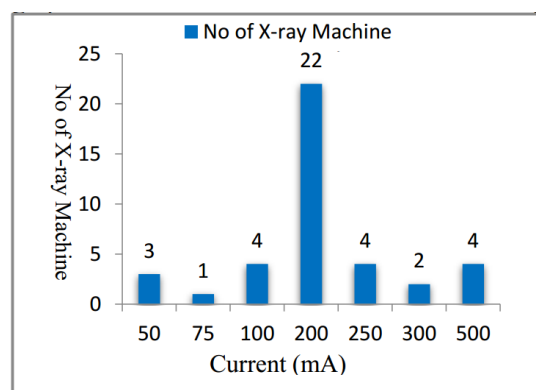
Figure 1: quantity of X-ray machine with mA

Figure 01 shows a graphical illustration of number of X-ray machine with different current level (mA). For the control panel of the X-ray room, the majority of installations use lead and brick as shielding materials. Most of the installations X-ray rooms are smaller than the regulatory requirement of 21sq. m (225ft²), which is a major concern from a shielding standpoint. In the case of X-ray facilities some places require shielding analysis, particularly the control panel, outside the entrance door, where a group of radiation workers may be exposed to a significant amount of radiation [6]. The equipment and workers cannot move around freely during radiological examinations due to insufficient room size. In a number of cases, X-ray rooms are not well-planned and designed with radiation safety regulations in mind. Unwanted exposures of occupational workers, patients, and the general public are unavoidable as a result of this issue.

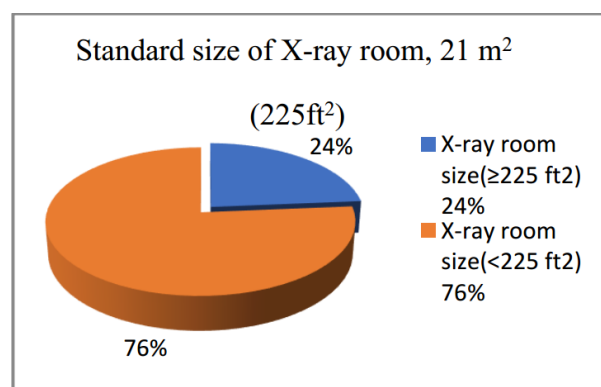
Figure 2: X-ray room size status at Gazipur district city

Figure 2 illustrates the X-ray room size condition in Gazipur district city, showing that just 24% are standard size and 76% are below standard, indicating that a significant improvement is required to meet regulatory demands. Except for two, all X-ray rooms feature has a 10" brick wall that fulfill regulatory requirement and effectively protects X-rays. More than half of the inspected installations radiation dose level was out of regulatory limit (10µSv/hr for occupational worker) because the shielding was not adequate in entrance door and control panel.

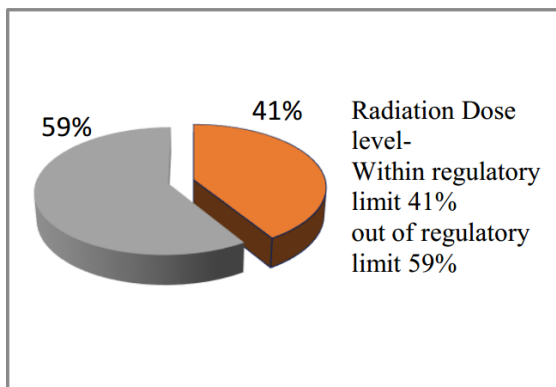
Figure 3: Dose level status of X-ray installations at Gazipur district city

Figure 3 shows in 41% facilities radiation doses are within regulatory limit where 59% are out of regulatory limit.

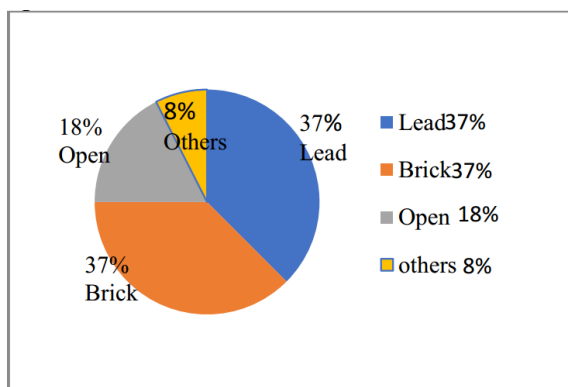
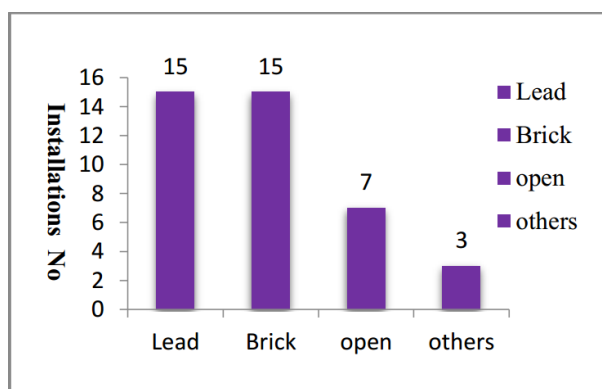
Figure 4: Shielding status of control panels (%) of x-ray machines at Gazipur district city

Figure 5: Shielding status of control panels (Number) of X-ray machines at Gazipur district city

Figure 4 and 5 indicate the shielding condition of the secondary barrier (Control Panel); lead and brick are most commonly used shielding material in control panels, covering 74% of all installations, where other materials are used as shielding in 8% control panel and 18% are in open condition.

As 18% of the control panels are found in open condition, high amount dose is observed at operator place in this situation. It is a matter of concern from regulatory point of view. The chest stand is sometimes positioned in such a way that the primary beam is directed towards occupied areas or the dark room, which also contains undeveloped films. Many cases, adequate patient waiting places are not provided. During exposures, patients and their relatives are sometimes required to wait near the X-ray room which may harmful for patient as well as relatives. Radiation warning signals are rarely observed, although radiation caution signs are commonly displayed. The lead Goggles and lead hand gloves for the operators were found in only one X-ray facilities but lead apron was available in 34 installations among the total of 40 installations for the protection of radiation worker. Among the 40 installations, only 25 installations have TLD-Badge for personal radiation monitoring. In terms of radiation safety and protection, the majority of radiation workers are unqualified. Among all inspected installations in Gazipur district city, 33% installations have been found satisfactory performance from radiological safety point of view (Table.1 and Figure 6).

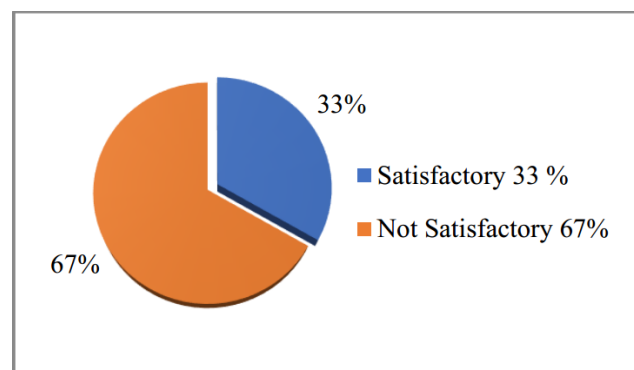
Figure 6: Overall condition of X-ray installations at Gazipur district city

The results indicate that the overall performance of the radiographic X-ray systems is little satisfactory since only 33% of them have satisfactory performance in compliance with the regulatory requirements. Therefore, to improve the equipment performance and operational safety in medical X-ray installations, greater monitoring and surveillance is required. The dose rates observed at several points of interest surrounding the X-ray machines are tabulated in Table 1.
