Case Study of Failure of Titanic Ship

Mohd Nazim¹, Dr. Ravi Butola², Dr. JP Kesari³

^{1,2,3}Delhi Technological University, Delhi, India

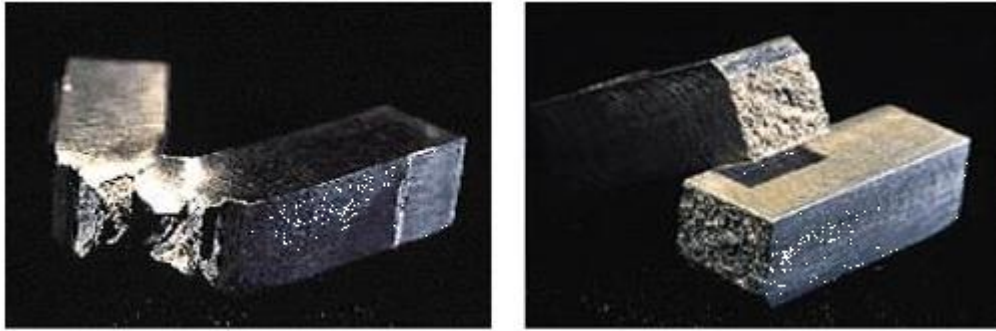
Figure 1: Results of the Charpy test for modern steel and Titanic steel

Further evidence of the brittle fracture of the hull steel was found when a cigarette-sized coupon of the steel taken from the Titanic wreck was subjected to a Charpy test. Used to measure the brittleness of a material, the Charpy test is run by holding the coupon against a steel backing and striking the coupon with a 67 pound pendulum on a 2.5-foot-long arm. The pendulum's point of contact is instrumented, with a readout of forces electronically recorded in millisecond detail. A piece of modern high-quality steel was tested along with the coupon from the hull steel. Both coupons were placed in a bath of alcohol at -1°C to simulate the conditions on the night of the Titanic disaster. When the coupon of the modern steel was tested, the pendulum swung down and halted with a thud; the test piece had bent into a "V." However, when the coupon of the Titanic steel was tested, the pendulum struck the coupon with a sharp "ping," barely slowed, and continued up on its swing; the sample, broken into two pieces, sailed across the room [Gannon, 1995]. Pictures of the two coupons following the Charpy test are shown in Figure 1. What the test showed, and the readout confirmed, is the brittleness of the Titanic's hull steel. When the Titanic struck the iceberg, the hull plates did not deform. They fractured.

When a pendulum struck the modern steel, on the left, with a large force, the sample bent without breaking into pieces; it was ductile. Under the same impact loading, the Titanic steel, on the right, was extremely brittle; it broke in two pieces with little deformation.

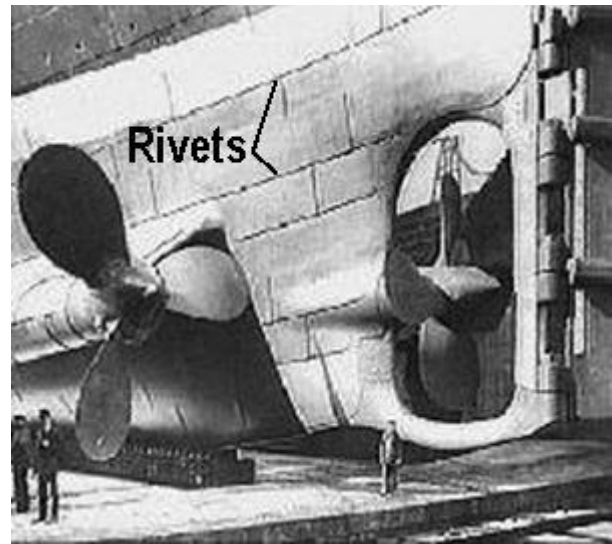
Figure 2: The Titanic in the shipyard during her construction

The wrought iron rivets that fastened the hull plates to the Titanic's main structure also failed because of brittle fracture from the high impact loading of the collision with the iceberg and the low temperature water on the night of the disaster. Figure 2 shows the Titanic during her construction, with the riveted hull plates of her stern visible. With the ship travelling at nearly 25 mph, the contact with the iceberg was probably a series of impacts that caused the rivets to fail either in shear or by elongation. As the iceberg scraped along sections of the Titanic's hull, the rivets were sheared off, which opened up riveted seams. Also, because of the tremendous forces created on impact with the iceberg, the rivet heads in the areas of contact were simply popped off, which caused more seams to open up. Normally, the rivets would have deformed before failing because of their ductility, but with water temperatures below freezing, the rivets had become extremely brittle.

Note the hull plates, fastened on all sides to the ship's main structure by thousands of rivets. When the iceberg tore through the hull plates, huge holes were created that allowed water to flood the hull of the ship. As a result, rivets not in the area of contact with the iceberg were also subjected to incredible forces. Like a giant lever, the hull plates transferred the inward forces, applied to the edges of the cracked plates by the water rushing into the hull, to the rivets along the plate seams. The rivets were then either elongated or snapped in two, which broke the caulking along the seams and provided another inlet for water to flood the ship.

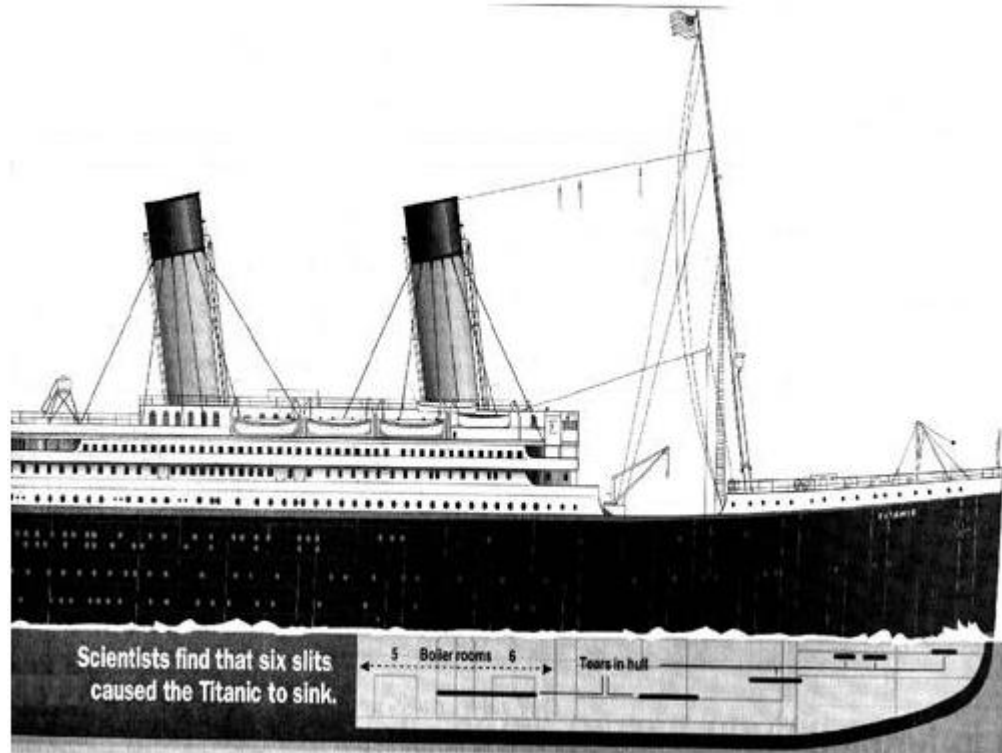
Figure 3: A layout of the watertight compartments and the damage from the collision

Sealing off the compartments was completed immediately after the damage was realized, but as the bow of the ship began to pitch forward from the weight of the water in that area of the ship, the water in some of the compartments began to spill over into adjacent compartments. Although the compartments were called watertight, they were actually only watertight horizontally; their tops were open and the

walls extended only a few feet above the waterline.

The thick black lines below the waterline indicate the approximate locations of the damage to the hull. The watertight compartments were useless to countering the damage done by the collision with the iceberg. Some of the scientists studying the disaster have even concluded that the watertight compartments contributed to the disaster by keeping the flood waters in the bow of the ship. If there had been no compartments at all, the incoming water would have spread out, and the Titanic would have remained horizontal. Eventually, the ship would have sunk, but she would have remained afloat for another six hours before foundering. This amount of time would have been sufficient for nearby ships to reach the Titanic's location so all of her passengers and crew could have been saved.

If the transverse bulkheads (the walls of the watertight compartments that are positioned across the width of the ship) had been a few feet taller, the water would have been better contained within the damaged compartments.
