Technical Analysis of a Cause of a Vehicle Transfer Case Failure

Abstract: *The article deals with a transfer case failure of Skoda Octavia Combi and a procedure of a technical expert necessary to detect a cause of this failure. During the operation of the vehicle the transfer case and subsequently the gear box started to show a loss of functionality. In order to find out the cause, the damaged aggregates were dismantled from the vehicle in the car service facility in the presence of the technical expert. Based on his instructions, dismantling and disassembly of the aggregates was carried out and the technical analysis performed.*

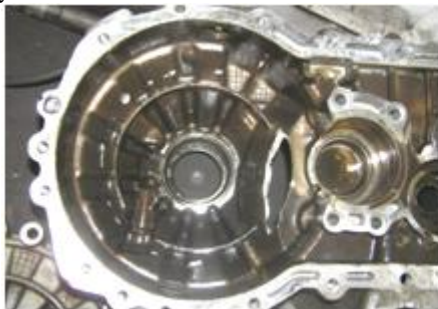
Gear box and transfer case housing cover:
Traces of contacts around the circumference in the area of the differential

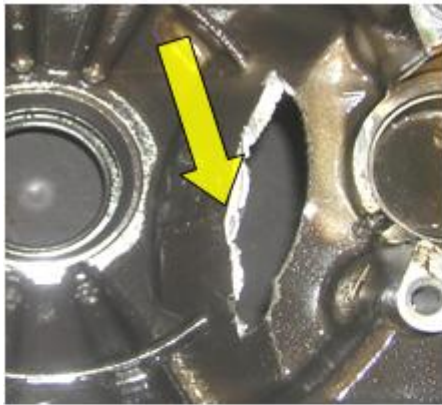
Damaged gear box housing in the differential area as a result of the contact with a part of the differential

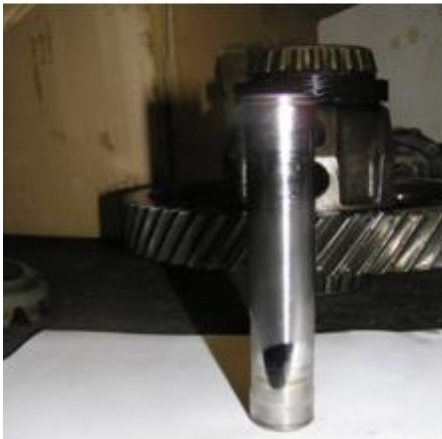
A view of the differential satellite pivot

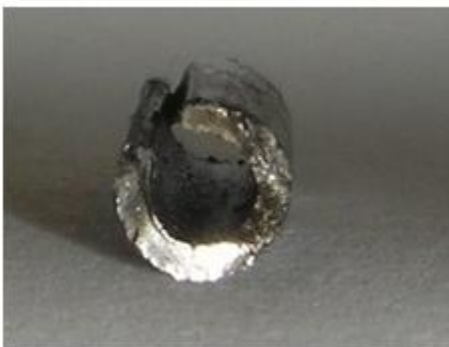
A view of the flexible locking pin of the satellite pivot

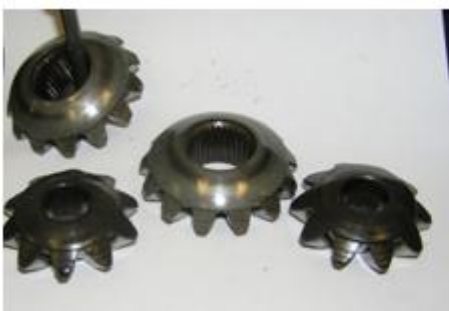
A view of the differential satellites

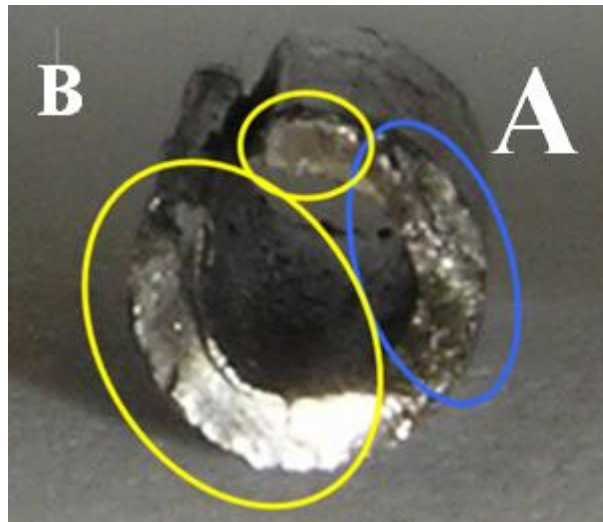
Flexible locking pin of the satellite pivot:

damage A (blue area)
traces of fatigue fracture over part of the area

damage B – yellow area
traces of brittle fracture over part of the area

Based on the known facts and findings, the technical expert came to a conclusion that the detected failure of the transfer case of Skoda Octavia Combi was caused by fatigue fracture, as shown in Fig. 2 – area A, on the flexible locking pin of the satellite pivot, the expansion of which subsequently caused brittle fracture – area B. As a result, the satellite pivot started rotating, gradually released and finally disengaged from its original position. Consequently, the end of the satellite pivot moved outside the segment of the rotating differential housing and the gear box and transfer case cover was destructed by the end of the satellite pivot. The estimated occurrence of the fatigue fracture of the flexible locking pin of the satellite pivot was determined within a longer period of the vehicle operation until the fracture B occurred.

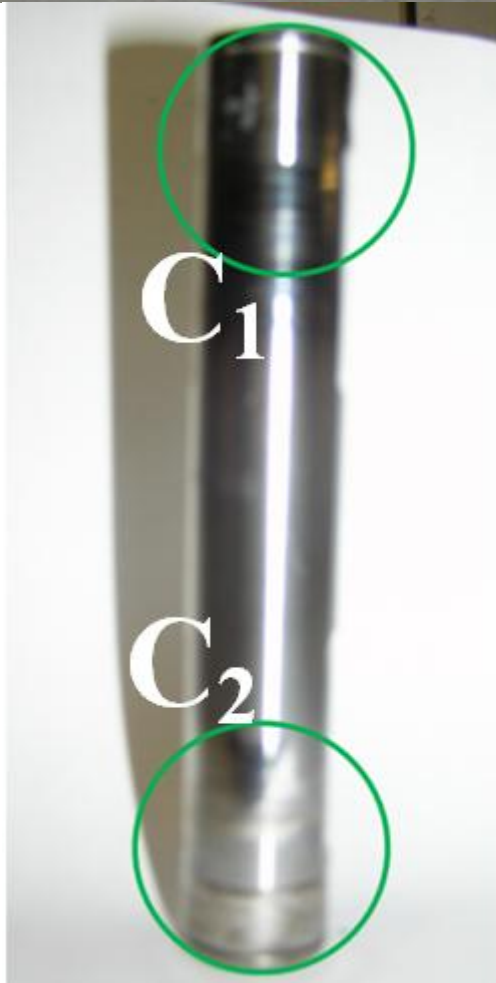
Satellite pivot:

C₁, C₂ – green area
traces of the pivot turning over in the differential housing segment

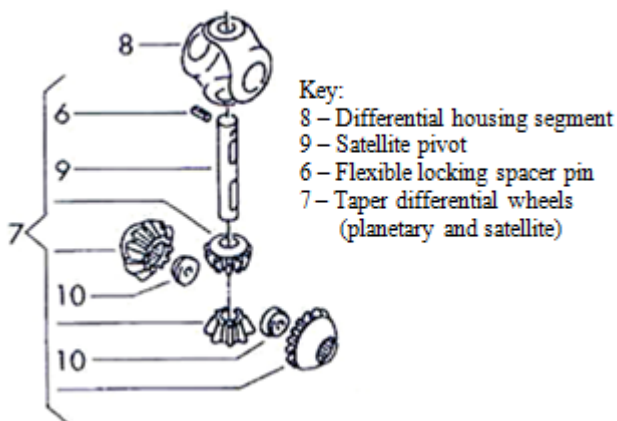
Figure 4: A view of the design of the transfer case and differential

- Occurrence of fatigue fracture on the flexible locking pin of the satellite pivot
- Breaking off the flexible locking spacer pin of the satellite pivot (position 6, Fig. 4), the active cross-section of which was reduced by the area of fatigue fracture

- Rotation of the satellite pivot (position 9, Fig. 4) in its position in the differential housing segment (position 8, Fig. 4) and its gradual release
