Back Analysis of 1135_1065mRL Slope Failure in Shaba Open PIT

Abstract: *This study is about stability analysis of the Shaba open-pit, the back-analysis of the slope failure on the Eastern wall that ripped the main ramp away. The aim is to replicate the factor of safety and deduct the geotechnical properties before failure in order to estimate appropriate parameters while taking into account the influence of water on the rock mass as well as that of other parameters for the normal and safe continuation of mining activities below the unstable zone. The failure of the Eastern wall slope (1135-1065 mRL) has been caused by many factors. The presence of cracks along the contact zone between many friable lithologies. The failure is associated to the combination of many factors leading to gradual reduction of the rock mass properties and finally to the slope failure. The cumulative effects of surface and underground water as well as the blast vibrations around the failure zone accelerated slope failure. Stability analyses were conducted with Slide and other ancillary softwares GEM4D, Trimble 4D, etc... in order to make the best choice possible of geotechnical parameters for the better co

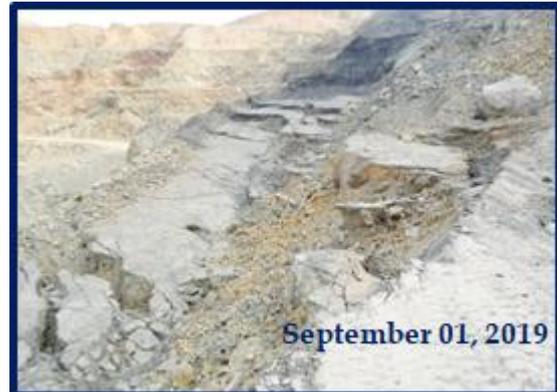
Figure 1: Illustration of the 1135-1060mrL benches failure in Shaba mine

A circular failure observed on September 1st ripped the main ramp away over 1120 m. This failure occurred on the Eastern side of the pit from 1135 to 1070 m.

After occurrence of many cracks on the ramp during mining activities, these intensified when they crossed the main crack which was transversal and oriented outward benches (Dip 42°/ Dip dir. 286°)

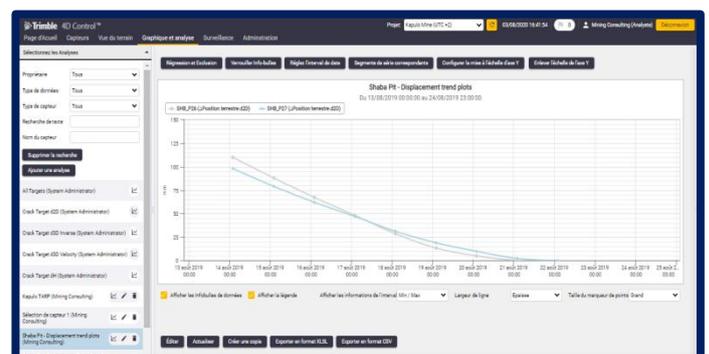
Figure 2: Velocity rate of the two prisms located in the rupture zone with the Trimble 4D software

In six days, the displacement trend chart (Figure 2) for the monitoring system of the two prisms has shown a high rate of 126.5 mm.

The velocity rate was 0.88mm/h and the alarm threshold went beyond the level 4 critical threshold alarm (Trigger Alarm Response Plan).

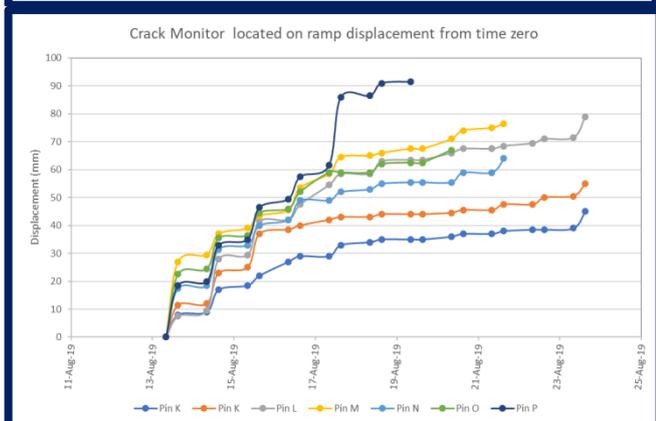
Figure 4: Displacement trend of cracks around the failure zone with Crack Monitor from time zero

The displacement trend for the cracks monitors indicates a high rate of 91.5 mm in six days or 0.64 mm/h.

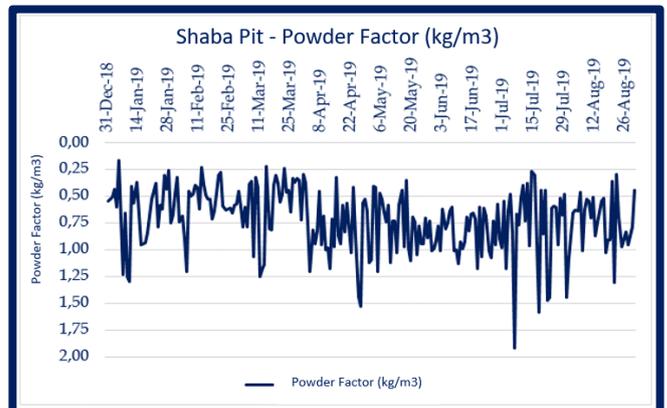
Figure 5: Shaba mine Powder Factor of the production blasting between December 31, 2018 and August 31, 2019.

Blasting data collected show high values of powder factors varying between 0.5 and 1.5 kg/m³. These excessive charges might explain the presence of cracks observed along the main ramp.

The production blasting might have impacted on the reduction of the rock resistance with time but are not directly associated to the failure even though the data collected indicate very high powder factors varying between 0.5 to 1.5 kg/m3.

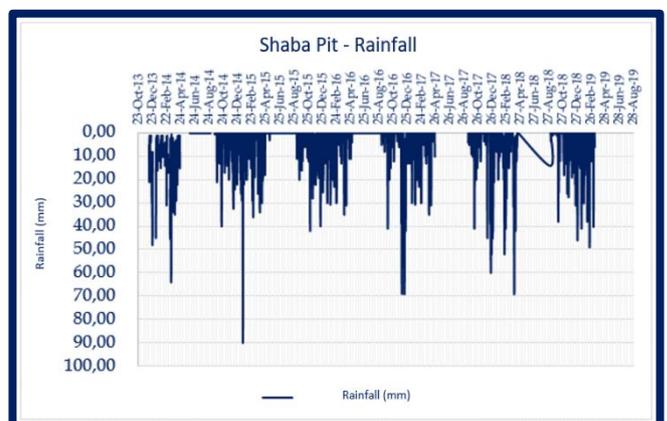
Figure 6: Shaba mine Rainfall December 2013 and May 2019

Underground waters are visible in the cracks, which might also have played a key role in the ramp rupture. Yet, we cannot directly associate the two.

This slope failure cannot be directly associated to heavy rains even if the latter might have contributed to the weathering of Blackshale and granite breccia rocks.

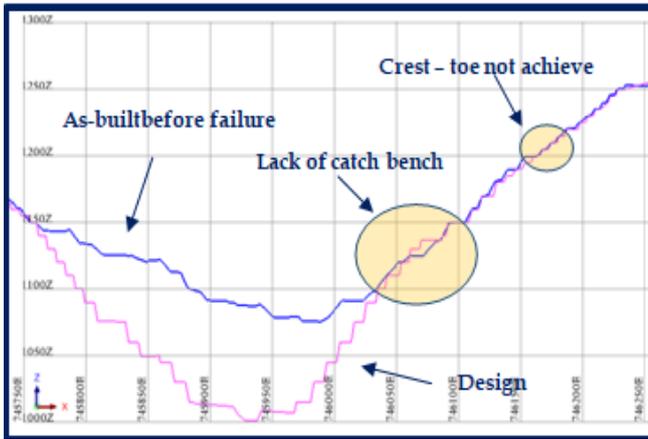
Figure 7: Cross section of the final design vs Topography as-built before the failure

Many cross-sections indicate that the final pit design is not designed as required.

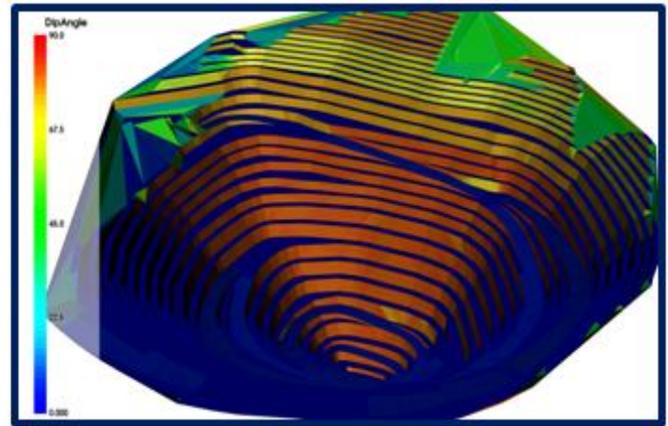
Figure 9: Quick check bench face angles on the final design

The main BFA in the field (figure 10, topo) is comprised between 40° and 55°, which is shallower than the design BFA as shown above. (figure 9).

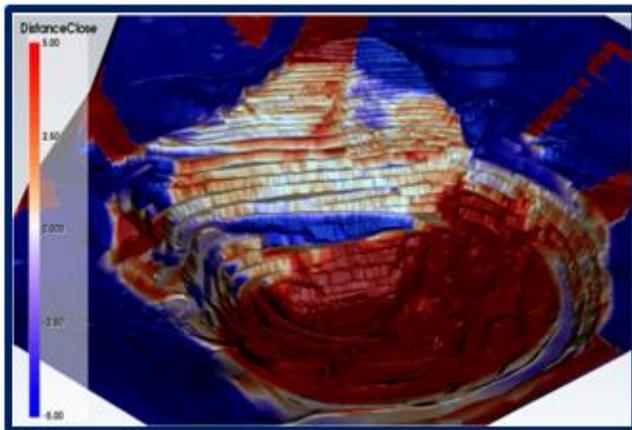
Figure 8: Heat map of the crest loss (red) and under breaks (blue) compared to the final design

The actual crests and toes are not achieved compared to the final pit design and the poor catch berm has been observed in most benches.

The failure zone shows a multiple crest slide and the design is not achieved.

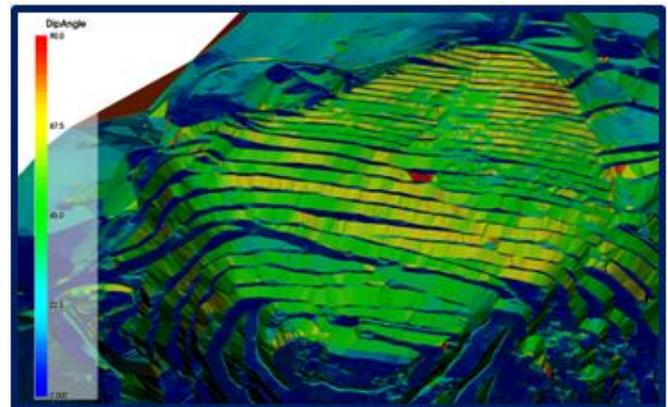
Figure 10: Quick check bench face angles on the topography as-built before the failure

By means of the two graphs, one can state that the design parameters before failure were not adapted to the rock's behavior.

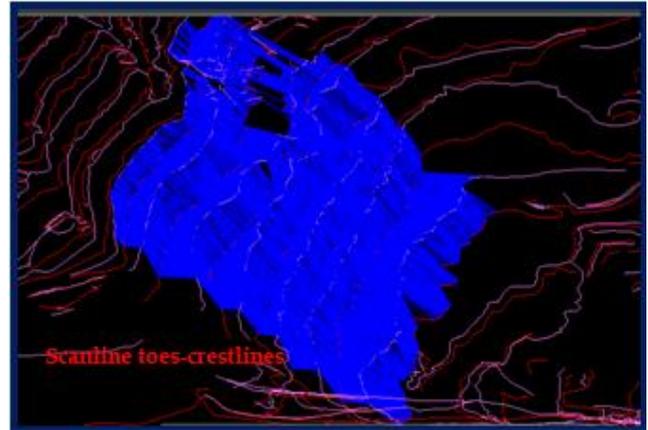
Figure 12: Measure of the configuration of the bench along the scan line around the failure zone before the failure

Map below shows measures bench configuration along scan lines. More benches varies between 40-70°.

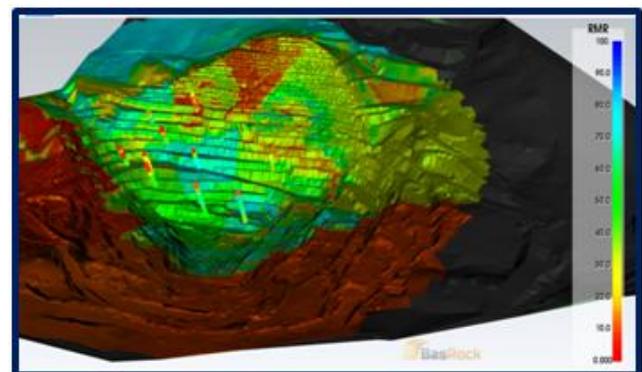
Figure 13: RMR based on the bench face mapping of the bench and geotechnical boreholes

Based on the studies of bench faces mapping and geotech drilling, the Shaba's RMR (Rock mass rating) vary between 22 and 75.

The figure 13 shows a friable rock on the upper benches and a slightly good rock of the bench below.

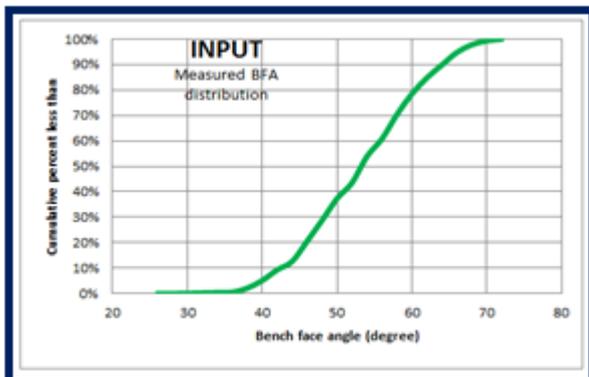
Figure 11: Cumulative percent of crest loss before failure

For the sake of illustration, a catch berm cibleof 6m as described by the final design, for instance for a 46.8° bench Face, the required reliability is 76.2% (1-23.8°), 33°Inter-ramp angle, Bench height of 10m.

From this illustration, it is clearly demonstrated the design BFA in the zone of ruptureis very high for this weak material type.

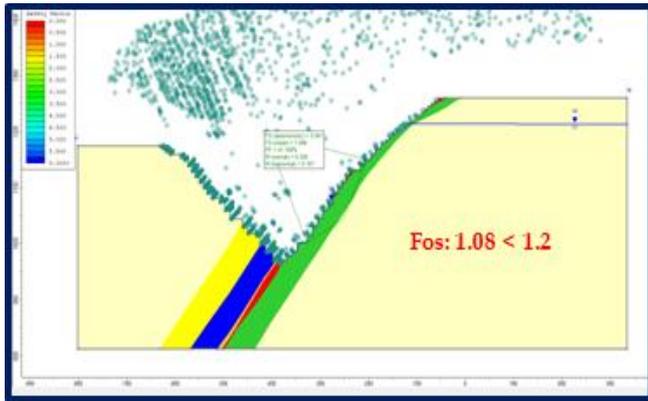
Figure17: Cross Section showing the current geometry after the failure in a dry environment

The sliding surface is located along black shale, Greywacke and Bxg / Bxpg with the current input parameters.

The current pit geometry fails along the contact between the black shale lithological unit / Greywacke and Bxc / Bxcg units.

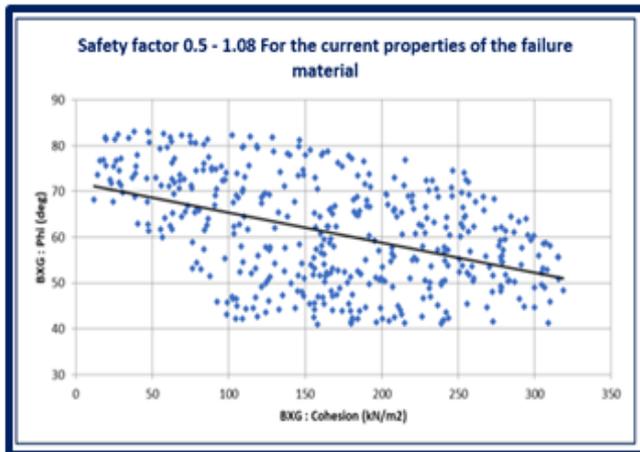
Figure18 : Correlation between cohesion and the friction angle.

The graph in Figure 18 shows the correlation between cohesion and angle of friction for the factor of safety ~ 1.08 for the specified sliding surface.

Any point on this line represents a pair of values (cohesion, friction angle of Bxc) which translate into a safety factor of about 1.08 for the given sliding surface.

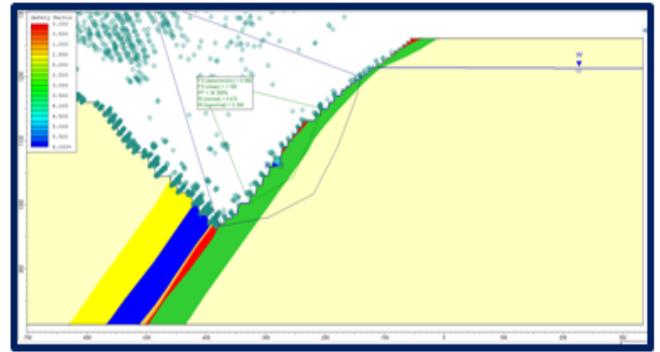
Figure19 : Section showing the new geometry of the pit with the buttress placed at the 1060m level in a saturated environment

For saturated slope the factor of safety FoS: $0.98 < 1.2$ in the buttress of 10 m height x 10 m width x 100 m length (full length of cleaning material) at 1060 ml, buttress face is 80 degrees.

In the case of the non-dry slope, it must be depressurized by drain holes drilling.

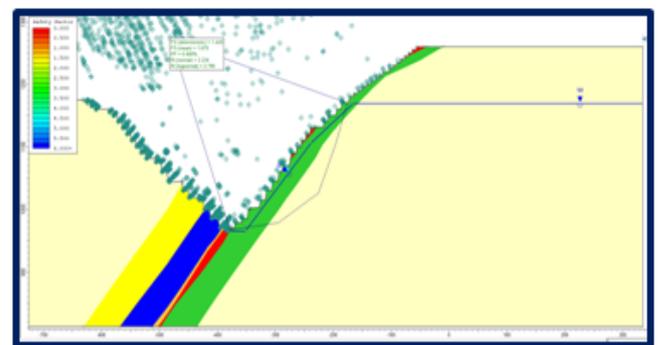
Figure 20 : Section showing the new geometry of the pit with the buttress placed at the 1060m level in a dry and depressurized environment

In the case of the dry slopes the factor of safety Fos: $1.4 > 1.2$ with the same parameters (10 m high buttress, > length for the cleaning fracture limit, width of 10 m).

The buttress must confine the slope and use rock material but make sure that it is properly compacted.

The buttress will be placed at the 1060m level, its bench height will be 10m, its width will be 10m and the slope face angle will be 80°.
