Water Leakages in Transmission Power Projects

Atiq Ahmad Aldosari¹, Baranidaran Santhanam²

There are several scenarios that causes water leakages resulting water ingress inside the basement of various substation projects and cable projects even though proper waterproofing works carried out to avoid ingress of water. Few scenarios list below:

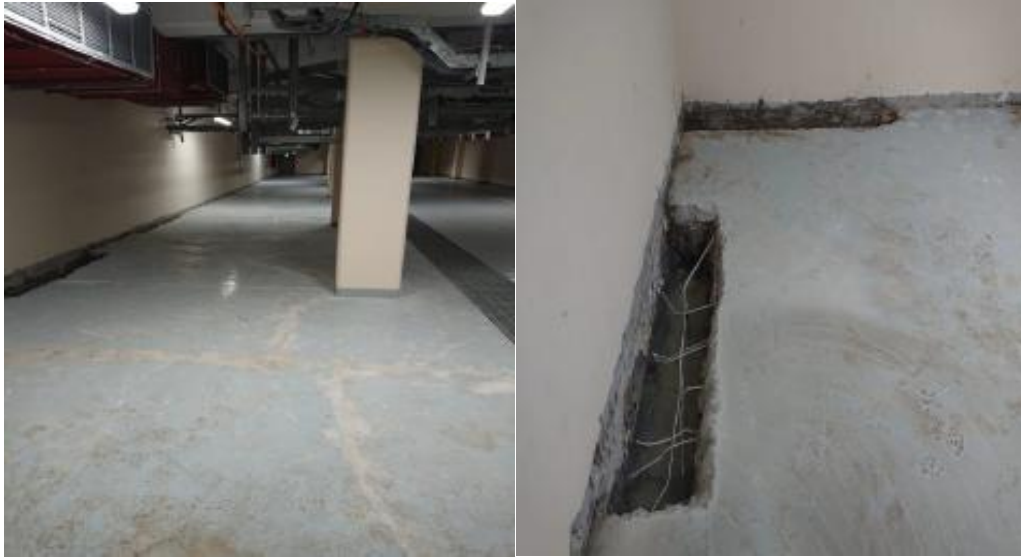
Figure 1: Basement

a) Raft where screed have been overlaid:

From visual observations, water leakages may appear along the construction joints or through nearby expansion joint. The retaining wall construction consists of cast-in-situ concrete. Retaining wall was casted, after the raft construction, with blind side water proofing application on the shoring. In blind side application of water proofing, membrane was applied on to the prepared shoring wall before casting of concrete. Once the water proofing membrane is in place, shutter will be casted and concrete will be poured. In such cases, it is common occurrence for water proofing membrane to be damaged during steel erection which can allow water ingress to happen or if the waterproofing membrane is not installed properly the water can enter into the breaches and results in leakages.

- Screed to be removed along the kicker joint for minimum 500mm to ensure whether water ingress is flowing through kicker joint or through cracks in the raft.
- Curtain wall injection to be done between the screed and the raft, or the screed to be removed completely and crack injection to be adopted using low viscosity PU resin

- After injection, the injected location should be observed for one week to check the effectiveness of the rectification methodology.

The rectification of the above cases are as per codes and standards which states-any cracks greater than 200 microns is required to be injected and closed so that the durability of the structure is maintained. This aspect is proposed to cover all aspects related to the durability of the structure as well as any temporary issue outlined above in the observations.

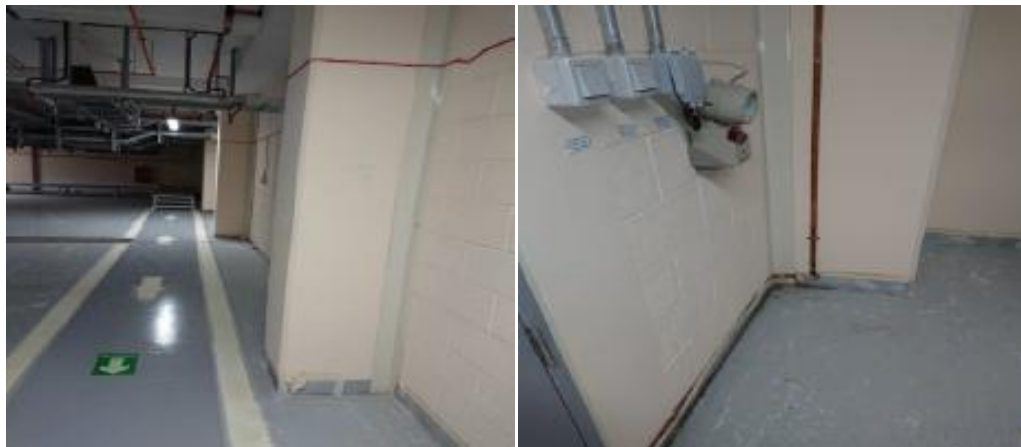
Figure 2: Basement expansion joint area

b) Expansion joints:

The water ingress from the basement expansion joint is due to some breaches in the waterproofing system or due to installation of improper waterproofing detail in the joint

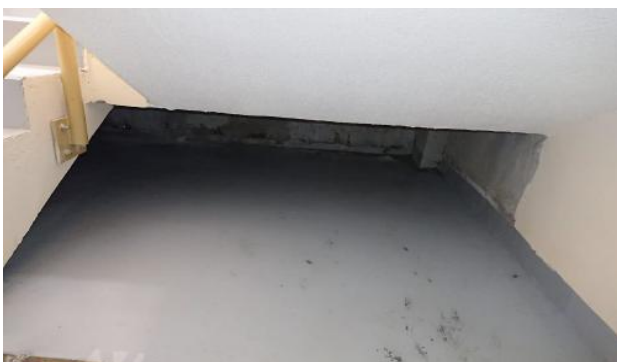
Figure 3: Basement staircase area

c) Staircase area:

There is no access to assess the source of leakage, the source of leakage may be due to breaches in the waterproofing system along the kicker joint.

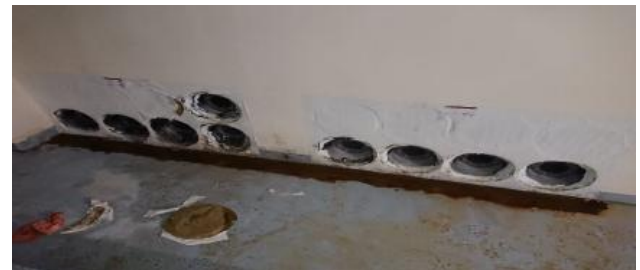
Figure 4: Basement cable entry ducts

d) Duct bank sleeves:

The source of leakage may be due to breaches in the waterproofing system along the kicker joint.

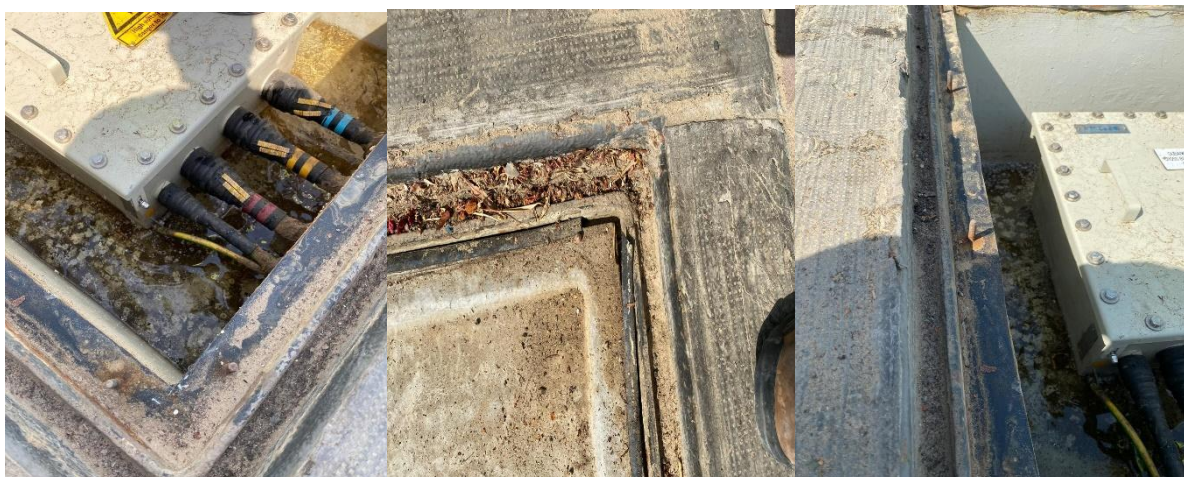
Figure 5: Flush type link box manhole

- Surface water flooding
- Street irrigation
- Humidity
- Use of inappropriate insulation on the cable entry sleeves
- Non-usage of water tight manhole covers.
- Manufacturer instructions not followed in installation of manhole covers & frames.

Street irrigation, surface water flooding and humidity are common causes that resulted to the water leakage in the flush type link boxes manholes due to failure of the waterproofing around the manholes.

- New design of manhole cover with 100% water tightness proper insulation shall be done along with manufacturer representative.
- Proper installation of waterproof system have been done around manholes.
- Mechanical sealant used to seal all the cable entry sleeves
- A mock up was done for one manhole and kept under two months observation for make sure the effectiveness of the system.

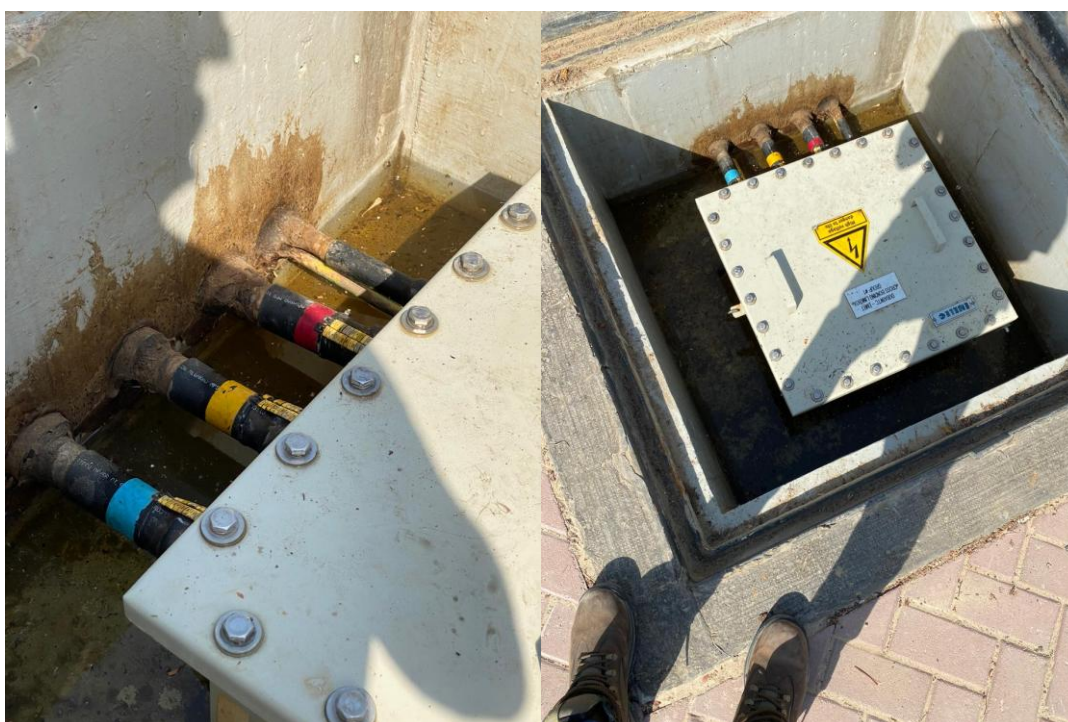
Figure 6: Flush type link box manhole

Apart from that, the failure of water proofing around the cable entry sleeves is another issue and mainly due to

chemical used to seal the entry sleeves from inside of manholes.
