Predictive Maintenance of the Transmission Overhead Lines to maintain the Reliability of the Overhead Transmission Lines Network: A Utility Experience

Transmission Maintenance Department-Lines Maintenance, Dubai Electricity and Water Authority

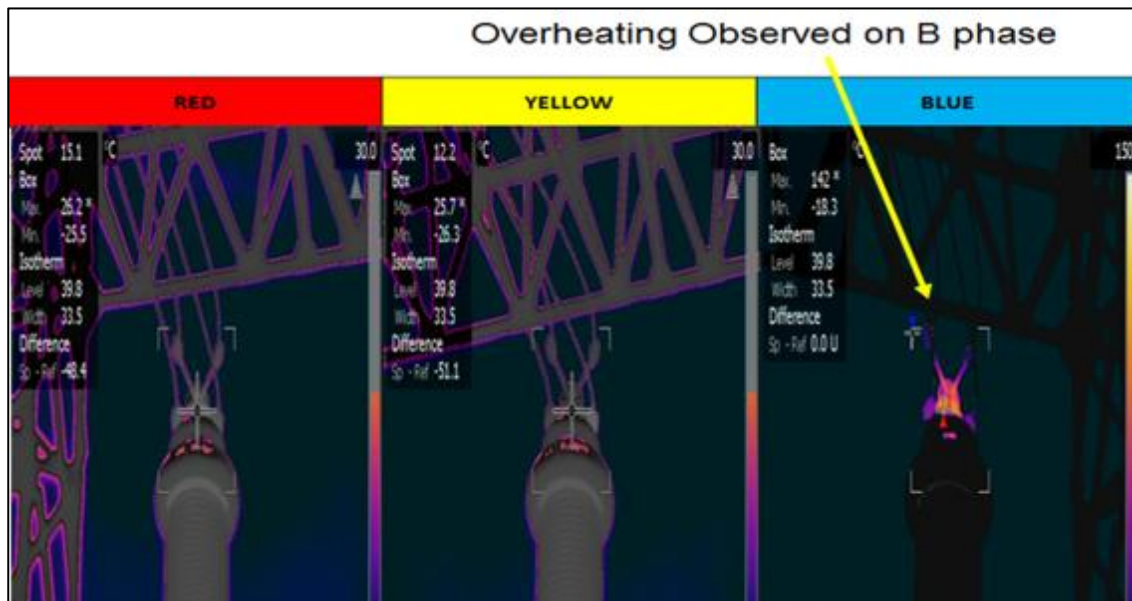
Figure 2: Examples of the overheating abnormalities detected, and thermal images generated (Source: DEWA infrared inspection site reports, 2012)

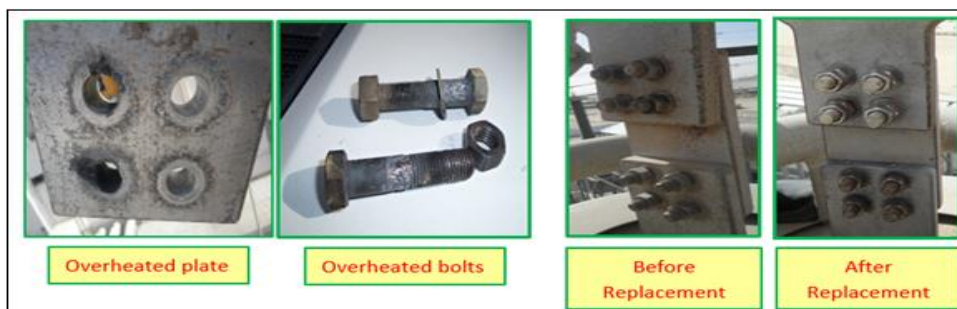
Overheating on joints may be caused by overloading of the conductor or loosening of connection on the clamp or compression joint. However as experienced, all were related to loosening on the connection joints. In all cases where the overheating was rectified, the contact resistance is found high and way beyond the allowable contact resistance (based from standard value) as measured using a contact resistance meter. The causes of the high contact resistance found during rectification are loosened machine bolts (in few cases undersized machine bolts), loosened compression joints and intrusion of contaminants in between the terminal plates as shown below in Figure 3.

Figure 3: Overheating due torusted and undersized bolts. (Source: DEWA corrective maintenance site work reports, 2012)

During rectification, the terminal plates were opened and thoroughly cleaned with the use of appropriate tools needed in compliance with the methodology established for the repairing of overheating. In some cases, the compression joints are retightened using hydraulic pressing machine with appropriate size of die. To check if the repairing work is done properly, the contact resistances of the points are again re-checked with the use of contact resistance meter.

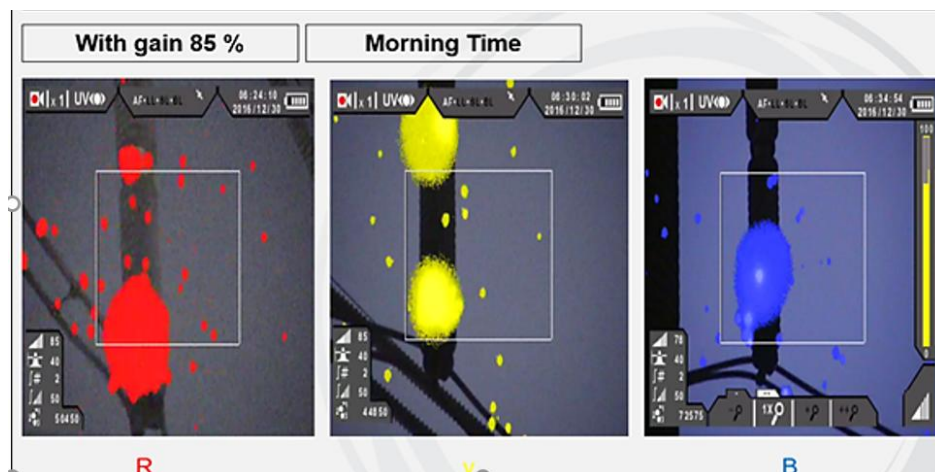
insulators. It can be seen from the picture the localized corona discharge with high corresponding photon readings found on all the 3 phases R, Y & B.

Figure 4: Sample of Ultraviolet Corona discharge abnormality (Source: DEWA ultraviolet inspection site reports, 2016)

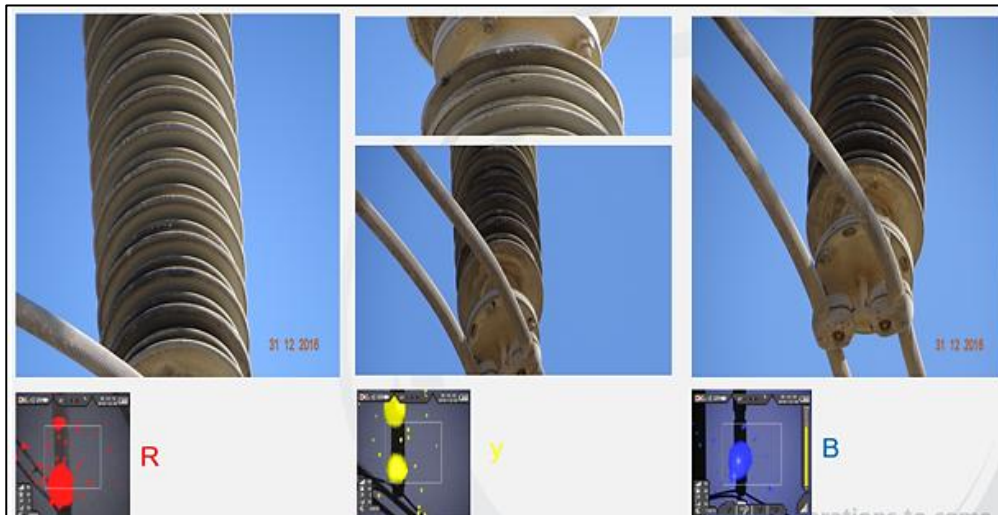
Figure 5: Defects (traces of black spots) found on the under slung insulator silicone coating. (Source: DEWA ultraviolet inspection site reports, 2016)

After detecting the abnormality, it was verified through binocular inspection traces of black spots on the insulators. Based on these findings, a close-up inspection on the insulators were conducted during a planned outage of the 400kV circuit and it verified the existence of burnt marks and deterioration of the silicone coating on the local areas where the corona discharges were found. Based on this confirmation, silicone coating has been re-applied and the corona readings from the later UV camera inspections found normal.
