# An Experimental Study of Microbial Corrosion and Fatigue-Corrosion of HSLA Steel in Seawater

**Abstract:** High strength low alloy steel known as HSLA is widely used in naval construction and ship building due to its capacity to resist to fatigue and corrosion which are considered to be complex phenomena. A study on microbial corrosion in seawater is held on steel plate and compared to specimen removed from a 27-meter naval unit subject to about 37 years of service. Both mechanical properties and microstructural behaviour were studied. The study showed a huge decrease in ductility of steel after exposure to microbial corrosion which is confirmed with Scanning Electron Microscopy (SEM) images. The steel serving for about 37 years showed less decrease in ductility but more in terms of elasticity and this was confirmed with SEM images showing a huge quantity of micro-cracks and corrosion sites. The steel submerged in calm sea water showed a form of pitting corrosion and less fractures.

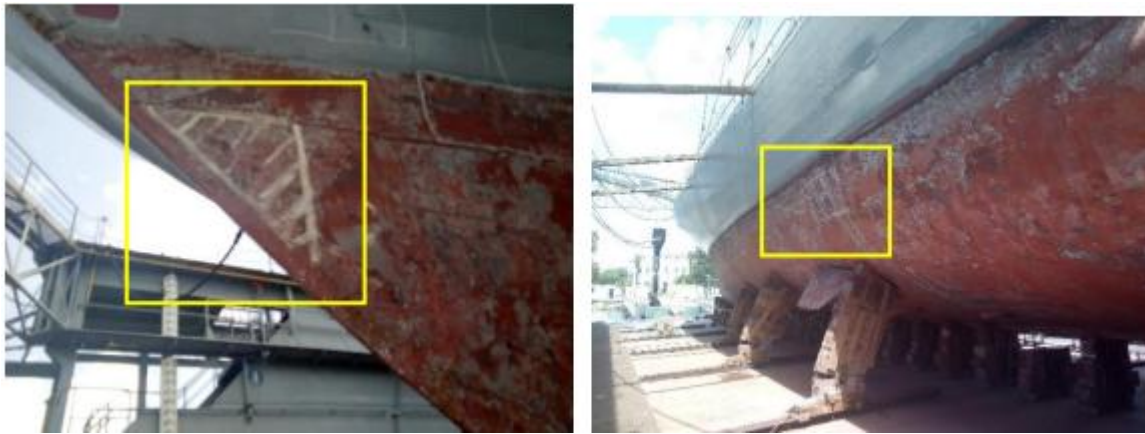
Figure 1: Acquisition of samples of the 37-year-old ship; front and middle area (samples S1 and S2)

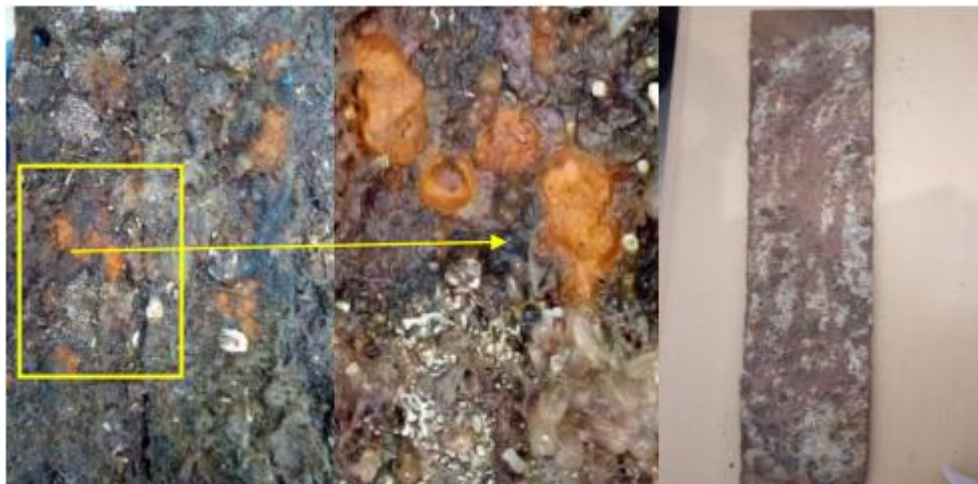
Figure 2: immersion of HSLA steel plate in harbour for 220 days (sample 3)

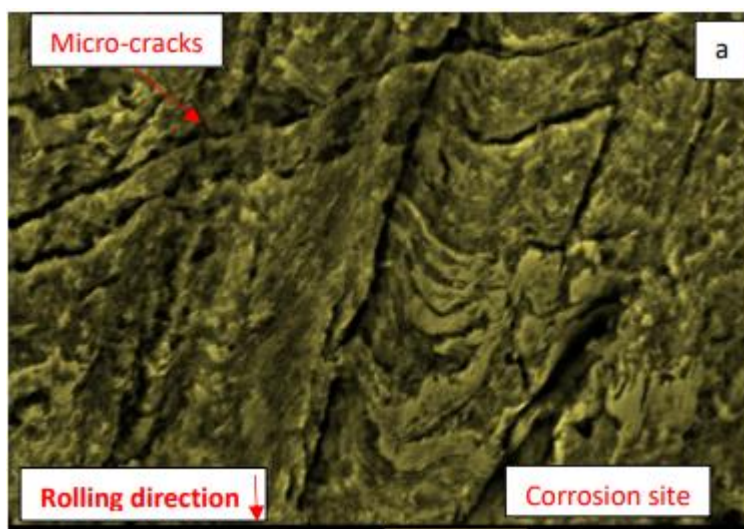
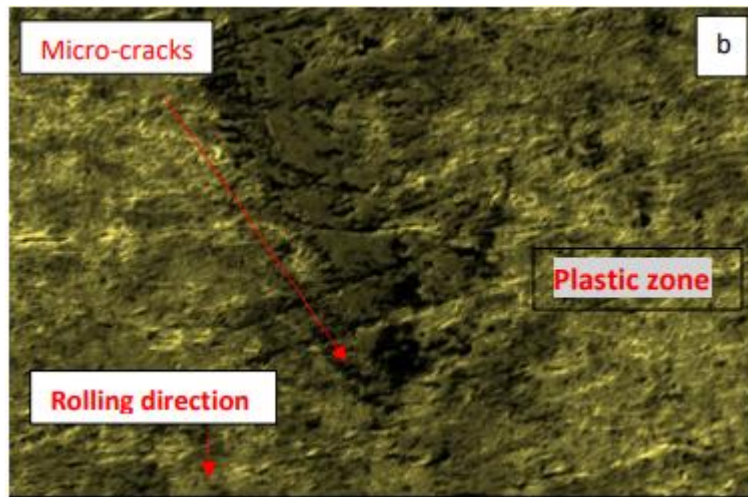
Figure 6: Microstructure evolution of sample S1 (a) and (b) sample S2 after 37years and 220 days of corrosion exposure

All of the three samples were carefully cleaned, polished and etched with Nital solution (5% nitrate, 95 ethanol) for the SEM. The microstructure of base metal is shown in figure 5. It presents a homogeneous structure of ferrite and pearlite with numerous precipitations of alloy carbides. Figure 6 shows the microstructure evolution of S1. The presence of microcracks is very clear. A significant amount of microcracks is revealed with a perpendicular direction compared to the one of rolling. The cracks spacing is estimated to about 1.3  $\mu\text{m}$  in S1 and about 2.2  $\mu\text{m}$  in S2. Thus, S1 is more solicited than S2. Plastic zones are relevant by SEM images which is the region beyond the rupture zone and host aspects of both effect of cycling loading and fatigue indicators such as the beach marks well expressed in the surface with presence of multiple striation and second of crack propagation and closure phenomena. It is more obvious in sample 1 than 2, so it is considered to be an important parameter in fatigue crack growth.

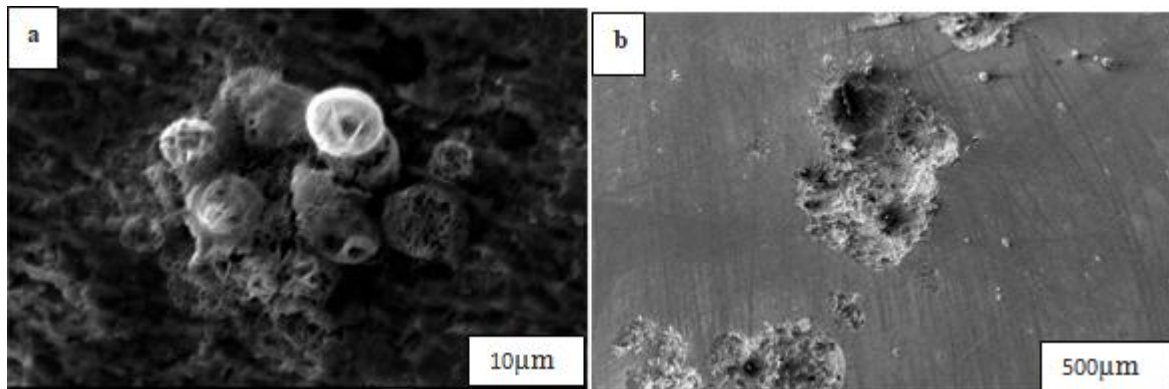
Figure 7 (a, b): Microstructure evolution of sample S3 (a)

Figure 7 shows the presence of microbial culture on the surface of the sample which had a great atmosphere for their proliferation. This form of attack led to the pitting corrosion phenomena which is obvious by microscopy investigation. In fact the presence of those active species induce a difference on the electrochemical potential on the surface of the steel and leads to breakdown of the passive film initially formed to protect from the reduction process. Bacteriological presence causes the propagation of pits to a scale of 500 $\mu\text{m}$ . Thus microbial-influenced corrosion occurs

in stagnant conditions of flow which enhance the deposition and bacteriological growth.
