Rockfall at Siyar Baba Waterfall, Tehsil and District Reasi, Jammu and Kashmir (UT)

Raj Kumar¹, J.S. Pawar²

Abstract: *The Siyar Baba Waterfall located in Reasi District of Union Territory (UT) of Jammu and Kashmir is famous for its beauty and tourist attraction. The occurrence of rockfall/ landslide on 15th July 2018 adjoining the waterfall caused casualty of more than 07 visitors which led to reduction in flow of tourists. Accordingly an attempt has been made to determine nature and structure of rocks, topography and drainage pattern in the area to ascertain the causes of rockfall/landslide and to work out preventive measures thereof. Geologically the area under study is a part of Reasi Inlier and comprises of rocks consisting mainly of cherty/non-cherty, grey to creamy white and pale to brown, dolomitic limestone bands belonging to Sirban/ Trikuta/ Reasi Limestone Formation of Proterozoic Age. The rocks in and around the waterfall are affected by numerous fractures and joints due to proximity of the area to Reasi Thrust (M.B.F). The general trend of the rocks in the area are NE - SW with dips inside the hills having angle of inclination from 21^o to 57^o due North and North-We

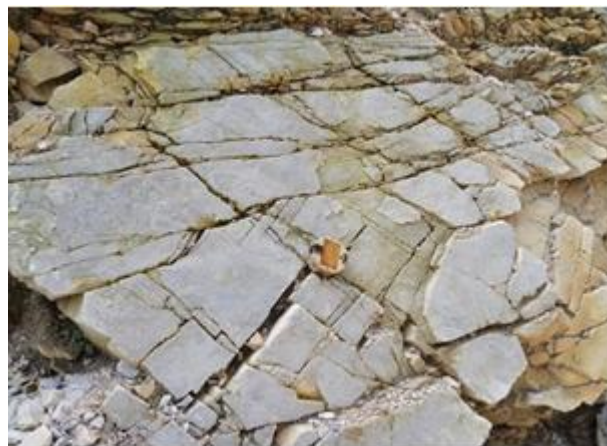
Reconnaissance Survey was conducted in and around the affected area and various observations were made. Geologically the rock in the area under study is Sirban/Great Limestone forming a part of Reasi inlier, which consists of cherty/non-cherty, grey to creamy white and pale to brown flaggy, dolomitic limestone bands. The rocks exposed at site and adjoining waterfall have strike North East - South West with dips inside the hills having angle of inclination from 21° to 57° due North and North West. The dolomitic limestone in the area is affected by numerous fractures and joints (Fig. 4) with considerable orientation having moderate to wide fresh spacing between joints have been observed (Fig. 4&5). The orientation of the joints varies from few millimeters (mm) to centimeters where the dominant deformation has taken place. The rock has been shattered into small rhomb shaped fragments due to deformation by the impact of the nearby active Main Boundary Fault. (Fig. 5).

Figure 4: The joints in Sirban Limestone near the landslide having variable Orientation

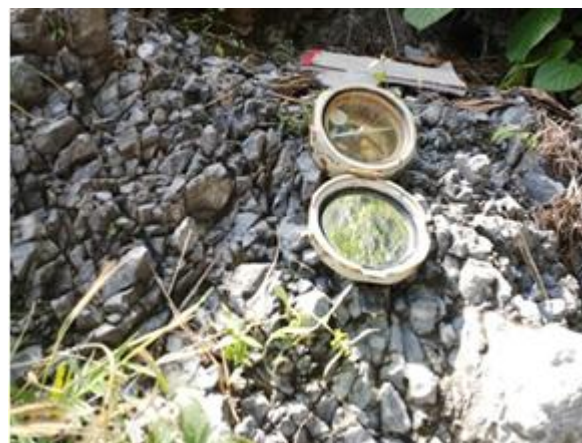
Figure 5: The rocks shattered into small rhombs adjacent to the Siyar Baba waterfall.

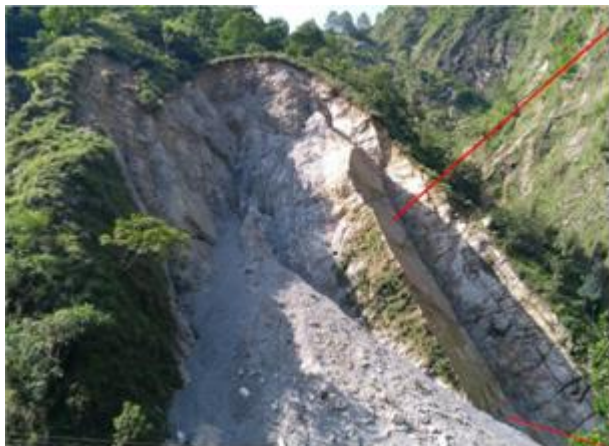
Another landslide (slope failure) has occurred at about 80-100 m southeast of the Siyar Baba waterfall due to the wedge failure caused by the intersection of two set of joints. The one set of joints along the bedding plane whereas other one across to the bedding plane (Fig. 6 & 7). The occurrence of joints in the rocks present in the area may be due to the proximity of the Reasi Thrust (M.B.F) which passes near Talwara (Aggarwal and Bhattacharya 1981). The Reasi Thrust (M.B.F.) is the most significant from Geology point of view in the area and is neo-tectonically active (Auden 1944) and (Gansser 1964). Raha (1984) has identified a prominent joint plane dipping at 40° North East at up section just near the road linking Siyar Baba waterfall. Due to the proximity of the Main Boundary Fault (M. B. F.) the rocks are more susceptible to displacement/movement which is also considered one of the major causes of the occurrence of joints of variable orientation/spacing and condition.

Figure 6: A Landslide occurred earlier southeast of Siyar Baba Waterfall

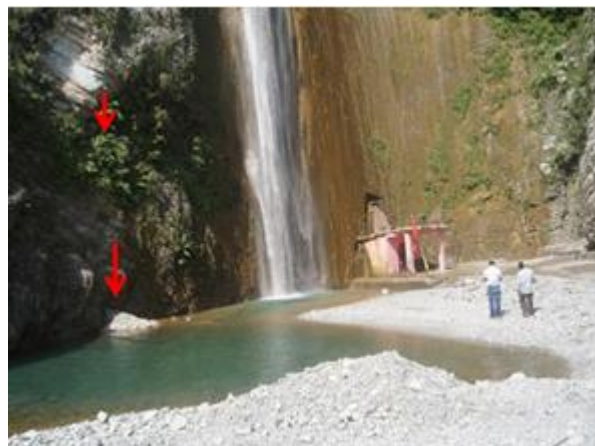
Figure 8: A fresh rockfall (depicted by arrows) adjacent Siyar Baba waterfall.

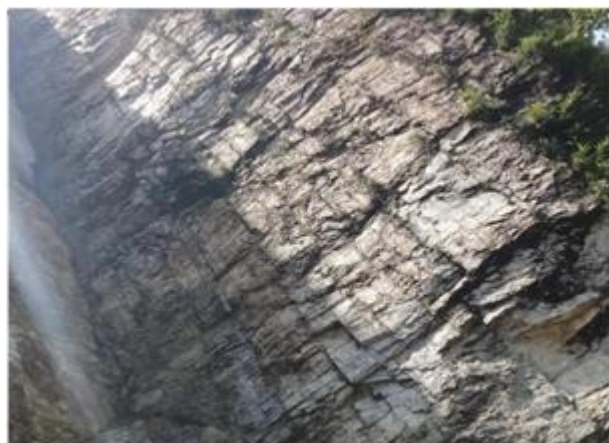
Figure 7: Close view of the joints which have major role in triggering landslide

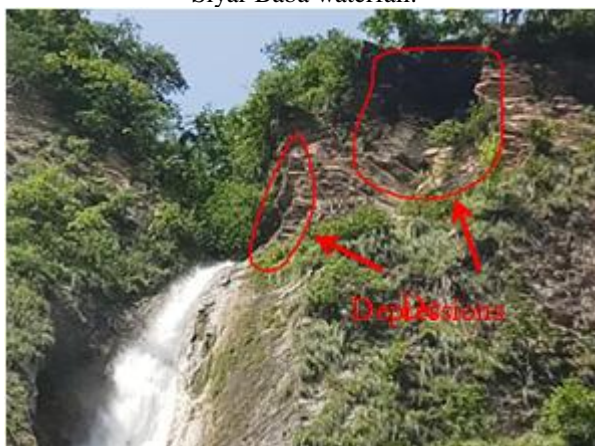
Figure 9: Depressions created after fall/ displacement of the rock mass.

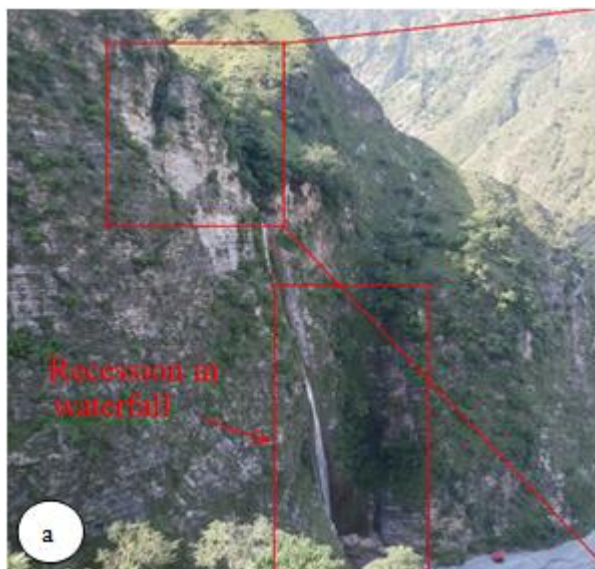
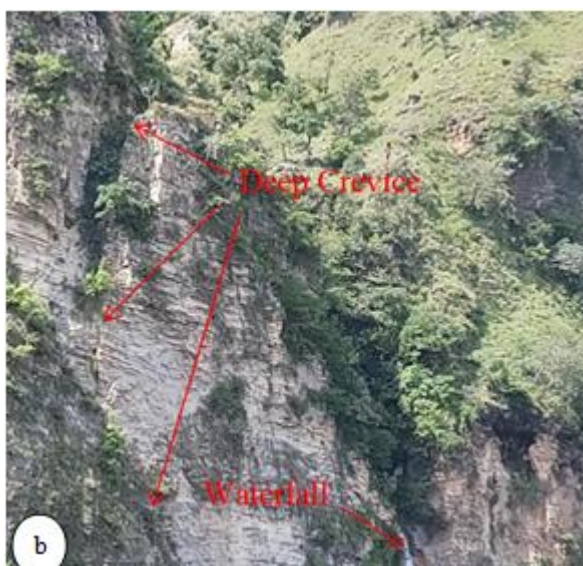
At the point source of waterfall along the left side a deep crevices has been observed pointing increase in its width upward where some plants have also been noticed (Fig. 10 a&b). The roots of the plants too have exerted pressure on the bed rock and played major role in origin of the joints/fractures. The rocks at the right side of the waterfall are also affected by joints as well as folding and at places weathered fragments have tumbled down from the cliff under the influence of gravity. The joints and crevices become deeper and wide due to surface weathering, pore pressure on oversaturation besides modification of weathered sediments by the fluvial action especially during flood season. Thus the wedges caused the rocks to fall due to the presence of the roots of the trees by exerting tremendous pressure to weaken the rock strength at source to displace from its place of deposition (Fig.10-a&b). The concentric as well as elongated depressions have developed in the rocks at the middle and lower part adjoining the waterfall from where limestone band has eroded due to the continuous expansion and contraction of the mineral present in the bed rock and existence of numerous joints/fractures. The joints are so deep which are clearly visible. The recession of point of waterfall is clearly depicting that the bed rock at the point of the waterfall either has been eroded or a block of it has been displaced which is evident by the geomorphic features at site (Fig. 10-a&b).

Figure 10 (a): A deep crevice developed at the left side of the waterfall widening upward due to growth of vegetation. The lower part shows waterfall area recede due to weathering and erosion.

Figure 10 (b): Enlarge view of the Crevice developed at site shown in figure 10-a.

- 1) The rocks at the source, crest and adjoining the waterfall can be treated by adopting latest Engineering Techniques i.e. gentle offloading and plugging of major crevices.

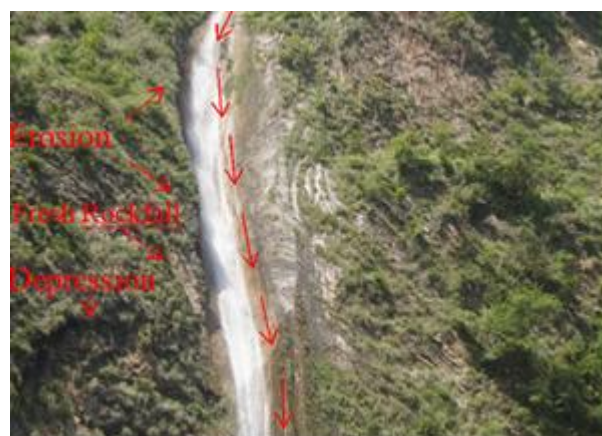
The water released through the cascades does not fall straight. Initially it hits the rocks at top where it deflects towards right side and then has straight fall up to the base (Fig. 11). The rocks which come in spade of jet of waterfall are also subjected to erosion causing further displacement of sediments downward. The impact of falling blocks of rocks from the cliff to dislodge rocks adjoining the waterfall is clearly evident due to the presence of fresh depressions and scars at left side of the waterfall (Fig.11). Similarly the percolation of water in the jointed rocks in the watershed area also have important role in weakening them as there are many small springs located in the catchment area of the waterfall (Fig. 12) which are feeding water to the nalla/khad which is the main source of water in the origin of Siyar Baba Waterfall. The first order streams in the catchment area having high gradient have significant role in depositing huge sediments in the main nalla of waterfall.

Figure 11: Deflection in the waterfall and presence of depressions in the waterfall area

- 2) The erosion created by jet of water at the base of waterfall and by Siyar Nalla along the right bank can be minimized by constructing a concrete wall below the waterfall and along the bank adjoining the hill.

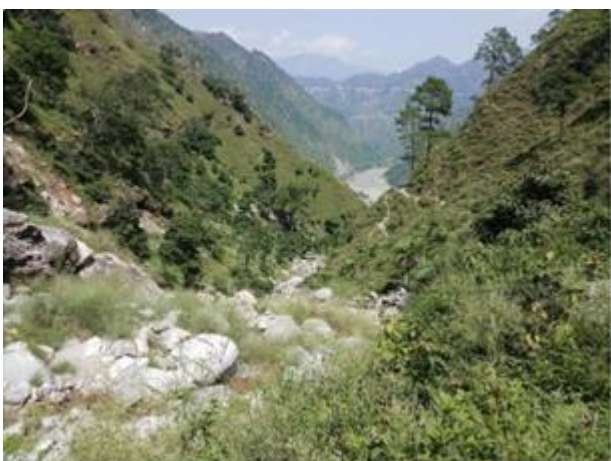
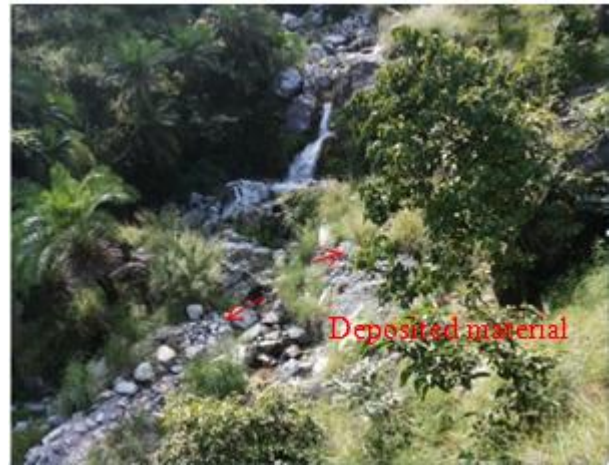
The first order streams are comparatively broad at its origin but as it flows down, the gradient as well as size of rock boulders along with the width of the nalla decreases which is depositing pebbles, grit, sand and silt/clay as small braided bars and natural levees (Fig.13&14). The deposited material is further modified during floods in rainy season which is either eroded or a part of that is deposited at point source of the waterfall. By the passage of time it is either eroded gradually by the nalla water or deposited at the waterfall point and due to impact of Neo-tectonism suddenly falls

Figure 13: Presence of boulders and cobbles in the nalla upstream of the Siyar Baba waterfall

Figure 14: Pebbles, Grit and Sand in the form of small braided bars levees upstream of the Siyar Baba Waterfall

- 3) Gravels and sand carried by the water increases erosion which causes the waterfall to carve deeper into bed rock as well as ridge above it. If small check dams are constructed at the catchment above the waterfall within the main nalla upstream at a specific interval and feeding channels near the confluence with main nalla can play effective role to restrict further transportation of the material from the source.
