# Complications during Multi-Level Basement / Deep Foundation Construction Projects

**Abstract:** *This paper chiefly confronts the major complications during multi-level basement / deep foundation construction projects in Delhi. Few of the problems are specifically discussed for Delhi, whereas others are ubiquitous. The major realm of concern are presented here: inadequate dewatering procedure, improper or inadequate soil nailing and shotcreting, poor workmanship in steel placing and binding, improper disposal of anchor slurry and muck, excessive water pressure. Lack of proper monitoring / leniency in monitoring of water table attributed to collapse of earth brim. Improper or inadequate soil nailing and shotcreting contributed to deposition of soil to foundation thereby adding to increase in deposition of muck. Inadequate PCC thickness led to collapse of PCC and creation of large pits thereby increasing inconvenience in muck clearing and causing poor workmanship in steel placement and binding. Failure to proper marking of steel bars in stacks after their cutting and bending can also be a major cause for poor workmanship in steel placement. In this paper, we present illustration o

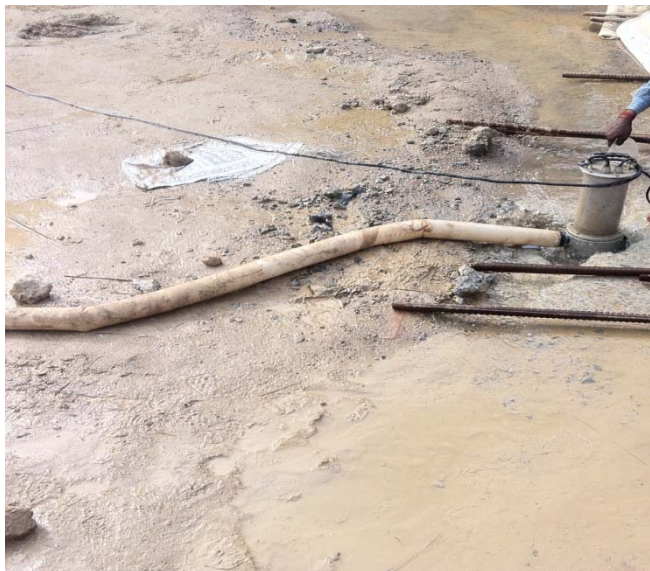
**Figure 1:** Deep Well Pump Dewatering System Used For Dewatering Excavated Area

Fig. 1 and Fig. 2 illustrates a deep well pump dewatering system used for dewatering of excavated area and Gravity method dewatering system: centrifugal pump used to prevent rise in water table for foundation construction of a multi-tower high rise building project near Pragati Maidan area in Delhi. The depth of excavation is 15.25 meters i.e. around 50 ft below N.G.L for the 49331.18 sq mt. excavated area. Investigation revealed insufficient dewatering procedures for excavated area as 32 deep wells with 15-cm dia. pumps were used to draw down water-table. However, out of these 32 more than 10-12 pumps were found always out of order and no proper monitoring of water table was done because of which huge amount of water was stagnated in excavated area which was resulted in deposition of slurry and muck and unworkable conditions for labour. Problem is shown in fig. 3.

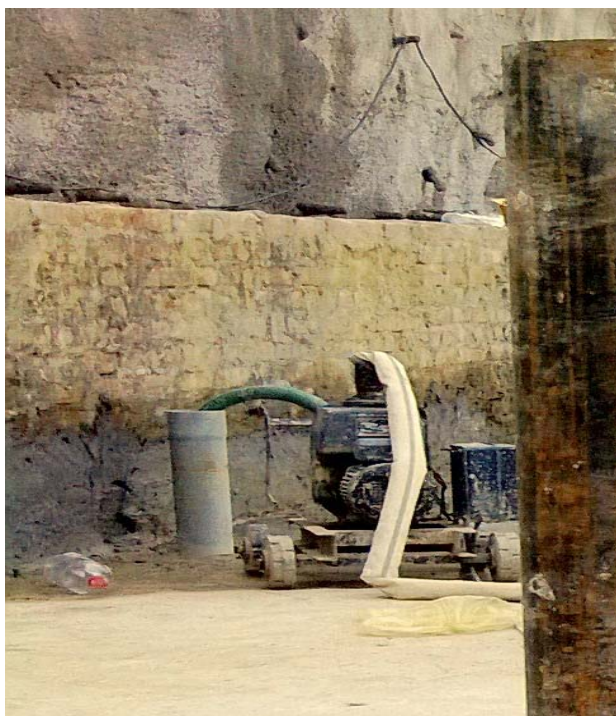
**Figure 2:** Gravity Method Dewatering System: Centrifugal Pump Used To Prevent Rise In Water Table.

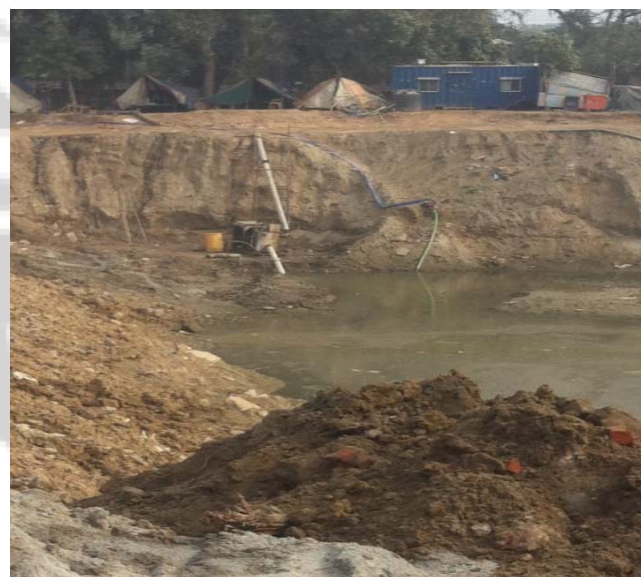
**Figure 3:** Muck And Stagnated Water, Unworkable Conditions Due To Improper Dewatering.

When dewatering is performed without adequate water-table monitoring procedures, settlement of the soil surrounding the excavated area can occur. It is recommended that planning of a dewatering system should refer to the original design data, boring logs, and the instrument system data. Due to non-homogeneous and non-isotropic soil properties, monitoring and, if necessary, modifying construction operations before each stage of excavation should be performed. Survey and evaluation of the neighboring structures and facilities before, during, and after the excavation are extremely important. If observations of a neighboring structure or facility indicate an inadequate

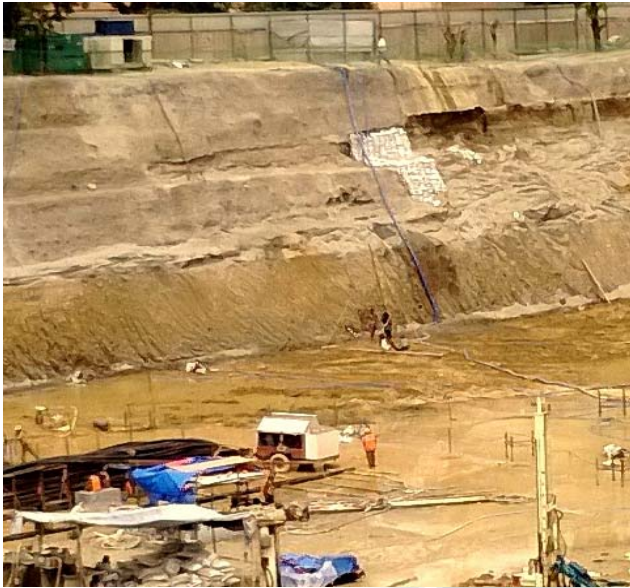
Fig.4 shows the earth retained on earth brims by means of nailing and shotcreting method. These nails are usually driven horizontally by mechanical driving method upto a depth of 7-8 meters spaced at 250 mm or more center to center depending upon the soil conditions.

**Figure 4:** Stabilization of Slopes By Soil Nailing And Shotcreting.

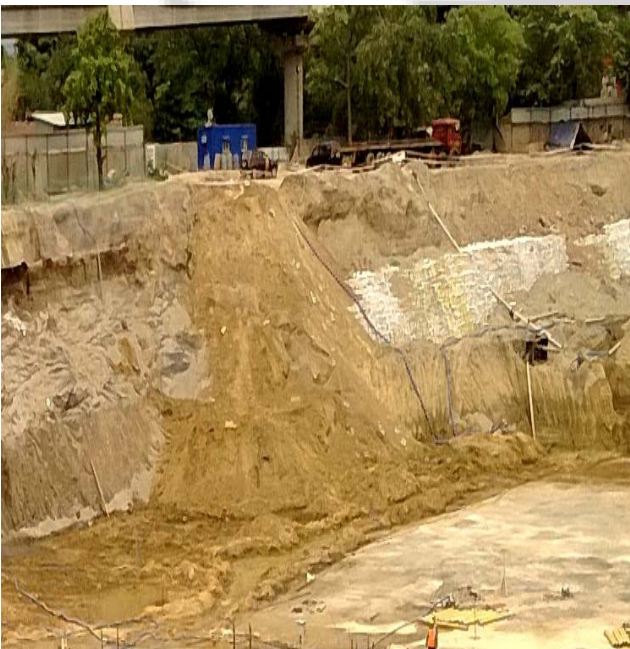
Investigation revealed that because of slow working and incomplete shotcreting unacceptable performance of soil nail has been encountered in several projects. The following case reviews problem related to inadequate nailing performance. In one project, soil nails were driven and left as shotcreting was delayed. Because of delayed shotcrete the soil of earth brim started to erode and fall in excavated area. It also added to formation of muck in excavated area. This problem did not result in any catastrophe, and therefore was seldom publicized. However, their “near disaster” condition was obvious. The problem is shown in fig. 5.

**Figure 5:** Soil Erosion From Earth Brim Due to Delay in Shotcrete.

Whereas, the problem of soil erosion from earth brim is concerned, it can be prevented by carefully and properly monitoring soil nailing and shotcreting process. One thing should be taken care of that after the nails are driven into soil, after that they should be locked with the help of S.S mesh of desirable size and a bearing plate mostly of size ranging from 150 sq. m to 250 sq. m, followed by shotcreting. Iron nails should not be left exposed for a longer period of time. In most cases, the parties involved in the foundation construction were aware of these deficiencies; however, since safety measures have not been adequately adopted, no action was taken to improve the nailing performance. Clearly, many problems could be avoided and many collapses could be prevented if stricter quality control measures were adopted.

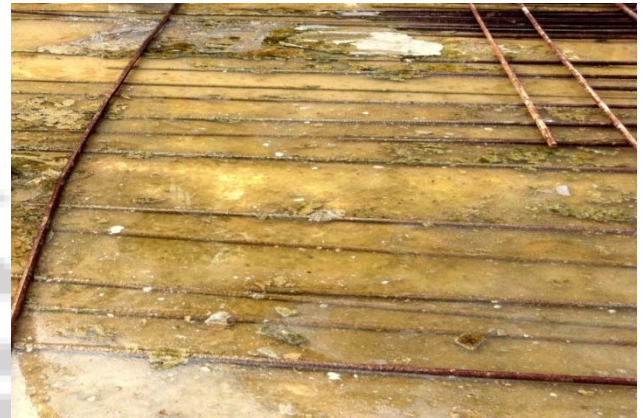
It was reviewed that poor workmanship in reinforcement placement is common in raft (foundation), and columns. Generally as there is no proper spacing maintained between rebars. Problem is evident when the de-shuttering reveals the bars exposed, without concrete cover. Clearly, such structures are less capable of accommodating proper strength and are susceptible to premature deterioration. In many cases the rebars get exposed to water, resulting in rusting. Such a problem is shown in Fig. 6.

**Figure 6:** Rebars Placed Get Exposed to Water, Resulting in Rusting

The common problem in the construction of deep foundation is the poor reinforcing steel placement. Such placement requires accuracy, particularly when the foundation is deep. Often the steel gets exposed to water in these kind of construction projects prior to concreting. The effect of exposure of steel can be diminished by coating steel with cement slurry coating. This will make a protective layer around rebars and will diminish rusting of rebars.

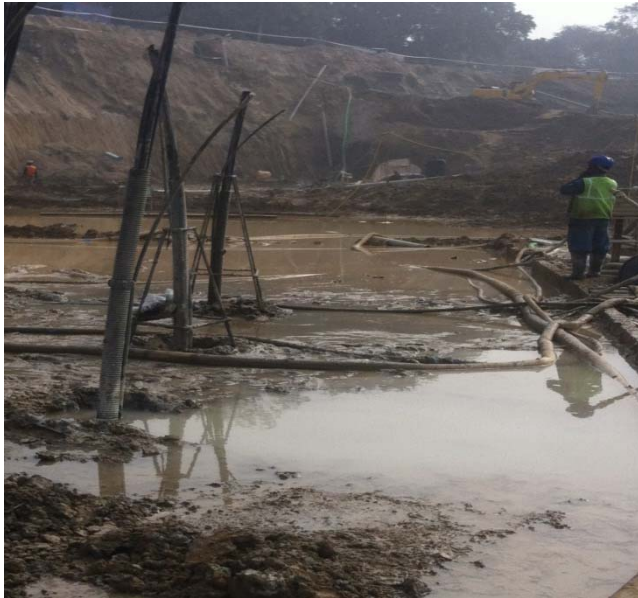
laying of foundation concrete in such a way that it raptures the PCC base of foundation over which steel has to be placed. The uplift pressure of water can cause seepage of water from ruptured PCC leading to creation of muck which makes conditions unworkable and also leads to formation of small ponds where soil has settled.

All the above discussed complications take place due to uncontrolled underground water table. Investigation revealed improper or less efficient dewatering system which leads to such complications and if not controlled all these factors have potential to cause catastrophe and delay the project to a large extent. Fig. 7 demonstrates such problems.

**Figure 7:** Deposition of Muck Due To Ruptured PCC
