# Complications during Multi-Level Basement / Deep Foundation Construction Projects

Jaspreet Singh<sup>1</sup>, Prof. V. Srinivas Raghavan<sup>2</sup>

<sup>1</sup>Student, M. Tech, Construction Engineering & Management, Manipal Institute of Technology

**Abstract:** *This paper chiefly confronts the major complications during multi-level basement / deep foundation construction projects in Delhi. Few of the problems are specifically discussed for Delhi, whereas others are ubiquitous. The major realm of concern are presented here: inadequate dewatering procedure, improper or inadequate soil nailing and shotcreting, poor workmanship in steel placing and binding, improper disposal of anchor slurry and muck, excessive water pressure. Lack of proper monitoring / leniency in monitoring of water table attributed to collapse of earth brim. Improper or inadequate soil nailing and shotcreting contributed to deposition of soil to foundation thereby adding to increase in deposition of muck. Inadequate PCC thickness led to collapse of PCC and creation of large pits thereby increasing inconvenience in muck clearing and causing poor workmanship in steel placement and binding. Failure to proper m

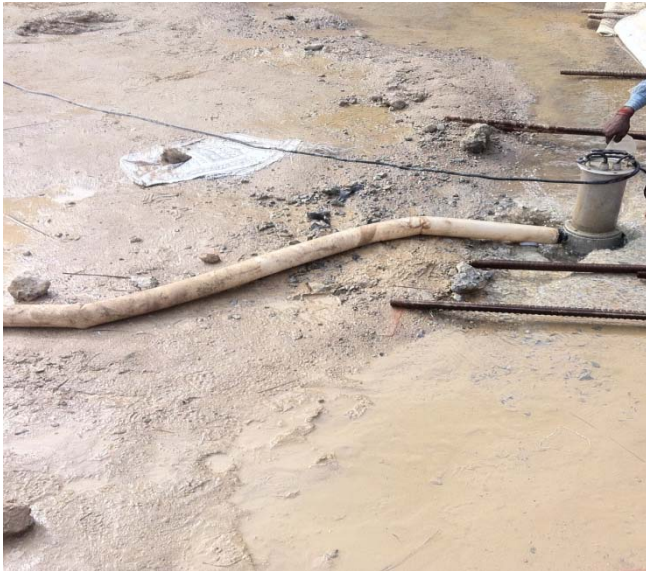
**Figure 1:** Deep Well Pump Dewatering System Used For Dewatering Excavated Area

Fig. 1 and Fig. 2 illustrates a deep well pump dewatering system used for dewatering of excavated area and Gravity method dewatering system: centrifugal pump used to prevent rise in water table for foundation construction of a multi-tower high rise building project near Pragati Maidan area in Delhi. The depth of excavation is 15.25 meters i.e. around 50 ft below N.G.L for the 49331.18 sq mt. excavated area. Investigation revealed insufficient dewatering procedures for excavated area as 32 deep wells with 15-cm dia. pumps were used to draw down water-table. However, out of these 32 more than 10-12 pumps were found always out of order and no proper monitoring of water table was done because of which huge amount of water was stagnated in excavated area which was resulted in deposition of slurry and muck and unworkable conditions for labour. Problem is shown in fig. 3.

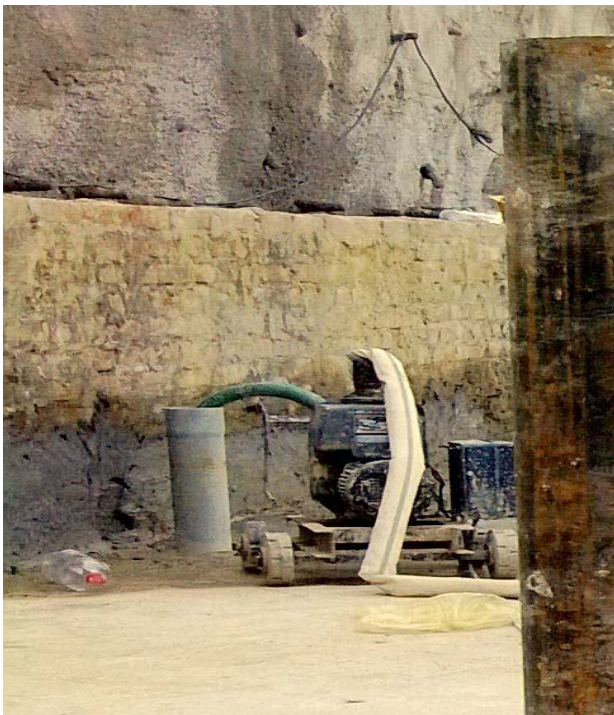
**Figure 2:** Gravity Method Dewatering System: Centrifugal Pump Used To Prevent Rise In Water Table.

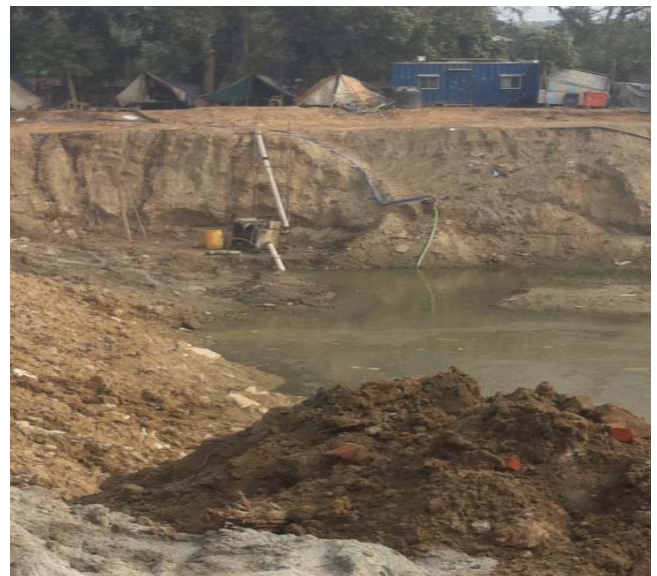
Inadequate dewatering procedure for deep foundation construction project cause many undesirable consequences which include settlement of existing buildings, cracks in walls and slabs of existing nearby buildings and improper working conditions, collapsing of soil from earth brims /shores. Particularly, if improper dewatering procedures are followed improper working conditions and collapsing of soil from earth brims are far most common problems in Delhi. These problems can be illustrated by the following case.

**Figure 3:** Muck And Stagnated Water, Unworkable Conditions Due To Improper Dewatering.

When dewatering is performed without adequate water-table monitoring procedures, settlement of the soil surrounding the excavated area can occur. It is recommended that planning of a dewatering system should refer to the original design data, boring logs, and the instrument system data. Due to non-homogeneous and non-isotropic soil properties, monitoring and, if necessary, modifying construction operations before each stage of excavation should be performed. Survey and evaluation of the neighboring structures and facilities before, during, and after the excavation are extremely important. If observations of a neighboring structure or facility indicate an inadequate

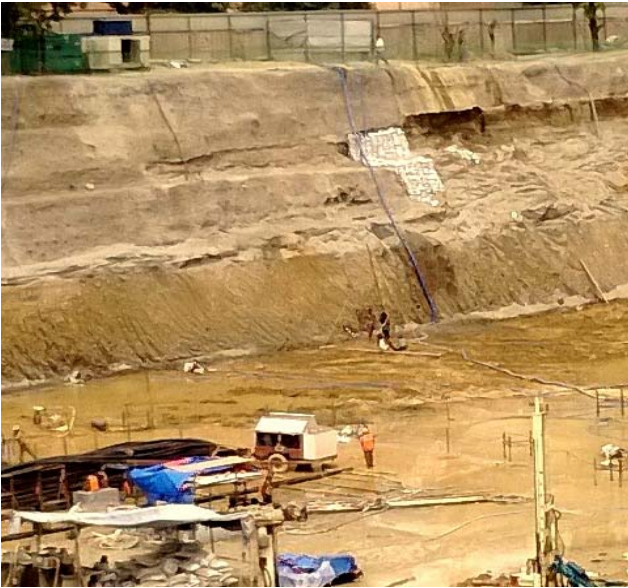
Fig.4 shows the earth retained on earth brims by means of nailing and shotcreting method. These nails are usually driven horizontally by mechanical driving method upto a depth of 7-8 meters spaced at 250 mm or more center to center depending upon the soil conditions.

**Figure 4:** Stabilization of Slopes By Soil Nailing And Shotcreting.

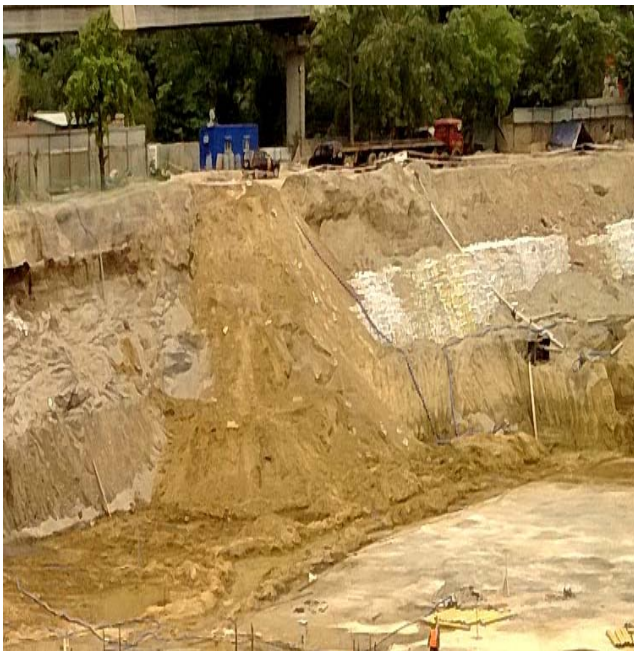
Investigation revealed that because of slow working and incomplete shotcreting unacceptable performance of soil nail has been encountered in several projects. The following case reviews problem related to inadequate nailing performance. In one project, soil nails were driven and left as shotcreting was delayed. Because of delayed shotcrete the soil of earth brim started to erode and fall in excavated area. It also added to formation of muck in excavated area. This problem did not result in any catastrophe, and therefore was seldom publicized. However, their “near disaster” condition was obvious. The problem is shown in fig. 5.

**Figure 5:** Soil Erosion From Earth Brim Due to Delay in Shotcrete.

Whereas, the problem of soil erosion from earth brim is concerned, it can be prevented by carefully and properly monitoring soil nailing and shotcreting process. One thing should be taken care of that after the nails are driven into soil, after that they should be locked with the help of S.S mesh of desirable size and a bearing plate mostly of size ranging from 150 sq. m to 250 sq. m, followed by shotcreting. Iron nails should not be left exposed for a longer period of time. In most cases, the parties involved in the foundation construction were aware of these deficiencies; however, since safety measures have not been adequately adopted, no action was taken to improve the nailing performance. Clearly, many problems could be avoided and many collapses could be prevented if stricter quality control measures were adopted.

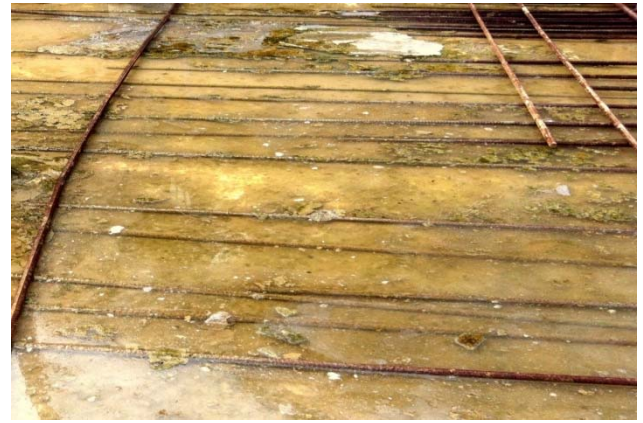
It was reviewed that poor workmanship in reinforcement placement is common in raft (foundation), and columns. Generally as there is no proper spacing maintained between rebars. Problem is evident when the de-shuttering reveals the bars exposed, without concrete cover. Clearly, such structures are less capable of accommodating proper strength and are susceptible to premature deterioration. In many cases the rebars get exposed to water, resulting in rusting. Such a problem is shown in Fig. 6.

**Figure 6:** Rebars Placed Get Exposed to Water, Resulting in Rusting

The common problem in the construction of deep foundation is the poor reinforcing steel placement. Such placement requires accuracy, particularly when the foundation is deep. Often the steel gets exposed to water in these kind of construction projects prior to concreting. The effect of exposure of steel can be diminished by coating steel with cement slurry coating. This will make a protective layer around rebars and will diminish rusting of rebars.

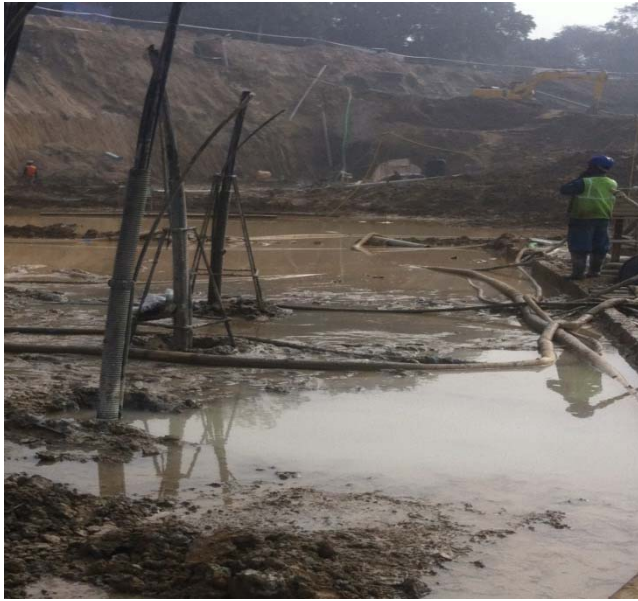
laying of foundation concrete in such a way that it raptures the PCC base of foundation over which steel has to be placed. The uplift pressure of water can cause seepage of water from ruptured PCC leading to creation of muck which makes conditions unworkable and also leads to formation of small ponds where soil has settled.

All the above discussed complications take place due to uncontrolled underground water table. Investigation revealed improper or less efficient dewatering system which leads to such complications and if not controlled all these factors have potential to cause catastrophe and delay the project to a large extent. Fig. 7 demonstrates such problems.

**Figure 7:** Deposition of Muck Due To Ruptured PCC
