Landslide Hazard in Mizoram: Case Study of Laipuitlang Landslide, Aizawl

Verma, Rahul

Department of Geology, PUC, Mizoram University, Aizawl – 796 001, Mizoram, India

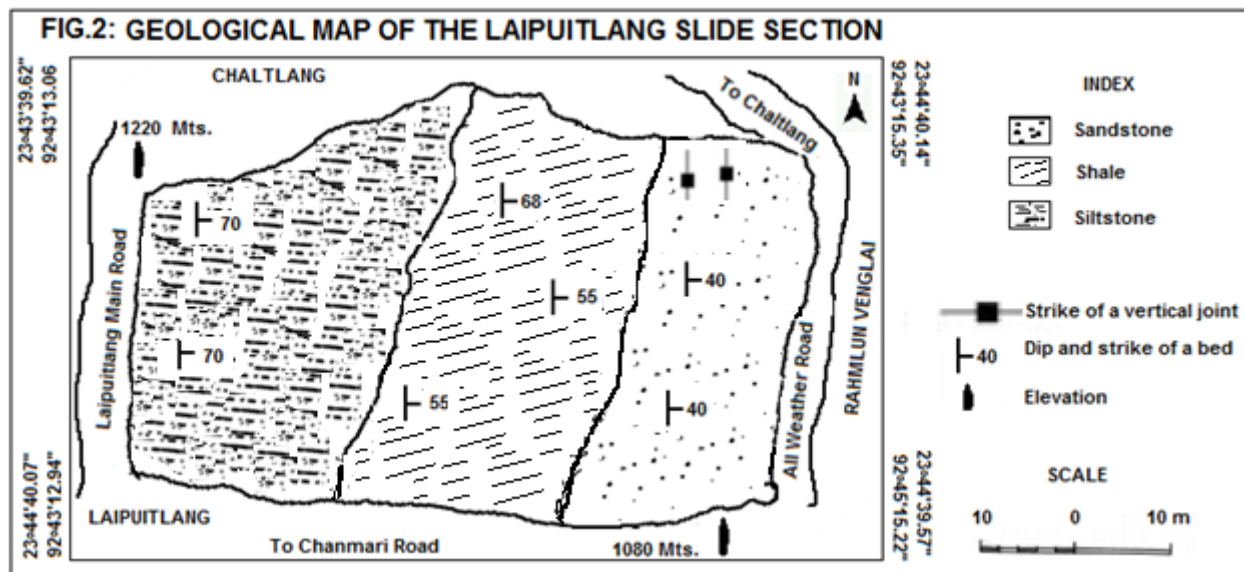
The geological map of the slide section (Fig.2), presents a clear picture of the disposition of rocks before the landslide occurred. The top sandstone layer is underlain by shale and siltstone. The PWD building was located on the top layer. The strata is generally high dipping with the dip amount varying from 40° to 70° as one moves up dip. The slope morphology is presented in Figure.3.

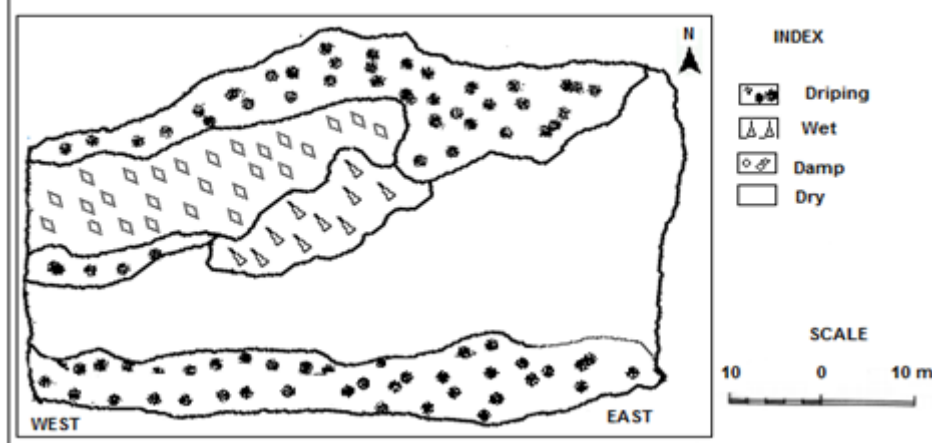
FIG.4: PRE DISASTER HYDROLOGICAL CONDITIONS OF THE SECTION

Major triggering aggravated in September, 2012 after heavy down pour of 328.9 cms. The rock basement, retaining wall and the walls of the Public Works Department (PWD) Building, which was located in the Crown position developed cracks. The cracks began to widen due to the continuous seepage and began to affect the base of the building that is a sandstone- shale junction. From all possible weakness zones, the continuous seepage began to spread down dip. Hydrological conditions before the slide,

has been presented in Figure.4. In the preliminary disaster prevention measure, the building was vacated and also the demolition order was issued. Unfortunately, due to administrative delay, the building could not be demolished timely and the load of the building caused the slide and collapsed, creating a big disaster.

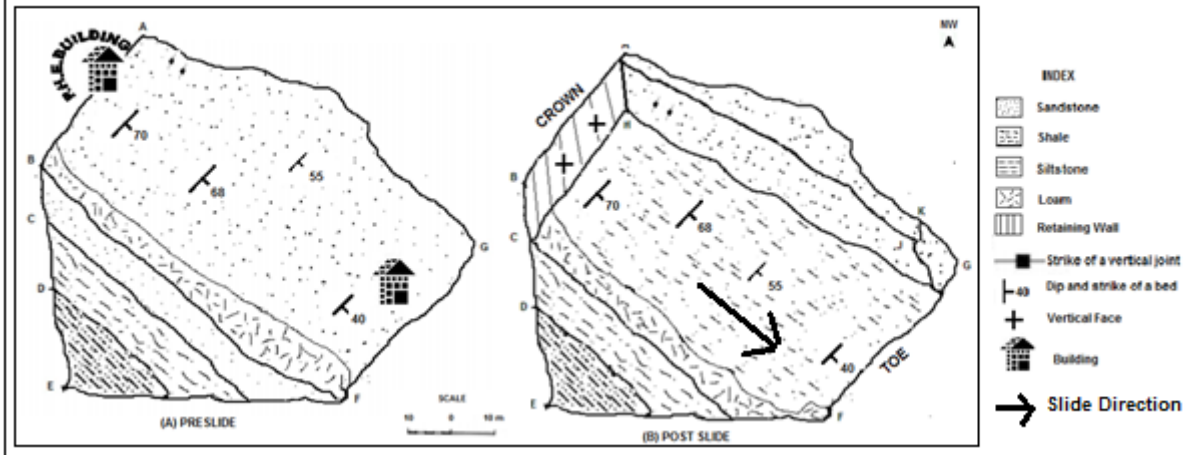
FIG.5: COMPARISION OF PRE AND POST DISASTER MORPHOLOGY

Figure.5 sketches the actual mechanism of the very slide. Fig.5 (A) shows the picture before the slide. Top sandstone layer on which the PWD building is situated, can be seen. Excessive seepage along the weakness zones badly damaged the base of the top layer and underlying shale bed. The weakened foundation, under the combined influence of the heavy load of the building and steep slope, lost the retaining capacity, and slid down, thus overriding another building which was located in the toe position. All collapsed structures slid further towards the Rahmlun Venglai section and caused fatal damage to life and property. Fig.5 (B) shows the morphology after slide. It can be marked that, after the slide, the top sandstone layer has almost vanished except a small notch along the left flank of the slide. For ready reference, Fig.6 shows the Pre and Post slide pictures of the slide location. Different views of the slide are shown in Figures 7 & 8.

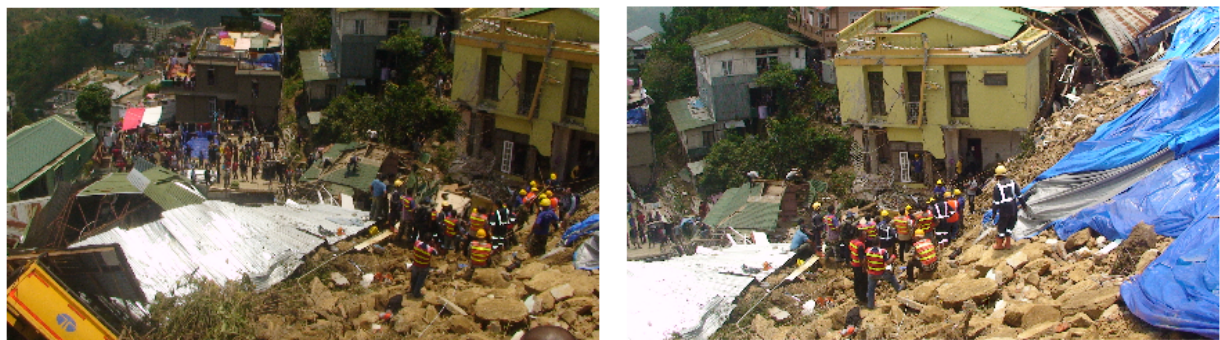
FIG.9 : DAMAGE DUE TO LANDSLIDE

The slide at Laipuitlang took place at midnight between 2:30a.m-3:00a.m. At the time, most of the resident were sleeping, that is why a high number of human casualties are recorded. 17 persons lost their Life 8 person injured. Property damage includes 7 RCC, 8 Assam type houses and

a part of the local church. Many vehicles were heavily crushed under the slide (Fig.9).
