Failure Investigation of Tawila Dam in North Darfur, Sudan

Magdi M.E. Zumrawi¹

¹University of Khartoum, Civil Engineering Department, Khartoum, Sudan

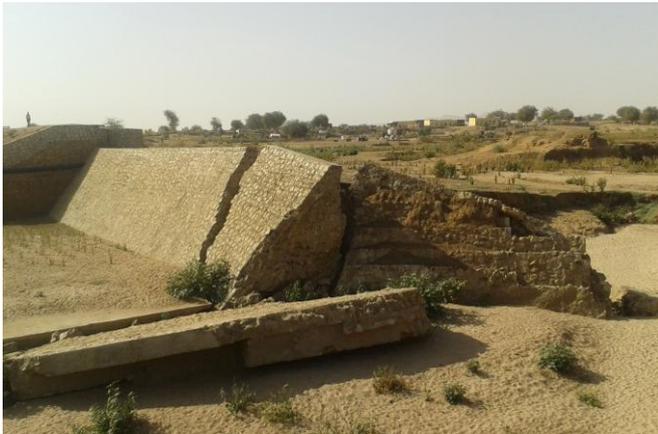
A visual inspection was conducted for the dam in order to detect any obvious structural defects in the spillways and the dam embankment. It was observed that the secondary spillway structure and the adjacent embankment of the dam collapsed due to excessive seepage that caused voids creation underneath the structure. The new constructed section of the secondary spillway has severe failure due to shear stress and washed away during the first rainy season. The reservoir is no more holding water. As per the information for the locals, the dam failure has occurred same year where the nearby secondary spillway was constructed and this had subjected to seepage underneath the embankment close to the spillway as shown in Figure 3.

Figure 3: Damaged spillway with severe cracks

The most probable cause of spillway failure may be due to poor construction. The new constructed part of the spillway has no link with the old part of the spillway. As settlement occurred in the new one, the two parts were completely separated due to shear forces. Thus leading to collapse and wash away with water flow of the new constructed portion of the secondary spillway.

It is clear that the failure of the spillway structure and the embankment of the dam are mainly due to seepage of water. Thus, to avoid and prevent any seepage of water below the spillway structure that may occur, vertical moisture barriers can be used to a satisfactory depth at different locations below the concrete slab. Also in order to control the escaping of fine particles, a rock toe drain to be provided which consists of filter and rock. The purpose of the filter and drain is to provide a way for seepage to exit the dam without causing excessive erosion of the dam material.

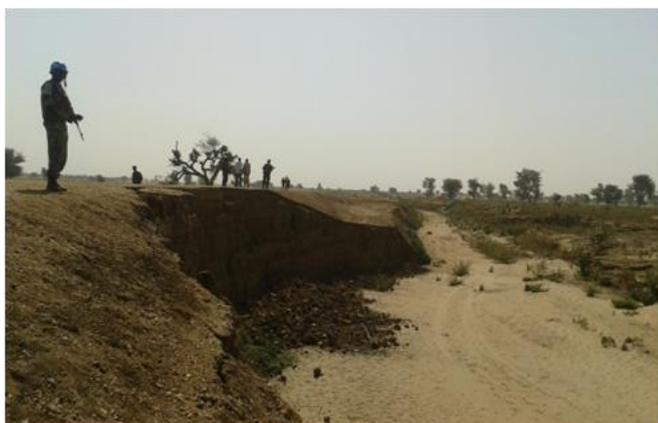
The partial breaching/weakening of embankment section is also observed at the far north part of the embankment which could lead to total collapse. This embankment weakening was happening mainly due to scouring effect of the incoming waddy which flows adjacent to the embankment section and parallel to the dam axis. This scouring has caused the embankment slope to get steeper and has increased the waddy depth which has increased the embankment height which can lead to failure (Figure 4). During rainy season, this steeper section was falling in to the waddy when it get saturated and washed downstream which further weakens the embankment section.

Figure 4: Weak and steep slope of the embankment

The embankment close to the spillway (right wing) of Tawila dam got saturated due to excessive seepage. It might have been eroded, producing small slumps/slides presenting relatively steep faces which once again became saturated by seepage from the reservoir and slumped again, forming slightly higher and unstable faces. This raveling process kept on going until the remaining portion of the embankment became too thin to withstand the water pressure, thus leading to the collapse of embankment and right wing-wall.

For a proper design and construction of dam embankment, hand-placed riprap can be used to protect the slopes of the embankment against destructive wave action in the upstream and from weathering effects for downstream slopes.

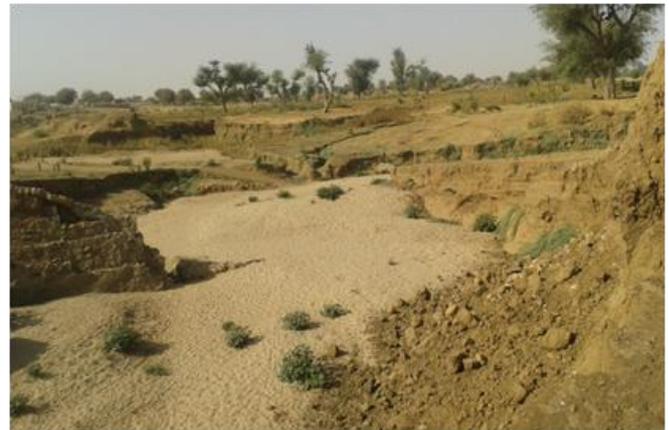
In addition to breaching and weakening of the embankment, the other concern observed in Tawila dam is sediment deposition in the reservoir area. The sediment deposition has reduced the storage capacity of the reservoir by significant volume. This is mainly due to huge sediment load from the catchment is caused by degradation and less vegetation cover. There is no any sediment releasing sluice gate provision to release flush floods carrying high sediment load are experienced in other dams in Darfur. As shown in Figure 5, the sediment deposition lead to reduction in reservoir capacity as well as reduction in aquifer recharging to augments the ground water.

Figure 5: Sediment deposition in the reservoir area
