Characteristics of Slope Failures in Tropical Hill Slopes of South West India

Arish Aslam¹, Sreekumar S²

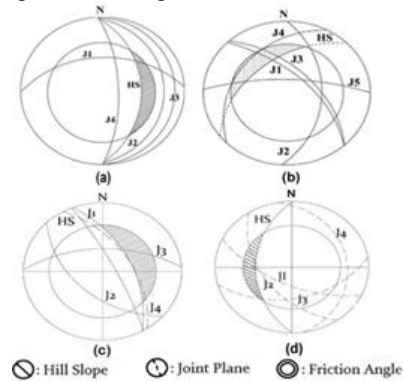
Figure 2a, b, c and d: Stereographic Projection of Joints and their relationship with the material properties and hill slope

Friction angle determined as 48°. Prominent joints in the exposed failure area are 51° N (J₁), 32° N 90 (J₂), 22° N 90 (J₃) and 80° N 90 (J₄). J₂ and J₃ are the potential slide surface along which the debris moved down slope (Figure 2a). The friction angle reduced during rainy season and FOS reduced further and slope failure occurred.

which causes extensive damage to forest land. Casualties were avoided as the settlements were a few meters away from the rolled down slide debris. Akamala hill slope profile form part of a reserved forest. The maximum elevation is 320 m and the lowest elevation is 80 m from MSL. The profile is at the western plank of the NW-SE trending ridge. Head scarp of this slide is shallow (0.5 m depth) and the width increases up to 15 m at the base and attain maximum depth up to 1.6 km. lithologically it is composed of gneissic charnockite and sub areal weathering has resulted laterites and highly weathered rocks of varying thickness. The forest is degraded to a certain extend. The analysis indicated that in akamala profile wedge failure occurred along the intersection of joints 30 N 315 and 70 N 80 falls within the crescent shaped shaded area (Figure 2b). Chances of plane failure along the joints 30 N 315 also exist in this location.

determined in geo technical lab is 22°. J1 and J3 acted as the failure surfaces and the intersection of these joints fall within the crescent shaped portion. The debris flow occurred along the direction N 26. This is categorized as a typical wedge failure (Figure 2c).

Methottimala is located in Idukki District Kerala. Two houses were destroyed and agricultural damage was caused by debris flow on 4th August 2013. Main cultivation includes tapioca, plantain and coconut. A raised metal road across the valley which partially submerges under flood season, with 29 m length and 3 m width was washed off by the hitting impacts of large boulders. The chief rocktype of the area is granitic gneiss. Thickness of soil is about 3 m. Two debris flows united and flowed down slope. The crown of the scar is having a width of 3 m, attains 29 m in the middle part and runs for 1 km downhill. Dip of the hill slope is N270. The discontinuities have no role in this disaster. Chance of toppling still exist in the area according to the figure 2 d.

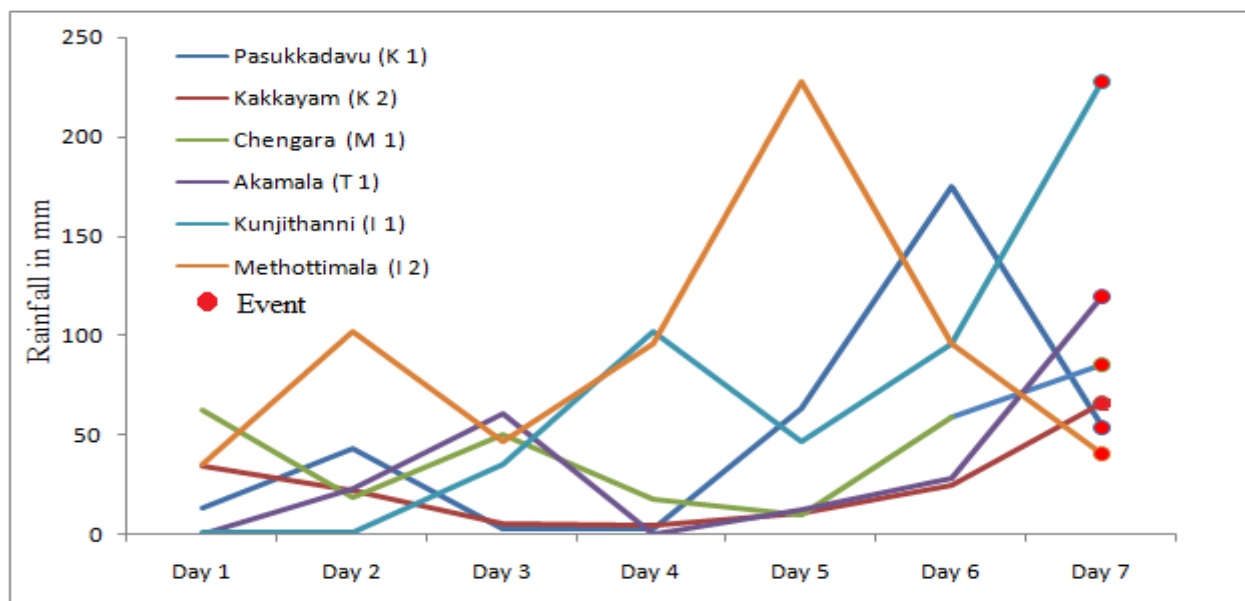
Figure 3: Graph showing rainfall in mm

The slope failure occurred when the minimum amount of rainfall for 7 days (including the day of incidence) was 167.41 mm (Table 3 and Figure 3). The minimum amount of rainfall required for slope failure for 3 days was estimated to be 101.33 mm. On other hand the minimum threshold for slope failure was 101.21 mm when penultimate 6 days of the disaster is considered. Storms that produce intense rainfall for periods as short as several hours or have a more moderate intensity lasting several days have triggered number of landslides [11].
