Designing Approach on Accessories to Align Clamp-Core in Reactor

Core-Clamp Shorting in Reactor

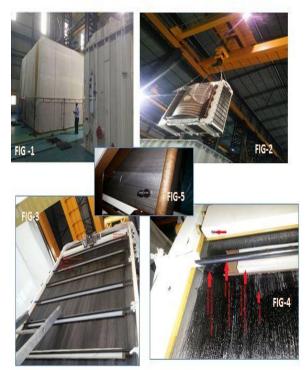
Ultimately the culprit was identified to be a small bolt that dropped off and shorted across a Core Clamping Bolt and the CRGO Lamination (Fig- 3,4,5). As I understand - a few threads of the bolt had sheared off (Fig-5).

Insulation Resistance been checked between Core & Clamp leads (twice using different Meggers for confirmation) recorded 1G-ohm / 2G-ohm - So ALL OK. Rector keep on vacuum after completed of troubleshooting activity and maintain 72 hour vacuum continuous after 1 tour . Then Oil circulation stared and persist 72 hour continuous and Tank maintain with positive Nitrogen pressure shake of transport concern after Oil drained from tank and.
