Engine Failure in Road Traffic as the Cause of a Traffic Accident

Abstract: *The article deals with technical analysis of the cause of a technical failure of the Mercedes vehicle, which led to a traffic accident due to the loss of the vehicle's controllability. The methodology and procedures during the inspection of a vehicle as well as the methods applied to process documentation are systematically clarified. Subsequently, the individual findings are presented and evaluated and their technical interpretation is made. The strength calculation of the component (the timing chain) and the calculation of forces exerted on the chain are introduced. In the conclusion, the findings are evaluated with regard to the calculations and technical evaluation of the case is presented.*

In this case, it was a MERCEDES BENZ S 350 L, the year of production: 2006, mileage 271,465 km.

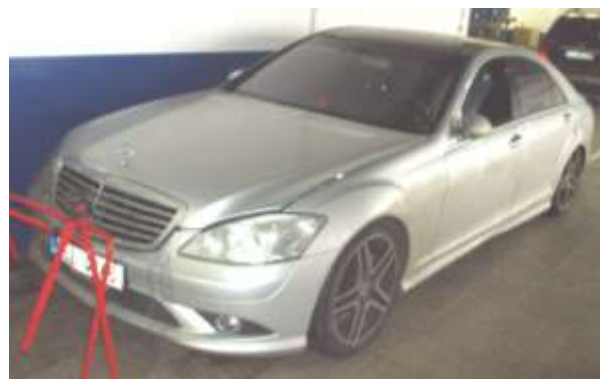
Figure 1: View of a vehicle

A vehicle: No issues that could affect operability and manoeuvrability of a vehicle were found in the course of inspection.

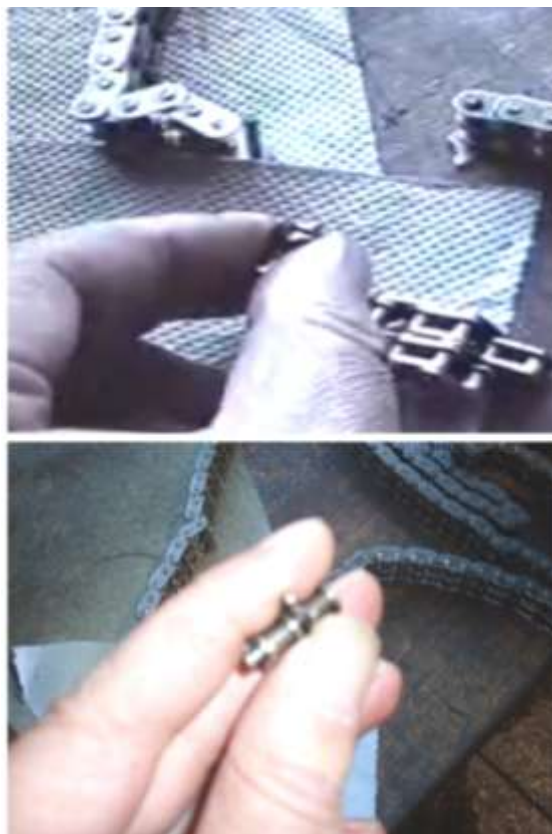
Figure 2: View of the damaged (broken) timing chain

Engine: The broken timing chain and the resulting damage to the piston group as well as valves were detected during the inspection of the engine – Figures 2, 3.

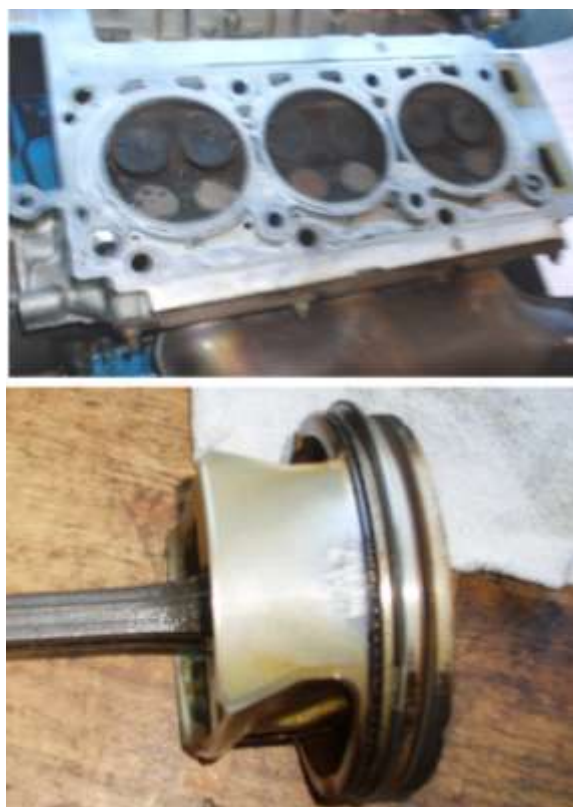
Figure 3: View of the damaged valves in a cylinder head

- 4) Because the fragment have got jammed in the gear, the wheels stopped running and thus the movement of the timing chain, on which the force caused by the movement of a vehicle- acting against the movement of the timing chain – was exerted (transmitted from the wheels through the gearbox, clutch, crankshaft to the timing wheel and chain), and because of such force the timing chain got strained and then broken.
- 5) Since this timing chain breakdown produced a change in valve timing, the valves contacted the piston top and then they bent down.
- 6) Due to the tightness loss of the combustion zone of cylinders (and combustion loss), the fuel flowed around pistons and consequently at least one piston (1st cylinder) was caught up due to lubrication loss along its walls – Fig. 3

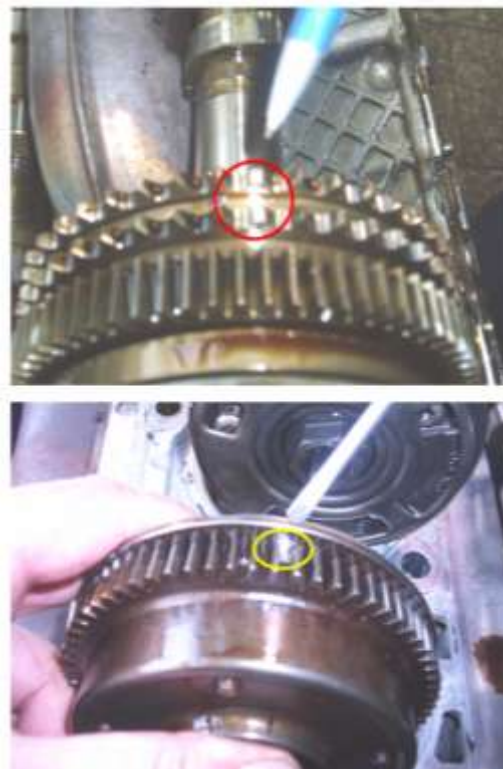
Figure 4: View of the sprocket gear

While inspecting the timing mechanism, it was detected that a steel splinter had been firmly pressed in the teeth of the counter running gear wheel of the 2nd exhaust valves camshaft and the 1st suction valves camshaft gear wheel connected to the control toothed ring, and that the teeth of

chain sprocket of the 1st suction valves camshaft to drive a timing chain is damaged -see Fig. 4.

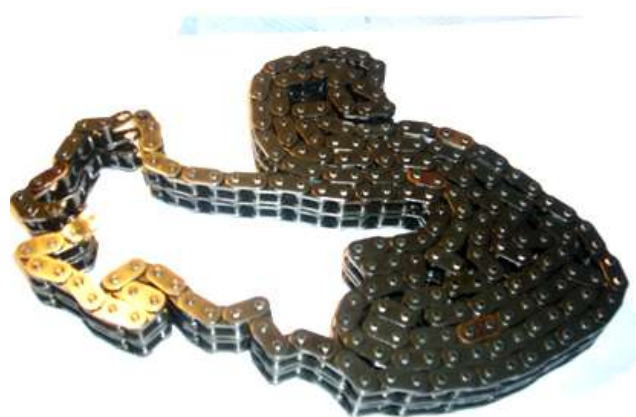
Figure 9: View of a timing chain

Upon a closer look at the timing chain illustrated in Fig. 9,

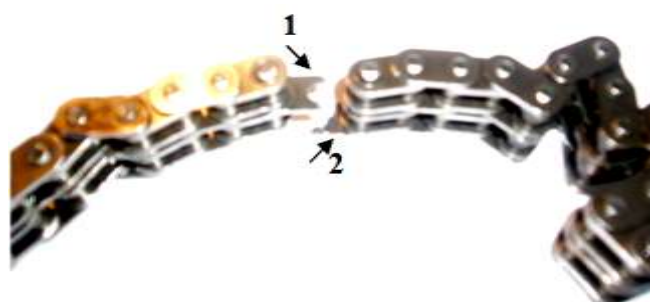
Figure 10: View of the damaged chain members

damage to two chain plates was detected (no.1 – inner and no. 2 - outer) – see Fig. 10

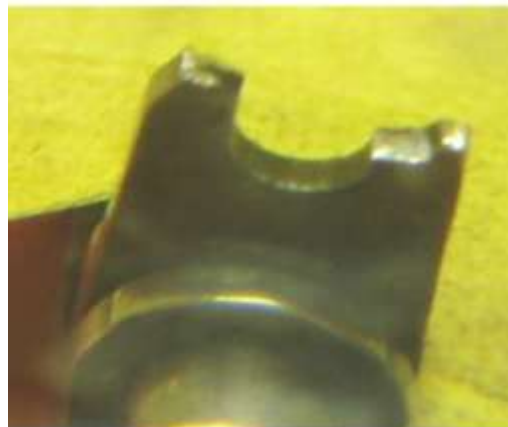
Figure 12: View of the detail of plate no.1 fracture of the chain member

Opinion on the fractures at chain plate no.1:

- The part (inside the pin), on which the chain plate no.1 had been placed, had been hitting the gear casing and timing gears, and subsequently got loose
- In this case, it is a brittle fracture without a crack (i. E. Fatigue characteristic) without a plastic change of the fracture surfaces (these are crystalline except for the area where addition damage occurred due to hitting) at a damaged chain plate no.2:

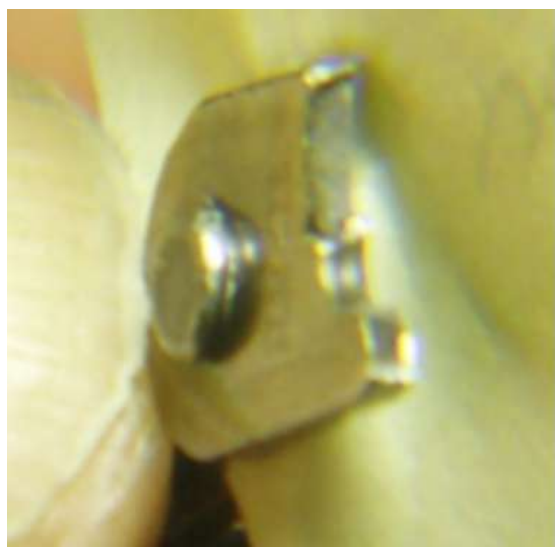
Figure 14: View of the detail of plate no. 2 fracture of the member chain

Opinion on the fracture zones at chain plate no. 2:

- The part (inside the pin) on which the chain plate no. 2 had been placed had been hitting the gear casing and timing gears, and subsequently got loose
- In this case, it is a brittle fracture without a crack (i.e. Fatigue characteristic) without a plastic change of the fracture surfaces (these are crystalline except for the area where addition damage occurred due to hitting)

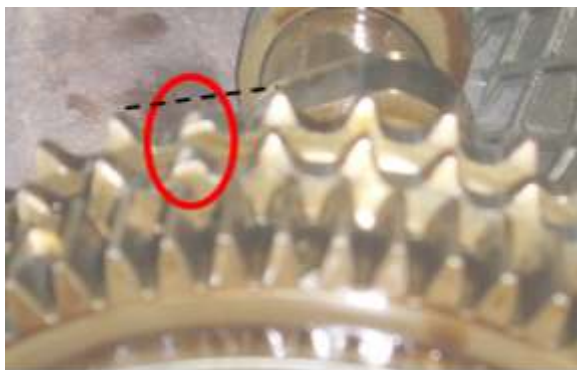
- 1) Two teeth of a chain wheel of the 1st suction valves camshaft were destructed and were broken because of excessive wear- see Fig.16

Note. The breakage did not have a direct effect on the engine's performance, as the chain has a multi-tooth engagement on the sprocket. It was impossible to detect breakage during operation without disassembly.

Figure 16: Broken teeth of the chain sprocket of the 1st suction valves camshaft

We consider two broken teeth of the sprocket wheel of the 1st suction valves camshaft a direct cause of the malfunction of the MB S350 L (breakage of a timing chain). The fragments of these teeth were during the engine run subsequently transferred onto (while driving) the counter running sprocket wheel of the 2nd the exhaust valves camshaft, where they were forced in by the sprocket wheel of the 2nd suction valves camshaft, as a result of which, timing wheels got blocked and the timing chain burst. As a result of the mentioned failure, the manoeuvrability was inevitably reduced both directionally (a sharp increase in steering effort) and with regard to the acceleration profile, too, resulting in the abrupt deceleration of a vehicle at the moment of the timing chain destruction and a short-term loss of steering control - directional manoeuvrability- occurred due to blocked front axle wheels.

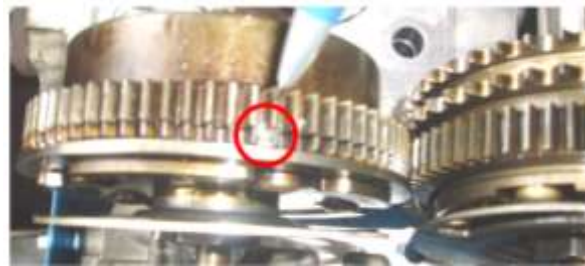
- 2) The broken parts started to move within the area of the timing mechanism but we cannot define time limits exactly. However, based on the degree of wear of the teeth remains we can say it was a longer time.
- 3) In the course of the engine operation, one fragment moved upwards and got jammed in the counter running sprocket wheel of the 2nd exhaust valves camshaft (and to the control sprocket wheel), where this fragment was later forced in by sprocket wheel of the 2nd suction valves camshaft when engaging its teeth – see Fig. 17

Figure 17: View of the fragment jammed in the sprocket gear II of the exhaust valves camshaft.
