Slurry Pipe Wear detection by Infrared Thermography: Case of Cyclone Underflow Pipe in Kinsevere Process Copper Plant in Democratic Republic of Congo

Mwamba A. Banza¹, Ngoy Y. Mukabi², Kalumbu G. Mutombo³

Abstract: *This article present the slurry pipes wear detection by using infrared image thermography analysis. By determining via the software the temperature difference on one of pipe area, it's possible to determine the wear while the fluid is moving into the pipe. The difference of temperature found on the pipe area makes easily to estimate the wear and suggest the corrective maintenance action. As part of condition monitoring technics, this is helpful to contribute to pipes thickness monitoring.*

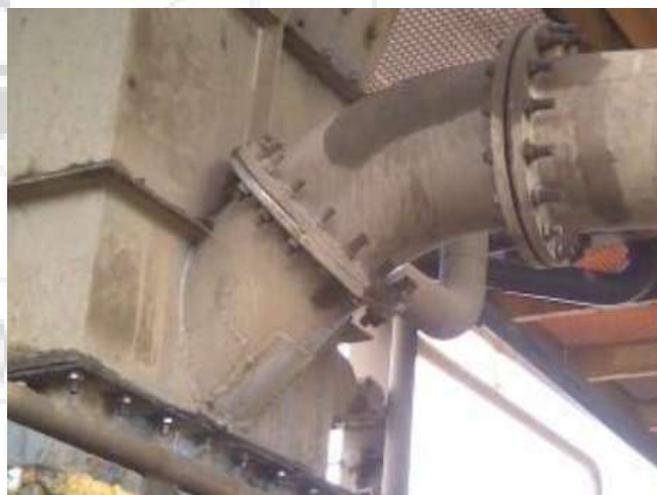
Figure 1: Cyclone under flow line

Repetitive failures have been experienced on this cyclone under flow line pipe.

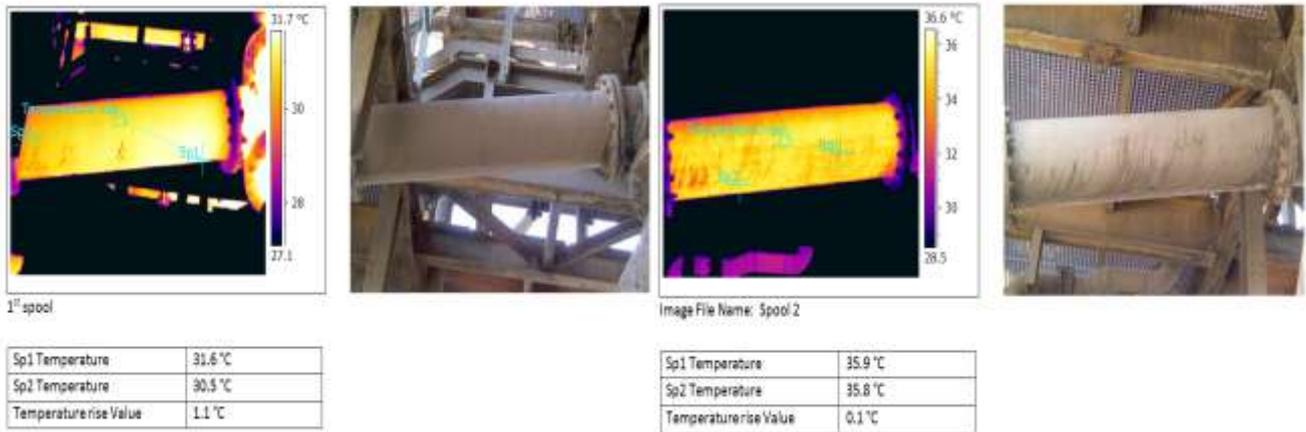
Figure 3: infrared image of spool 1 and 2

Spools	Spot1 Temperature	Spot 2 Temperature	Temperature Rise
1 st spool	31.6 °C	30.5 °C	1.1 °C
2 nd Spool	35.9 °C	35.8 °C	0.1 °C
3 rd Spool	35.2 °C	31.9 °C	3.3 °C
4 th Spool	35.7 °C	34.4 °C	1.3 °C
5 th Spool	31.9 °C	29.8 °C	2.1 °C
6 th spool	34.0 °C	29.8 °C	4.2 °C

The temperature rise comes from the difference in emissivity as some dried solution covers some part of the spool, that why the gradient path is like a fluid flowing over a surface. The condition is good and no action is required

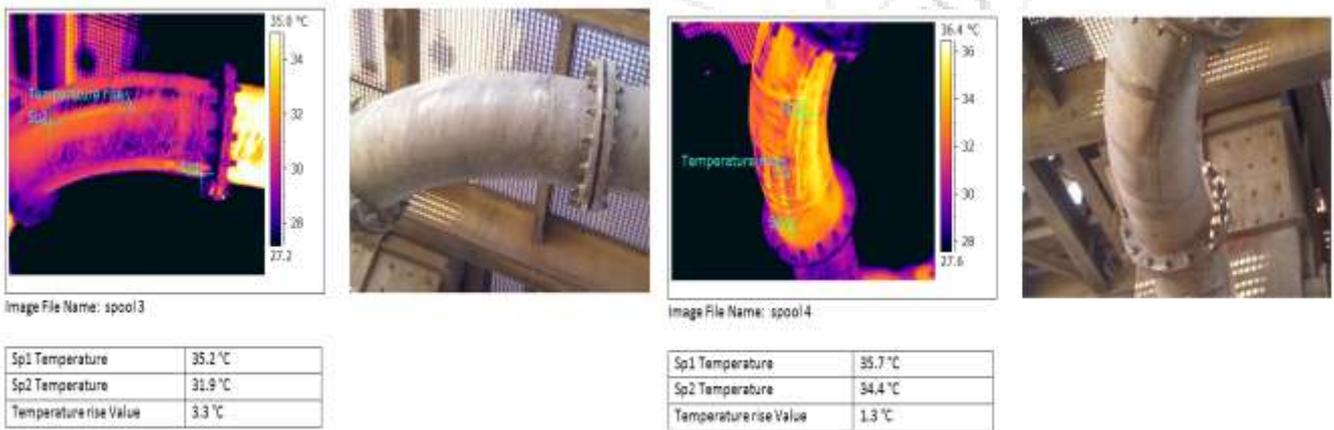
Figure 4: Infrared image of spool 3 and 4

The condition will required a closed monitoring, a future repair is necessary, and the confirmation from ultrasonic thickness measure is important.

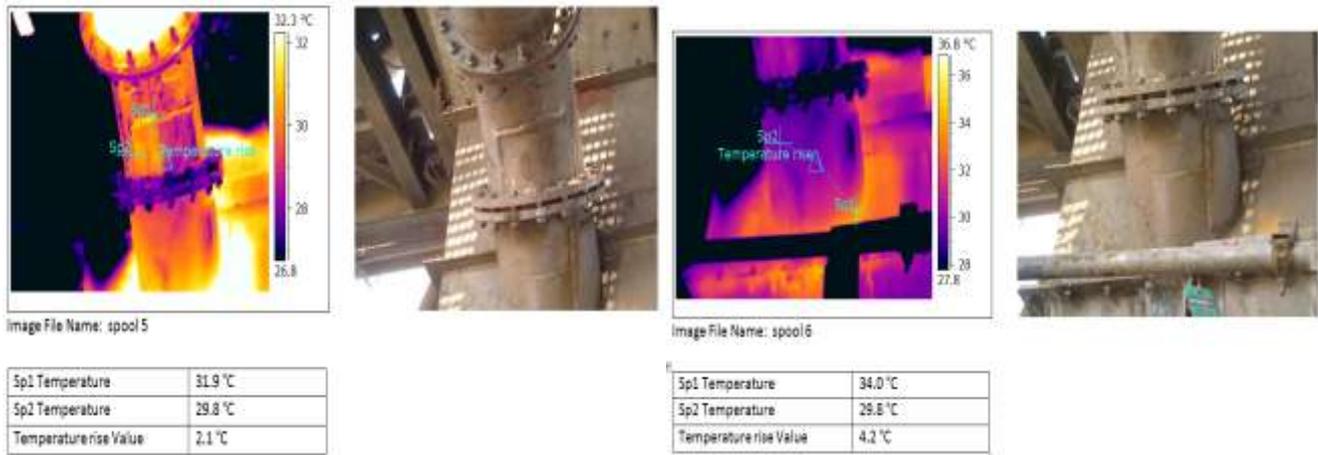
Figure 5: Infrared image of spool 5 and 6

The condition is less critical and regular monitoring is needed
