The Case of Chevrolet Cruze Clutch Destruction and an Expert Procedure at Technical Analysis of Its Cause

Ján Mandelík

Department of Transport Safety The University of Security Management in Kosice , Slovak Republic

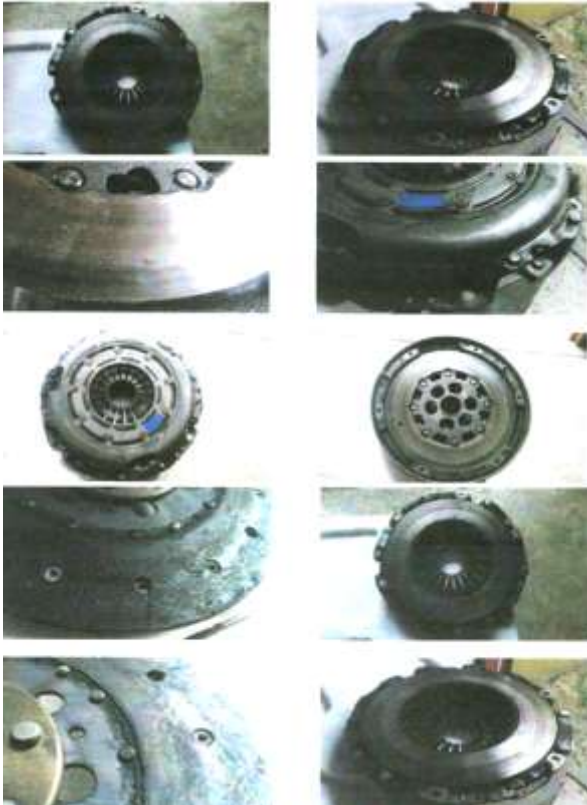
Figure 2: Selection of photo documentation of damaged parts of the vehicle after repair from 11/2012

Photo documentation of condition of parts exchanged during the repair performed in 11/2012 is shown in Fig. 2

| <u>11/2012</u> - | clutch failure and its repair (replacement: clutch master cylinder, clutch slave cylinder, |

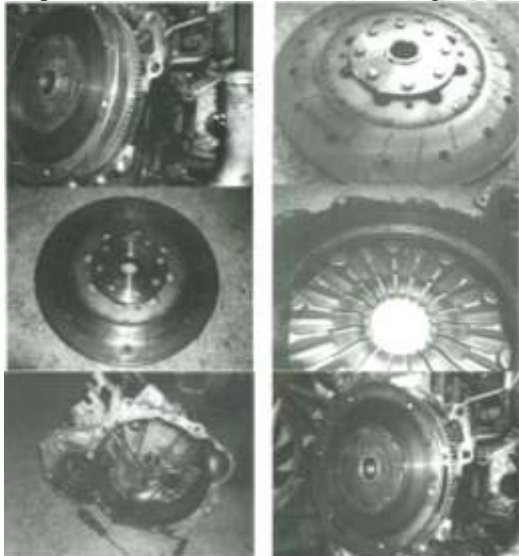
Figure 3: Selected photo documentation of damaged parts of the vehicle after repair from 03/2016

Photo documentation of condition of parts exchanged during the repair performed in 03/2016 is shown in Fig. 3

clutch disc with facings,
 pressure plate, flywheel)
 clutch failure and its repair
 (replacement: clutch master
 cylinder, clutch slave cylinder,
 clutch disc with facings,
 pressure plate, flywheel)

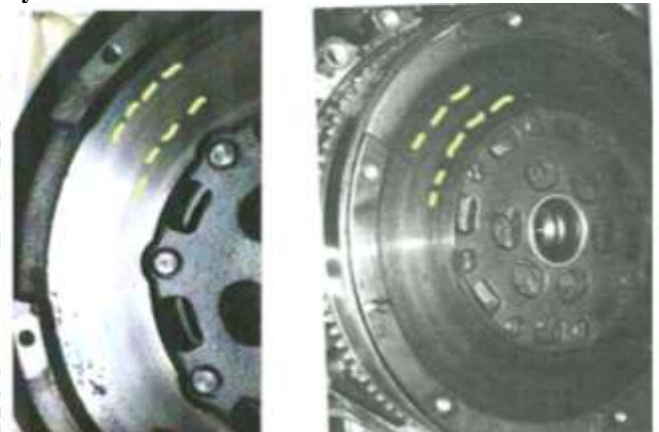
Figure 8: Indication of identical characteristics of damage to the flywheel impact surface

pressure on the side of flywheel was not uniform. Pressing on the flywheel surface even when the clutch is disengaged lawfully leads to transmission at this time and the clutch acts so that it does not completely disconnect the engine from gearbox, leading to poor chancing of gears. This phenomenon forces driver to use an increasing power to control the clutch in order to disengage and in this way cause abnormal pressure on the mechanical parts of the pedal group, resulting in minor deformations that are not detectable. Also, damage to the gearbox's radial shaft seal can be seen as a result of heat and mechanical stress resulting from faulty flywheel, since uncontrolled friction between clutch disc and flywheel produces excessive heat, which is mainly apparent on reduced lifespan of the rubber parts in question.

Damage on the photo documentation from 11/2012 is virtually the same as damage on the photo documentation from 03/2016 and it can be assumed that they were caused by the same cause, i.e. by failure of dual-mass flywheel as a result of way the vehicle was operated.

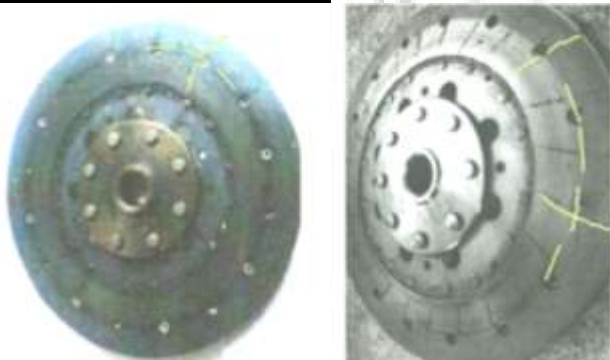
Figure 7: Indication of identical characteristics of clutch disc damage

Damage on the photo documentation from 11/2012 is virtually the same as damage on the photo documentation from 03/2016, and it can be assumed that they were caused by the same cause - defect of the dual-mass flywheel as apparent greater wear of one side (from the side of flywheel) than of the other side (from the side of pressure plate) can not be technically interpreted except that the flywheel surface has been released and pressed against the facing also in time when the clutch was disengaged as well as the
