The Case of Chevrolet Cruze Clutch Destruction and an Expert Procedure at Technical Analysis of Its Cause

Ján Mandelík

Department of Transport Safety The University of Security Management in Kosice , Slovak Republic

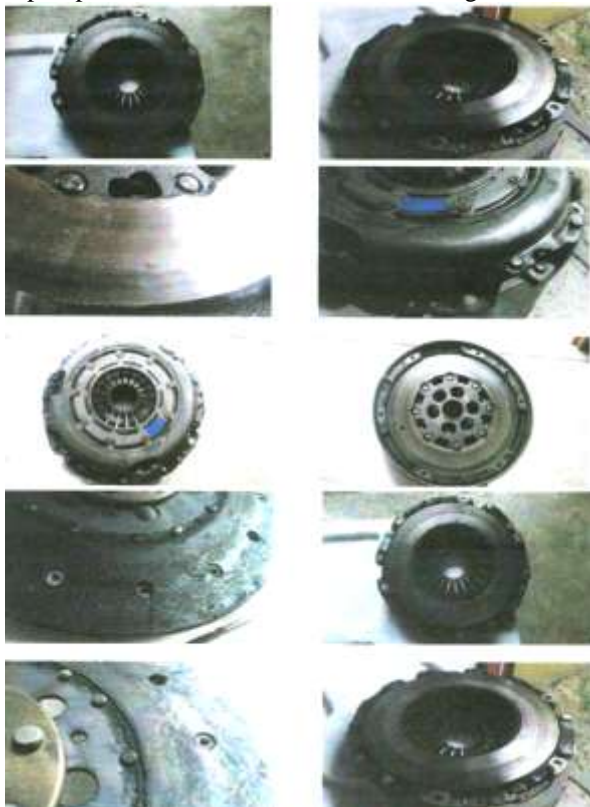
Figure 2: Selection of photo documentation of damaged parts of the vehicle after repair from 11/2012

Photo documentation of condition of parts exchanged during the repair performed in 11/2012 is shown in Fig. 2

| <u>11/2012</u> - | clutch failure and its repair (replacement: clutch master cylinder, clutch slave cylinder, |

clutch disc with facings,
pressure plate, flywheel)
clutch failure and its repair
(replacement: clutch master
cylinder, clutch slave cylinder,
clutch disc with facings,
pressure plate, flywheel)

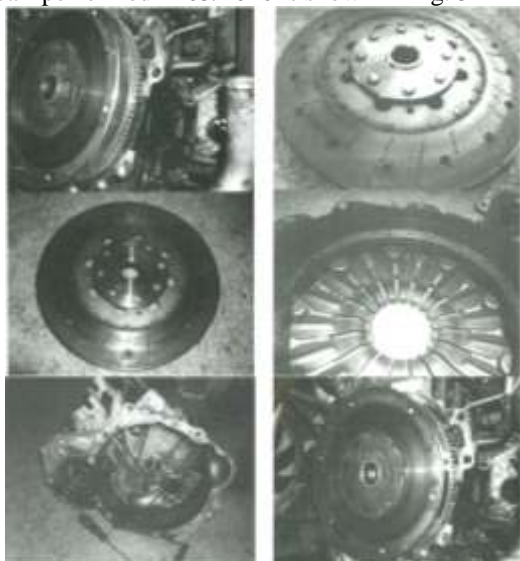
Figure 3: Selected photo documentation of damaged parts of the vehicle after repair from 03/2016

Photo documentation of condition of parts exchanged during the repair performed in 03/2016 is shown in Fig. 3

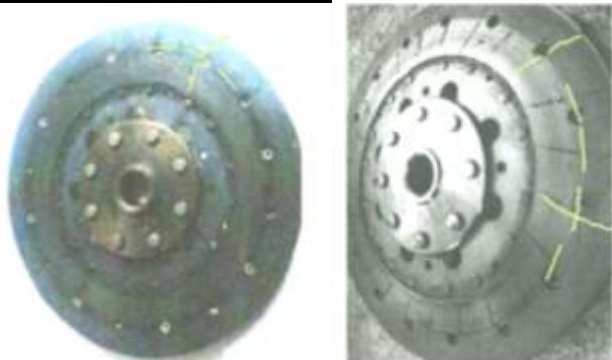
Figure 7: Indication of identical characteristics of clutch disc damage

Damage on the photo documentation from 11/2012 is virtually the same as damage on the photo documentation from 03/2016, and it can be assumed that they were caused by the same cause - defect of the dual-mass flywheel as apparent greater wear of one side (from the side of flywheel) than of the other side (from the side of pressure plate) can not be technically interpreted except that the flywheel surface has been released and pressed against the facing also in time when the clutch was disengaged as well as the

pressure on the side of flywheel was not uniform. Pressing on the flywheel surface even when the clutch is disengaged lawfully leads to transmission at this time and the clutch acts so that it does not completely disconnect the engine from gearbox, leading to poor chancing of gears. This phenomenon forces driver to use an increasing power to control the clutch in order to disengage and in this way cause abnormal pressure on the mechanical parts of the pedal group, resulting in minor deformations that are not detectable. Also, damage to the gearbox's radial shaft seal can be seen as a result of heat and mechanical stress resulting from faulty flywheel, since uncontrolled friction between clutch disc and flywheel produces excessive heat, which is mainly apparent on reduced lifespan of the rubber parts in question.

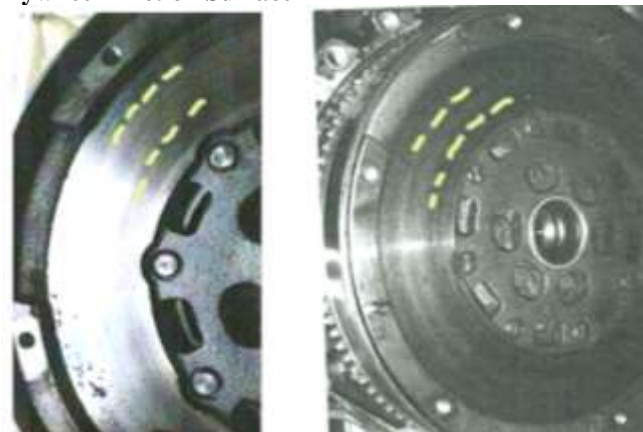
Figure 8: Indication of identical characteristics of damage to the flywheel impact surface

Damage on the photo documentation from 11/2012 is virtually the same as damage on the photo documentation from 03/2016 and it can be assumed that they were caused by the same cause, i.e. by failure of dual-mass flywheel as a result of way the vehicle was operated.
