Diagnostics of Iveco Stralis 440ST Truck Tractor Unit Engine and Identification of the Cause of its Malfunction

Abstract: *The article concerns the case of the Iveco Stralis 440St truck tractor unit engine failure and the methodology of the technical expert applied to identify the cause of failure. The engine has repeatedly exhibited failures –leaking crankshaft spring - energised seal and consequent engine oil leak, which has been repeatedly repaired at a car service station. Repeated engine failures resulted in the disputes between a vehicle owner and a car service station, finally leading to an agreement on finding the cause by an invited technical expert. To determine the cause, a vehicle was on the car service station premises, where a technical expert was present and according to his instructions, diagnostic and subsequent disassembly works were done. The outcomes of the investigation proved serious damage to the engine piston unit.*

Make and type: Iveco Stralis truck tractor unit, type 440 ST
Mileage: 173 485 km

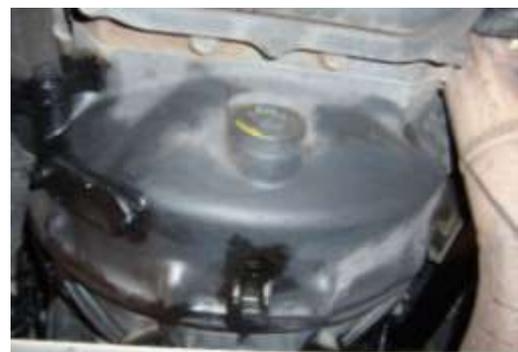
Figure 1: Vehicle condition detected during a visual inspection

A detailed visual inspection of the vehicle and its engine has been carried out. Findings revealed no incompleteness, however there was engine oil found on the front part of gearbox housing – Figure 1.

View of the front part of a gearbox housing (clutch – engine flywheel) that is contaminated with oil – oil leaking from an engine through a spring-energised seal.

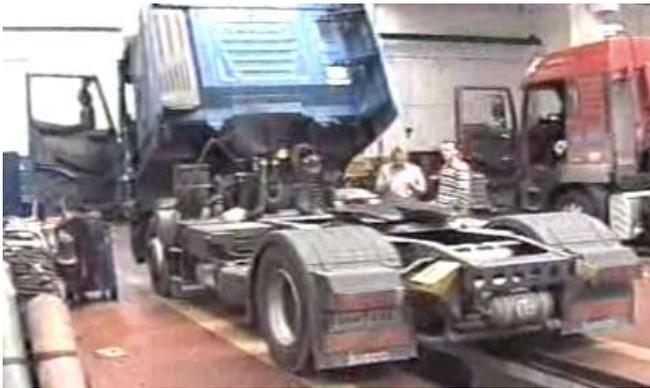
View of a vehicle with a running engine and excessive smoke

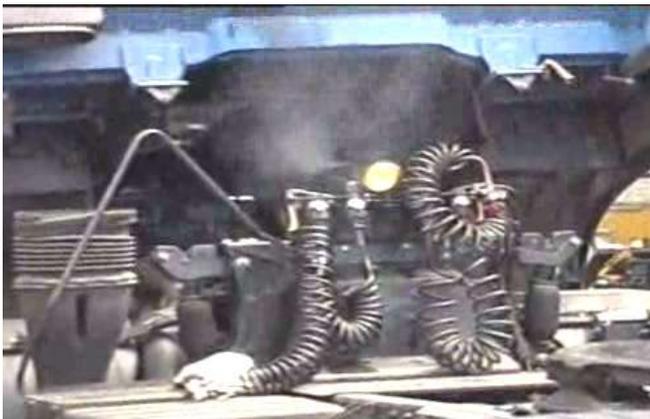
Close view of the engine excessive smoking

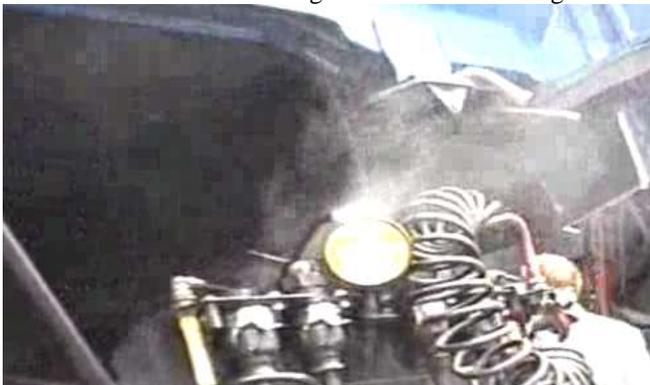
Detailed view of excessive smoke in a motor running

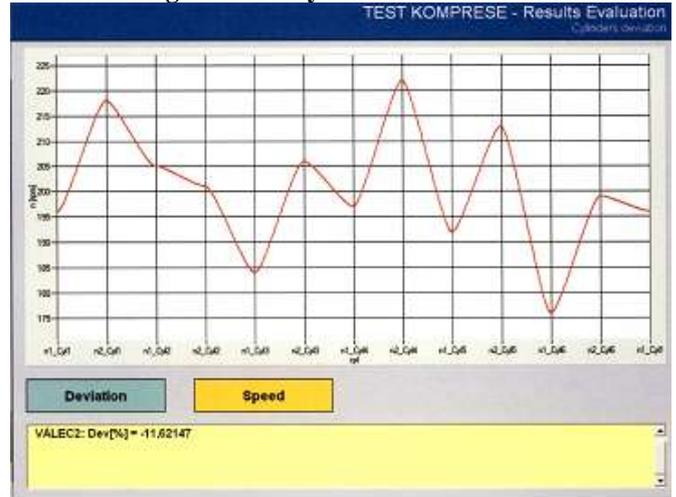
Detected irregularities in a crankshaft angular velocity

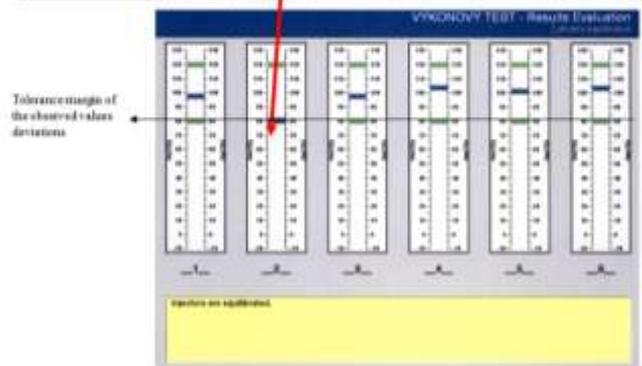
- The result of the compression control test A shows the difference in the performance of the 2nd cylinder and other five ones, but the observed deviation of the functionality decrease is within the manufacturer published tolerances (-3,5%)
- The difference in acceleration of a crankshaft (α rad/s²) is obvious but cannot be evaluated as a failure.

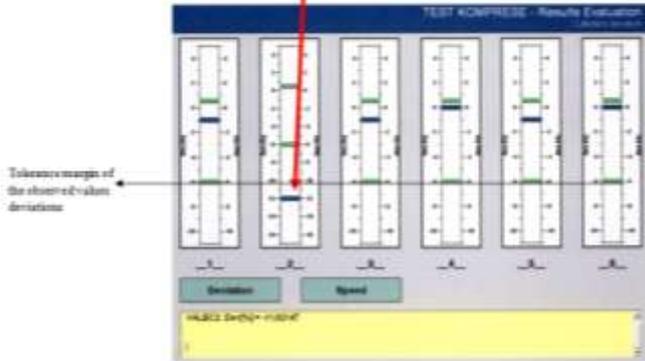
- The result of the compression control test B shows the significant difference in the performance of the 2nd cylinder and other five ones, and the observed deviation of the functionality decrease is above the manufacturer published tolerances (-3,5%)

- The difference in acceleration of a crankshaft (α rad/s²) is detected and indicates the deceleration of a crankshaft at the time of the 2nd cylinder activity.

Observed deviation of the values in cylinder compression test B, suggests in a significant way that the 2nd cylinder run did not correspond with the engine's technical condition and was significantly degraded. Since this test is based on the evaluation of the angular velocity change and the crankshaft angular acceleration, it may be considered an indirect indicative evaluation of the engine piston unit.

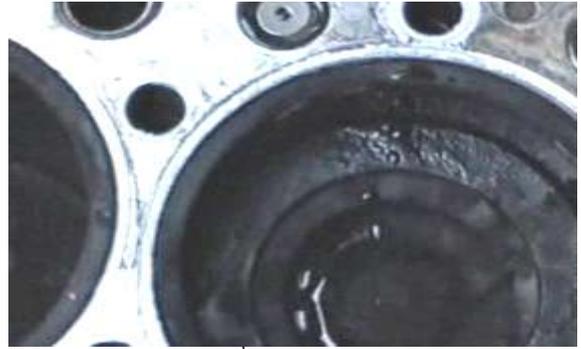
Detailed view of the 2nd cylinder piston bottom after the disassembly of the cylinder head

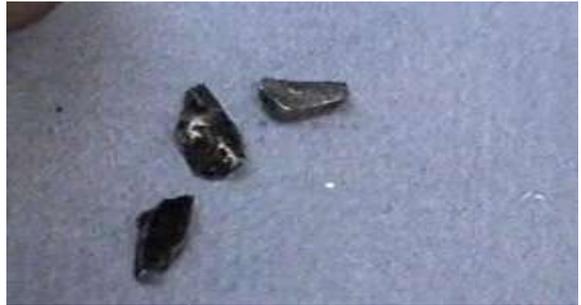
Fragments of the 2nd cylinder piston found in the engine oil bath after dismantling

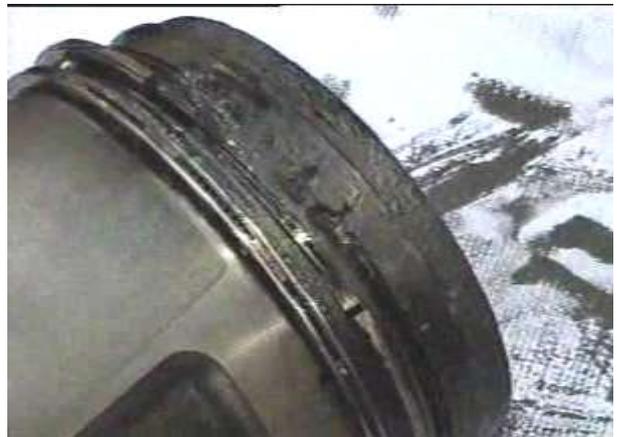
Detailed view of 2nd cylinder piston immediately after dismantling

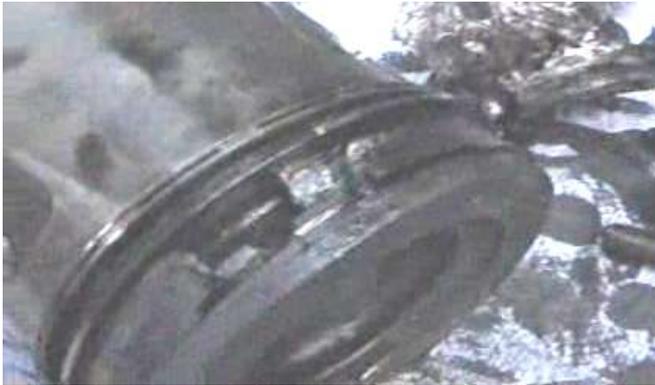
Detailed view of the 2nd cylinder piston after partial cleaning of carbon deposits

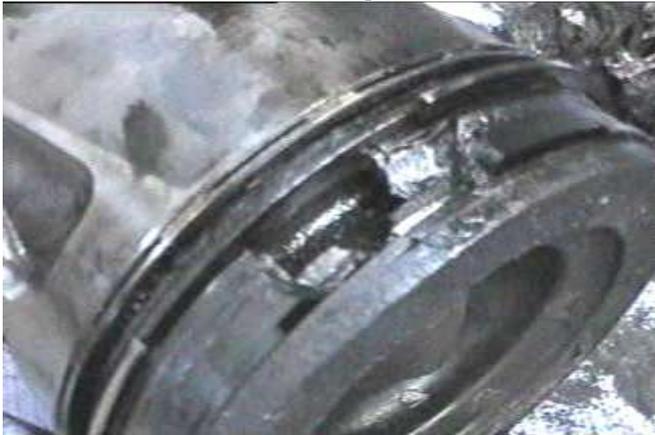
Detailed view of 2nd cylinder piston after partial cleaning of carbon deposits

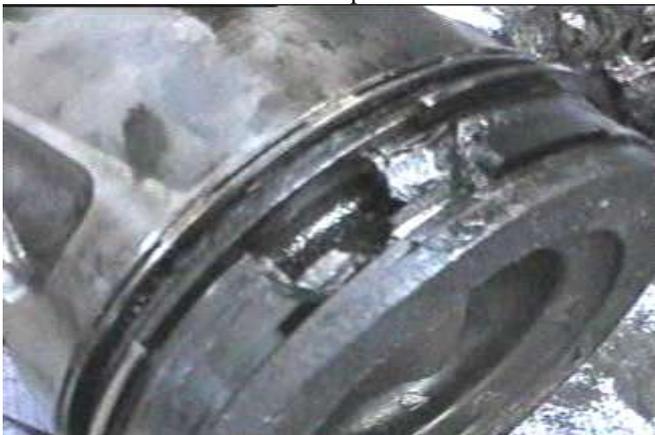
Detailed view of 2nd cylinder piston after partial cleaning of carbon deposits

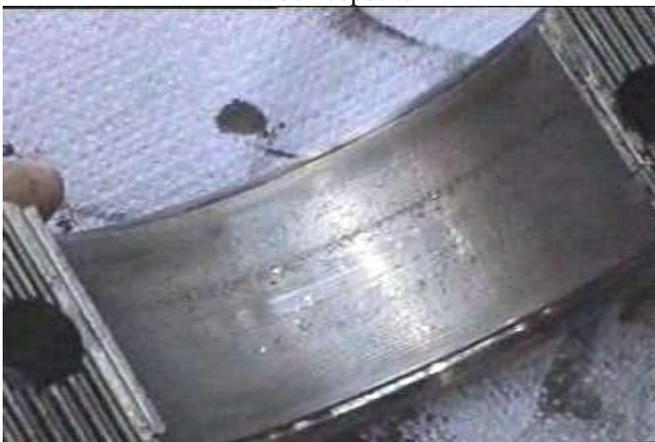
View of the 2nd cylinder connecting rod bearing (bearing bushing of a connecting rod) – 2nd part of a bearing (clamp)

- 2nd cylinder piston damaged, broken
- Connecting rod bearings of the 2nd cylinder: damaged
- Connecting rod bearings of 4th cylinder: damaged
- The crankshaft of 2+4 connecting rod: damaged

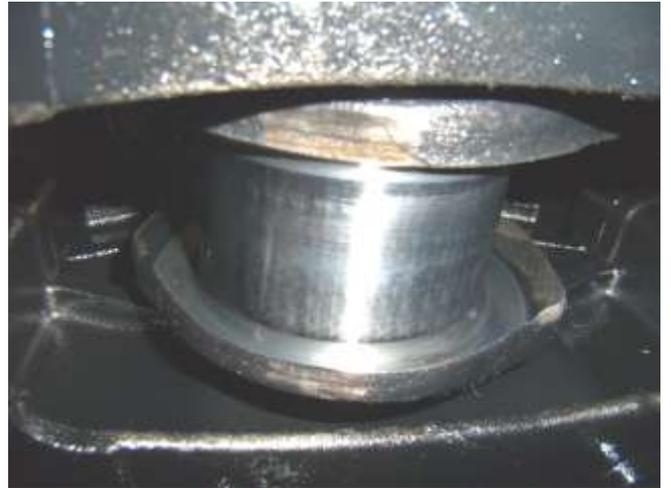
Detailed view of the engine crankshaft –connecting crank pin of the 2nd cylinder connecting rod

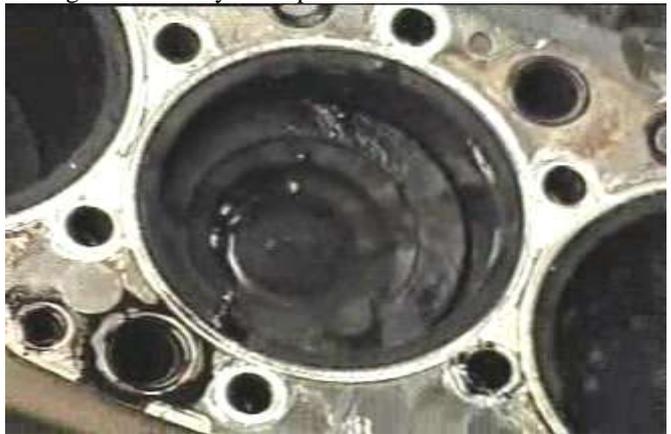
Carbon deposits on the piston bottom – the result of incorrect combustion

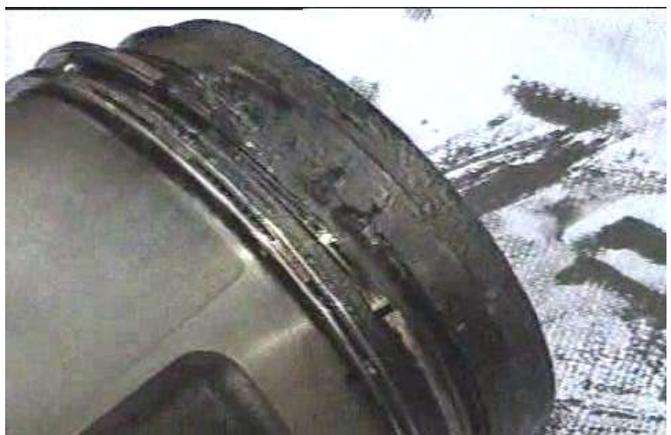
Carbon deposits on the piston above the piston rings – the result of incorrect combustion

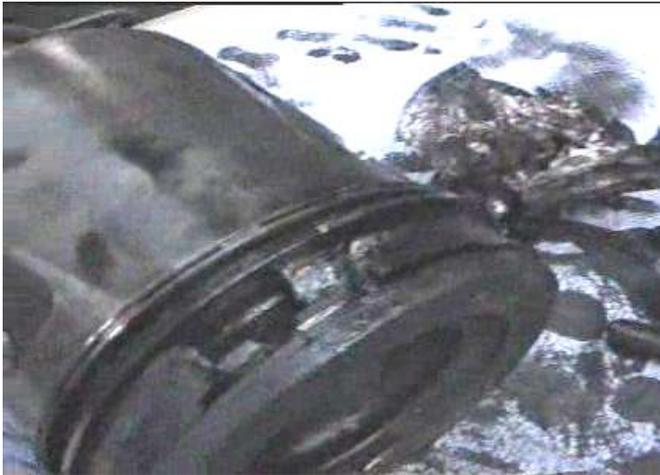
Damage to the piston detected after removing carbon deposits and piston ring fragments

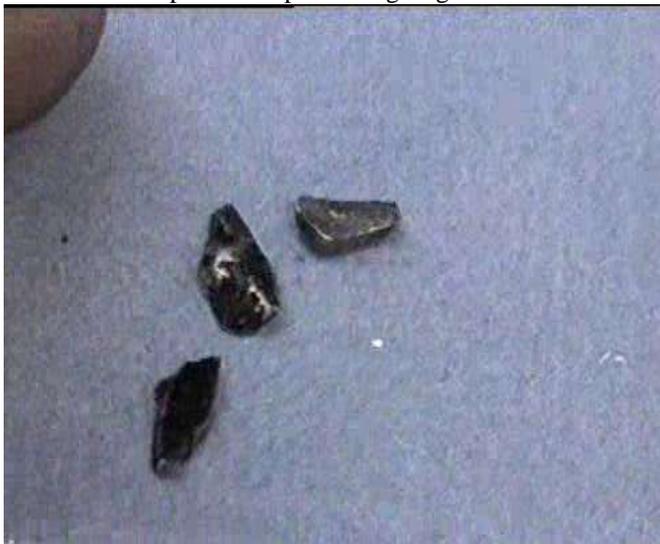
The fragments of the 2nd cylinder piston found in an oil bath – traces of blows on the moving parts of an engine

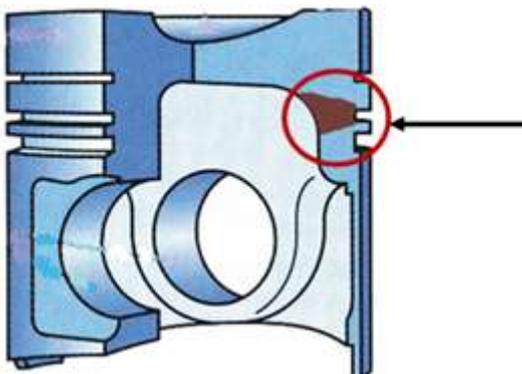
Marking of the damage to the 2nd cylinder piston – a broken part is marked black

- During the engine run, a part of the 2nd cylinder piston was broken off from its inner side in the zone of piston

rings due to the fabrication-related defect, or the defect of the piston material of the engine 2nd cylinder

- In the broken part, the burning fuel started to penetrate to the inner zone of an engine and the piston rings started to overheat locally consequently beginning to break
- When the burning fuel was flowing around piston rings, the carbon was deposited significantly on the piston in the piston rings zone
- As a result, we cannot rule out the possibility that a certain amount of fuel entered the engine zone unburned and mixed with engine oil (this can be assumed because the volume of the oil was not reduced)

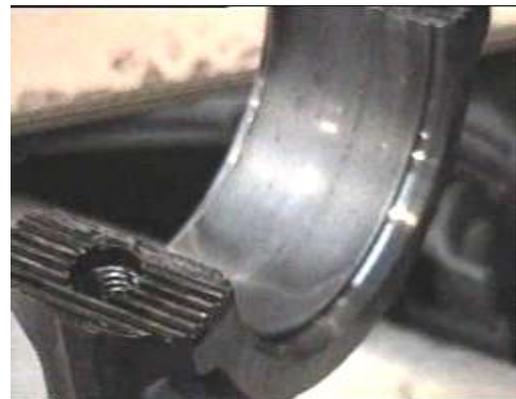
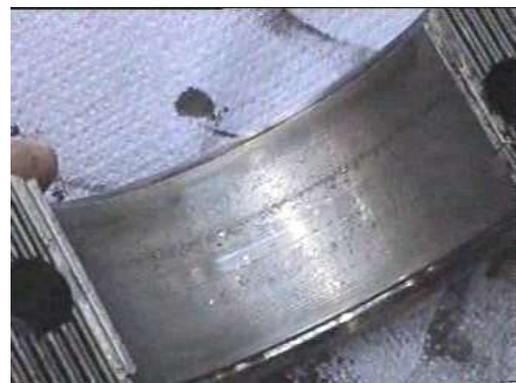
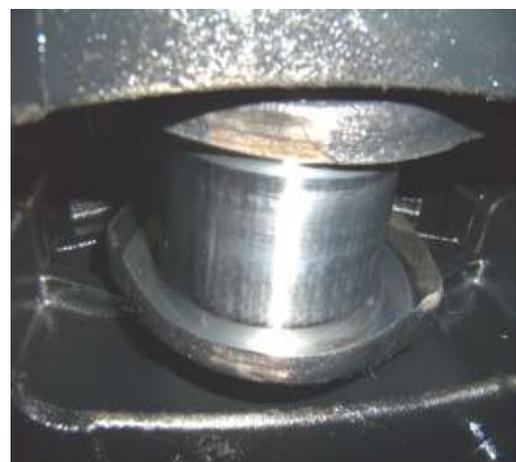
Damage to the connecting rod bearing of the 2nd and 4th cylinders and a crankshaft in the connecting crank pin of the 2nd and 4th cylinder:

We can assume that the above-mentioned damage occurred because of the reduction in the engine oil quality in

connection with increased stress of said parts in irregular engine run, i.e. as a direct consequence of the damage to the 2nd cylinder piston, since this involves abrasive damage to the parts mentioned.

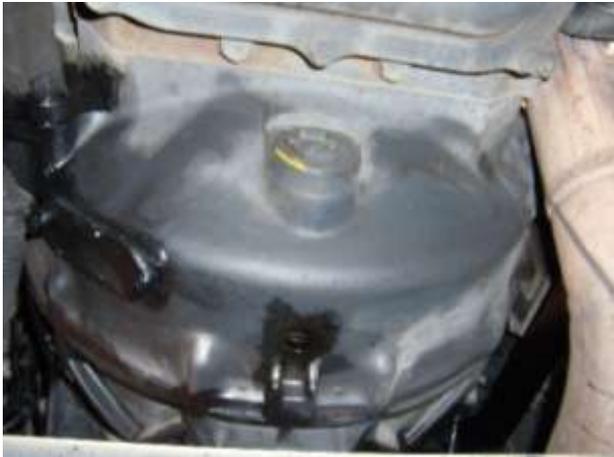
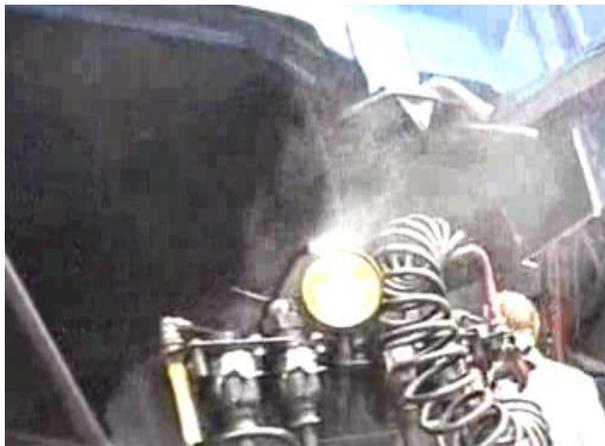
The evaluation of the repeated engine failures – a leak in the spring- energised seal of the crankshaft at the flywheel

According to the holder information, the engine has been repeatedly repaired, since the oil has been flowing through the spring -energised seal at a flywheel.
