Diagnostics of Iveco Stralis 440ST Truck Tractor Unit Engine and Identification of the Cause of its Malfunction

Abstract: *The article concerns the case of the Iveco Stralis 440St truck tractor unit engine failure and the methodology of the technical expert applied to identify the cause of failure. The engine has repeatedly exhibited failures –leaking crankshaft spring - energised seal and consequent engine oil leak, which has been repeatedly repaired at a car service station. Repeated engine failures resulted in the disputes between a vehicle owner and a car service station, finally leading to an agreement on finding the cause by an invited technical expert. To determine the cause, a vehicle was on the car service station premises, where a technical expert was present and according to his instructions, diagnostic and subsequent disassembly works were done. The outcomes of the investigation proved serious damage to the engine piston unit.*

Make and type: Iveco Stralis truck tractor unit, type 440 ST
Mileage: 173 485 km

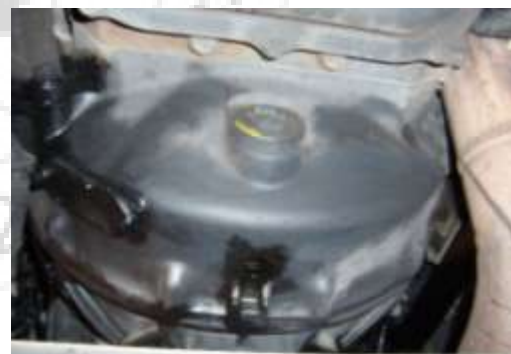
A detailed visual inspection of the vehicle and its engine has been carried out. Findings revealed no incompleteness, however there was engine oil found on the front part of gearbox housing – Figure 1.

View of the front part of a gearbox housing (clutch – engine flywheel) that is contaminated with oil – oil leaking from an engine through a spring-energised seal.

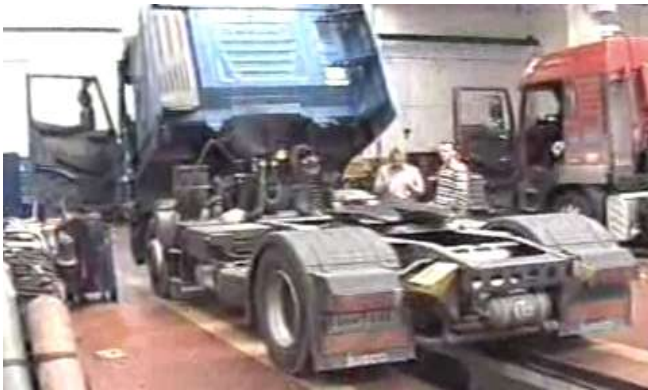
View of a vehicle with a running engine and excessive smoke

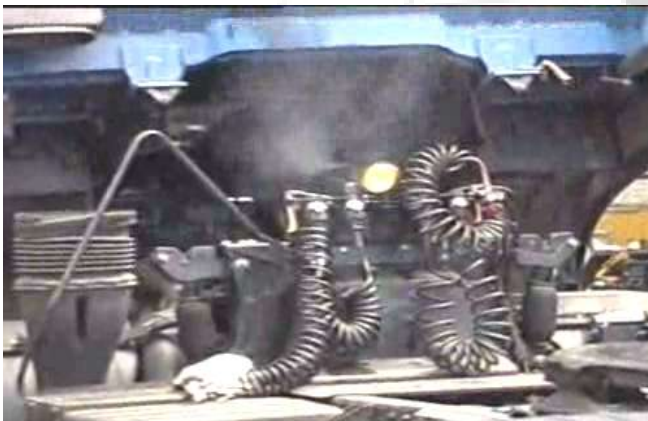
Close view of the engine excessive smoking

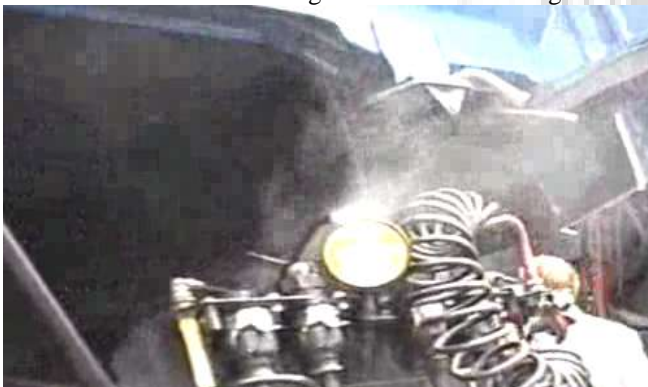
Detailed view of excessive smoke in a motor running

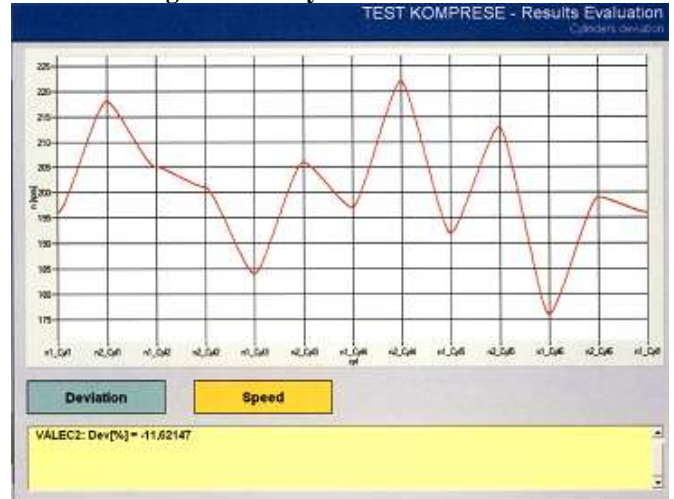
Detected irregularities in a crankshaft angular velocity

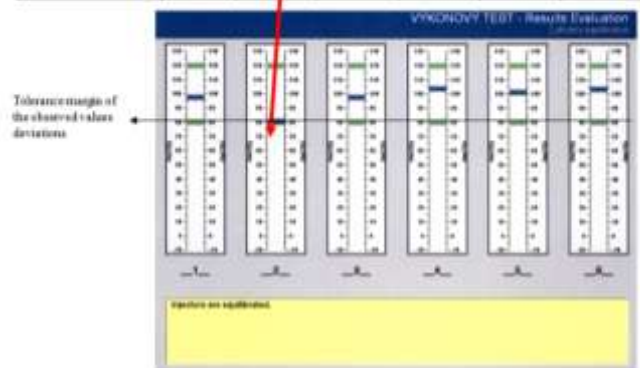
- The result of the compression control test A shows the difference in the performance of the 2nd cylinder and other five ones, but the observed deviation of the functionality decrease is within the manufacturer published tolerances (-3,5%)
- The difference in acceleration of a crankshaft (α in rad/s^2) is obvious but cannot be evaluated as a failure.

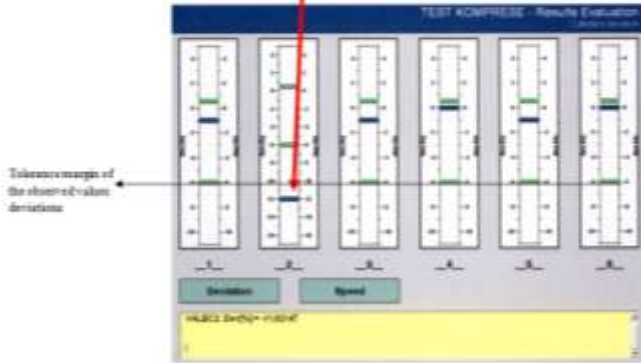
- The result of the compression control test B shows the significant difference in the performance of the 2nd cylinder and other five ones, and the observed deviation of the functionality decrease is above the manufacturer published tolerances (-3,5%)

- The difference in acceleration of a crankshaft (α rad/s²) is detected and indicates the deceleration of a crankshaft at the time of the 2nd cylinder activity.

Observed deviation of the values in cylinder compression test B, suggests in a significant way that the 2nd cylinder run did not correspond with the engine's technical condition and was significantly degraded. Since this test is based on the evaluation of the angular velocity change and the crankshaft angular acceleration, it may be considered an indirect indicative evaluation of the engine piston unit.

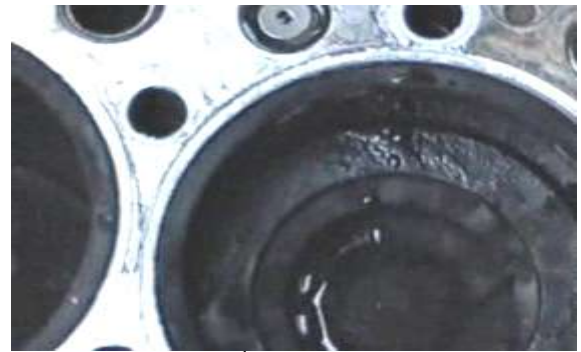
Detailed view of the 2nd cylinder piston bottom after the disassembly of the cylinder head

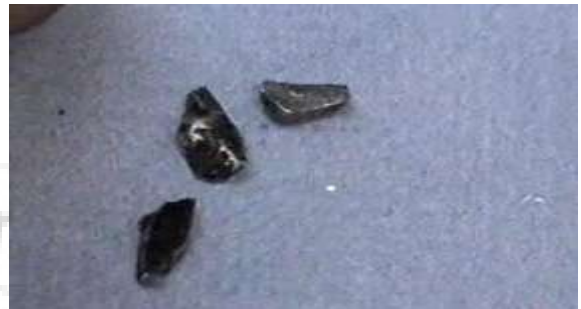
Fragments of the 2nd cylinder piston found in the engine oil bath after dismantling

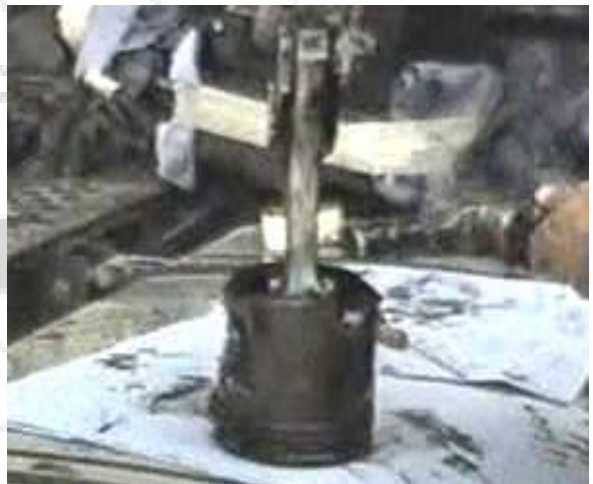
View of the piston and connection rod of the 2nd cylinder after dismantling

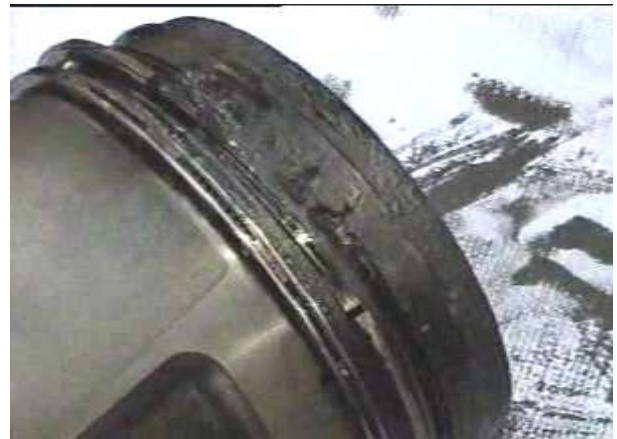
Detailed view of 2nd cylinder piston immediately after dismantling

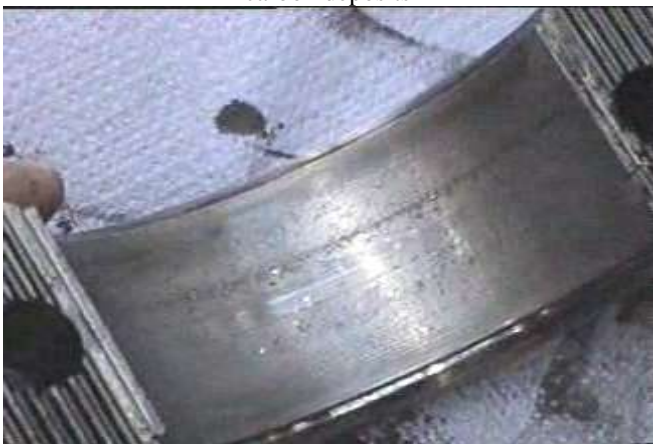
View of the 2nd cylinder connecting rod bearing (bearing bushing of a connecting rod) – 2nd part of a bearing (clamp)

- 2nd cylinder piston damaged, broken
- Connecting rod bearings of the 2nd cylinder: damaged
- Connecting rod bearings of 4th cylinder: damaged
- The crankshaft of 2+4 connecting rod: damaged

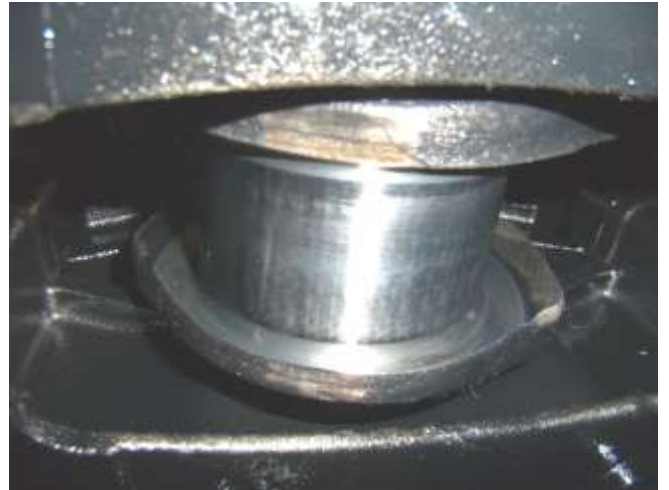
Detailed view of the engine crankshaft –connecting crank pin of the 2nd cylinder connecting rod

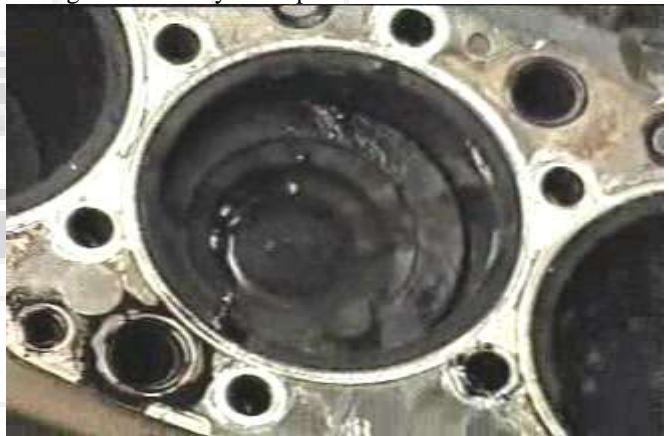
Carbon deposits on the piston bottom – the result of incorrect combustion

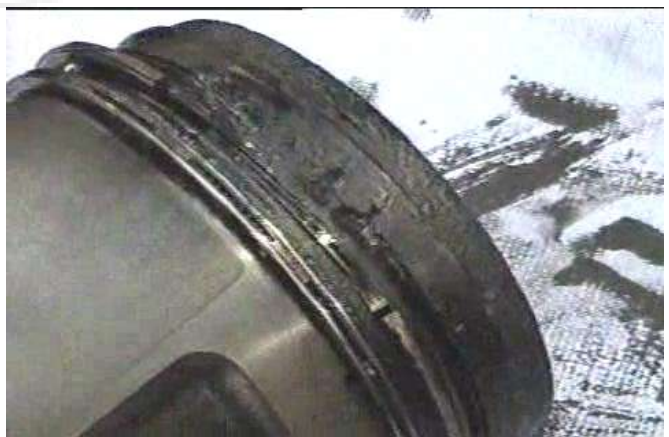
Carbon deposits on the piston above the piston rings – the result of incorrect combustion

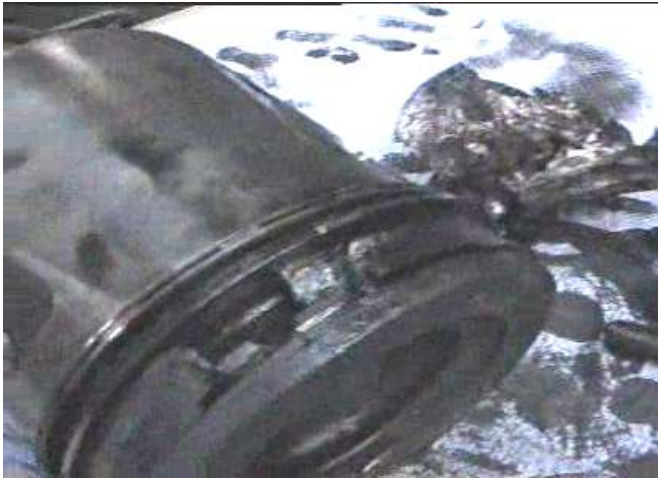
Damage to the piston detected after removing carbon deposits and piston ring fragments

- rings due to the fabrication-related defect, or the defect of the piston material of the engine 2nd cylinder
- In the broken part, the burning fuel started to penetrate to the inner zone of an engine and the piston rings started to overheat locally consequently beginning to break
- When the burning fuel was flowing around piston rings, the carbon was deposited significantly on the piston in the piston rings zone
- As a result, we cannot rule out the possibility that a certain amount of fuel entered the engine zone unburned and mixed with engine oil (this can be assumed because the volume of the oil was not reduced)

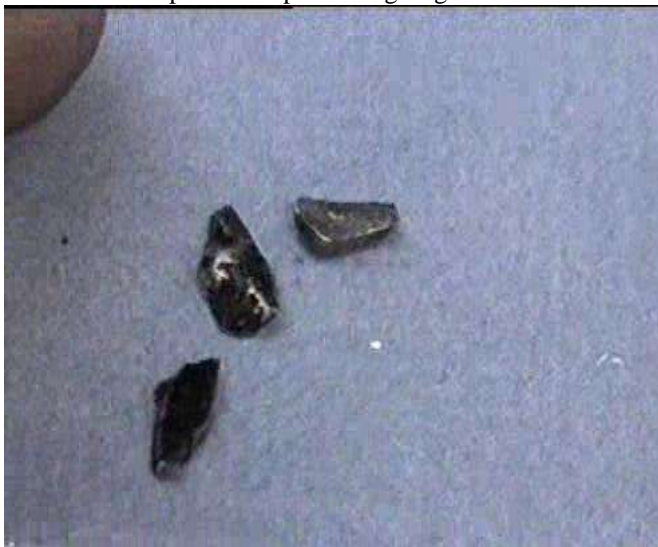
The fragments of the 2nd cylinder piston found in an oil bath – traces of blows on the moving parts of an engine

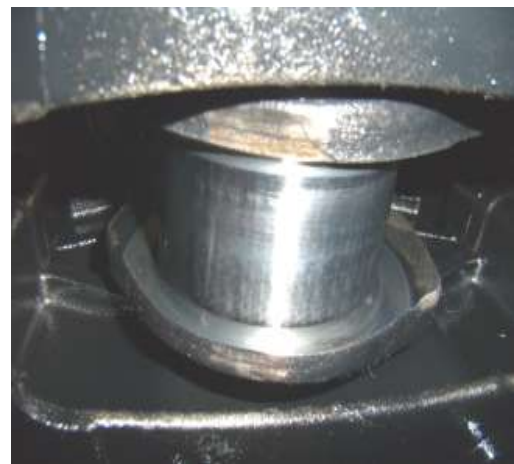
We can assume that the above-mentioned damage occurred because of the reduction in the engine oil quality in

connection with increased stress of said parts in irregular engine run, i.e. as a direct consequence of the damage to the 2nd cylinder piston, since this involves abrasive damage to the parts mentioned.

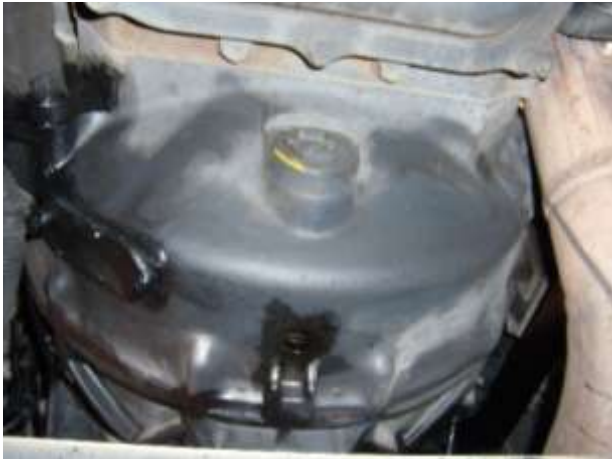
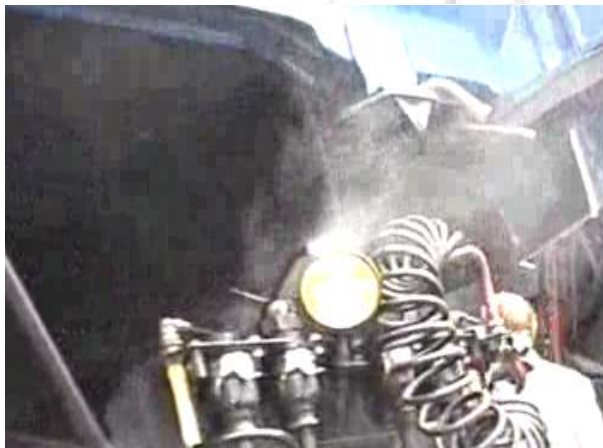
The evaluation of the repeated engine failures – a leak in the spring- energised seal of the crankshaft at the flywheel

According to the holder information, the engine has been repeatedly repaired, since the oil has been flowing through the spring -energised seal at a flywheel.
