Identification of Fabrication Related Defect on the Fiat Ducato Vehicle

Abstract: *The article deals with the case of damage to the Fiat Ducato engine and technical expert's procedure to determine the cause of its failure. The failure occurred in a way that the camshaft and motion adjustment's hydraulic system of the second cylinder intake valve were damaged. The result of technical analysis was the fact that the failure of engine occurred as a result of incorrect assembly in the production. The vehicle has been transported to an authorized service center and after the engine has been removed it has been examined by a technical expert. The article describes procedure of a technical expert and, in conclusion, his findings are presented. In order to find out the cause, the vehicle was inspected by a technical expert in the service station and diagnostic and consequently dismantling works were carried out according to his instructions. The procedure of evaluating the specific properties on the individual parts with their display and the resulting evaluation is described.*

Vehicle: Fiat Ducato 2.8 TDi, OHC

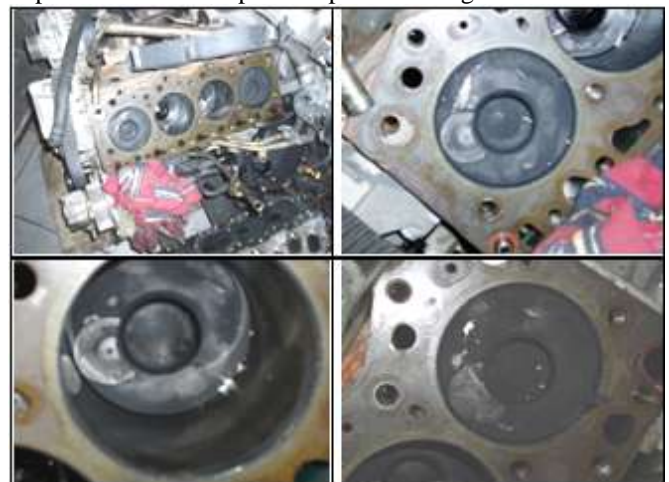
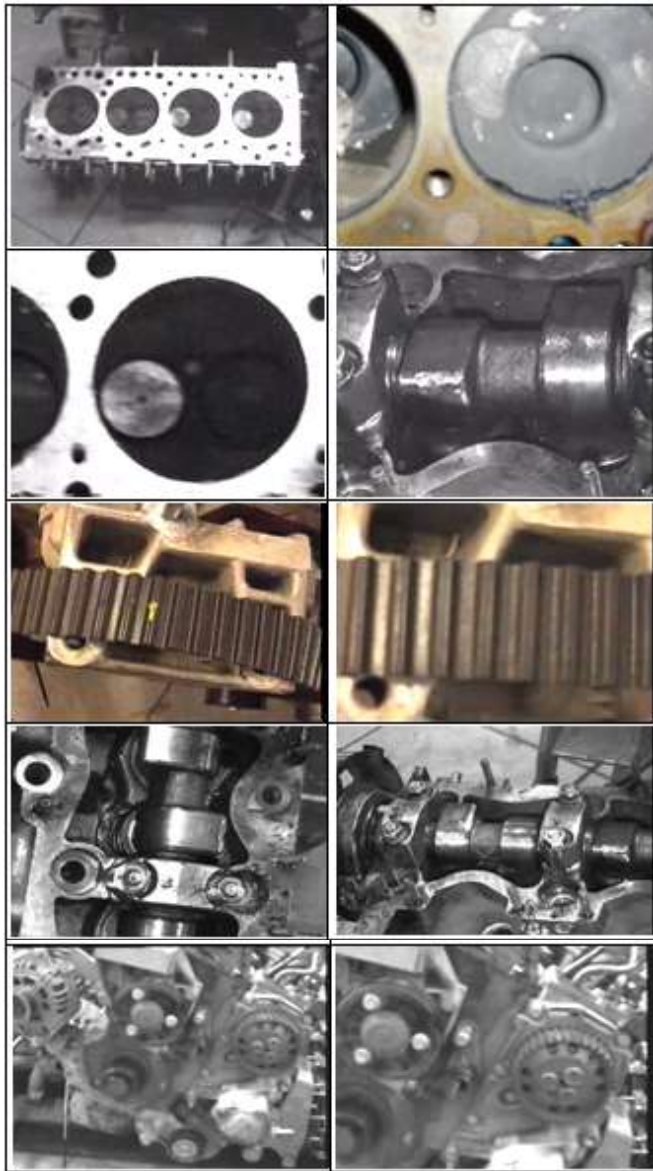
Figure 2: Visualisation of damaged engine parts' photos

- Pistons: signs of intake valve contacts at the top of all pistons are detected, according to the characteristic features of the long-lasting action, the depression marks about 2 - 3 mm in the pistons, obvious signs of rotation of the valves during the contacts
- Intake valves: signs of piston contacts found on all intake valves, depending on the surface - polished are long-term contacts
- Camshaft: camshaft chipping found on the 2nd cylinder's intake valve cam, signs of excessive wear found on the 1st cylinder's intake valve cam
- Tappets with hydraulic valve motion setting: tappet of intake valve for 2nd cylinder is missing - fallen out
- Geared timing belt (152 teeth): no obvious signs of damage, chipping or tooth breaking
- Timing wheels: No damage found

- 1) **Pistons:** signs of intake valve contacts found at the top of all pistons, according to the characteristic features of the long-lasting action, depression marks approx. 2-3 mm in the pistons, obvious signs of rotation of the valves during the contacts with repeated and long-term contacts without evidence of destruction, it is assumed that the functionality of the pistons has not been disrupted but that the lifetime of some parts of the timing group has been significantly reduced

- 2) **Intake Valves:** signs of piston contacts found on all intake valves, depending on the surface - polished are long-term contacts with repeated and long-term contacts without evidence of destruction, it is assumed that the functionality of the valves has not been disrupted but that the lifetime of some parts of the timing group has been significantly reduced

- 3) **Camshaft:** camshaft chipping found on the 2nd cylinder's intake valve cam, signs of excessive wear found on the 1st cylinder's intake valve cam the damage can be related to the piston and intake valve contacts that have led to formation of additional forces tappets

I consider the reason for the occurrence of an emergency motor fault of the above-mentioned motor vehicle Fiat Ducato an incorrect engine timing, which most likely occurred when the engine was installed. Mentioned incorrect engine timing has resulted in contacts of the upper piston parts with valves as well as subsequent damage to the hydraulic valve motion setting and valve cam.
