Case Study Papers on Practical Guidelines for the Inspection and Repair of Hot Dip Galvanized Coatings

Running Title: Practical Guidelines for the Inspection and Repair of Hot Dip Galvanized Coatings

Harshal S Khode

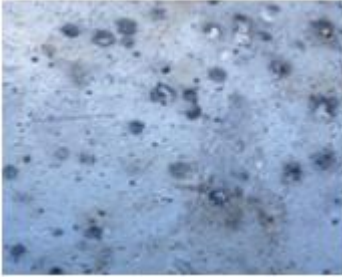
3	BARE SPOTS: Although excluded from ISO 1461, bare spots of about 5mm (2,2 x 2,2mm), due to small localised flows, are adequately protected by the sacrificial properties of zinc and will have very little effect on the service life of the coating. Where necessary, such spots may be repaired using one of the specified repair methods. Gross uncoated areas are a cause for rejection. See Coating Repair Procedures.	There are several causes of bare spots. These include: Over-drying: If the time between fluxing and hot dip galvanizing is prolonged or the drying temperature is too high, the barrier protection provided by the flux may be lost. This is indicated by a rusty appearance on the ungalvanized article, which can result in coating discontinuities after hot dip galvanizing. G Excess - aluminum: A condition sometimes referred to as black. Spots may occur if the aluminum content of a bath becomes too high. No trouble should be experienced if flux concentration is correct and the aluminum content of the bath is maintained below approximately 0,007%. G Further causes are: Blowouts; flux deposits; stains and inclusions; Mechanical damage; touch marks; uncoated surfaces caused by - surface contaminants, scale or sand; welds and weld spatter. See SC No's 6, 16, 19, 30, 33, 34, 35 and 37	REP If Necessary	A / R REP If Necessary

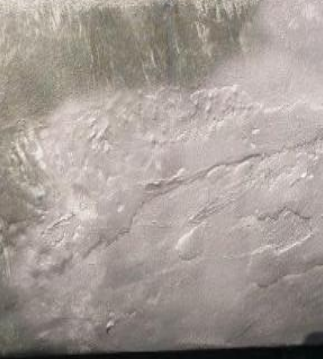
11	DISTORTION: Distortion is the unwanted warping that occasionally becomes evident after hot dip galvanizing. The hot dip galvanizing process occurs at molten zinc temperature of 450° C. This is at the lower end of stress relieving temperature for treating steel	Thus, any inherent rolling or welding stresses in the fabrication, are likely to be released. This may result in a dimensional change, i.e. distortion.	Use symmetrical designs; Use sections of similar thickness; Stiffen unsupported thin wall sections; Use preformed members with the correct minimum bend radii; Use balanced or staggered welding techniques; Make use of temporary braces on thin walled sections such as troughs, cylinders and angle frames. Avoid quenching after galvanizing.	A / N REP If Possible

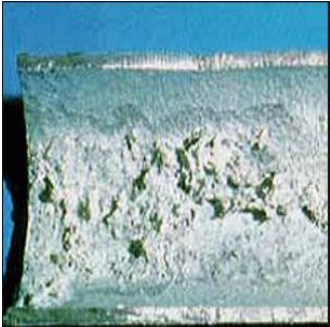
17	DISCOLOURATION OF THE PAINT COATING OVER HOT DIP GALVANIZING AFTER EXPOSURE TO THE ENVIRONMENT.	Inadequate repair of a damaged surface on the hot dip galvanized coating prior to the application of a paint coating.	Make use of the correct repair materials and application procedures when touching up cut or welded hot dip galvanized components. See Coating Repair Procedures. B	R REP

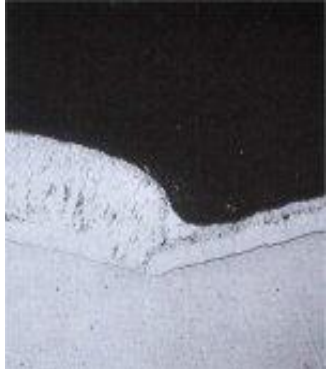
22	REACTIVE AND NON - REACTIVE STEELS, WELDED TOGETHERS: Variations in coating thicknesses can arise when reactive and non - reactive steel welded together. Efforts to increase to coating thickness on the less reactive steel may result in an undesirably thick and brittle coating on the most reactive steel.	This difference in coating thickness, is brought about by a combination of a more reactive silicon killed steel, and/or high phosphorous resulting in a thicker coating and a less reactive aluminium killed steel, resulting in a coating thickness sometimes below that required in the specifications. Should the galvanizer be asked to re-galvanize in accordance with the specification, the resultant coating thickness on the reactive steel will be excessively thick, resulting in a brittle coating more susceptible to damage.	Select the same steel for fabricating a component. If need be, accept a concession request by the galvanizer when the thinner coating is possibly below specification. D / B	A / N

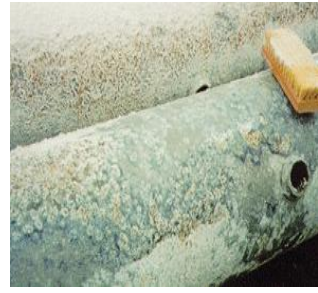
38	Wet Storage Stains and White Rust: Wet storage stains and white rust as it is commonly called, is a white voluminous deposit that is occasionally found on the surface of freshly galvanized coating.	Wet storage stain (zinc hydroxide) is formed on freshly galvanized surfaces whirled in close contact in presence of moisture. Freshly galvanized coatings react with the environment until such time as a stable zinc carbonate film is formed on the cooling surface.	Wet storage stain ceases when the cause is eliminated. If the coating thickness at the affected area is equal to, or greater than the minimum required in the specification, it is not a cause for rejection, other than for aesthetic reasons. The latter is subject to discussion with the end user. Customer is to exercise caution during transport and storage. G / B	A

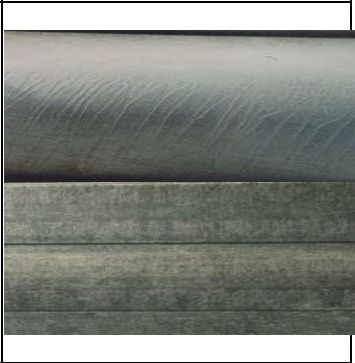
<p>Striations/ Fish Boning: These are the parallel ridges in the galvanized coaings.</p>	<p>Striations are characterized by raised parallel ridges in the galvanized coating, which can be caused by the chemical composition of the steel. Striations are related to the type of steel that was galvanized, and while the appearance is affected, the performance of the corrosion protection is not striations are acceptable.</p>	<p>Fish-boning, similar to striations, is an irregular pattern over the entire surface of the steel part, which is caused by differences in the surface chemistry of a large diameter steel piece and variations in the reaction rate between the steel and molten zinc. These surface conditions do not affect the corrosion performance and are acceptable.</p>	<p>A</p>

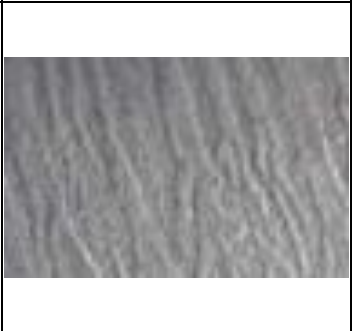
<p>Technical Guidelines for the Inspection and Repair of Hot Dip Galvanized Coatings as per ASTM / AS / NZS / ISO / AWS / AC</p>					
	<p>Description</p>	<p>Cause</p>	<p>Effect / Remedy / Responsibility</p>	<p>A/R/N/C/ REP</p>	<p>Example</p>
	<p>Puddling:</p>	<p>These are caused by poor drainage also the Design issues are the main cause of puddling and can only be eliminated by good design. With the exception of blowouts and bleeding, and where the galvanized coating is missing, ost galvanizing defects have no effect on the coatings' durability.</p>	<p>These defects are unavoidable in the hot-dip galvanising of general items and are acceptable as long as they do not interfere with the assembly of the function of the item or present a safety hazard in handling service.</p>	<p>REP If Necessary</p>
