# Grenfell Tower Fire

Jagath Kumari Dungi

**Abstract:** West London, the Grenfell Tower in North Kensington was built in 1974. On Wednesday 14 June 2017 the fire was first reported at 12:54 a.m. Firefighters responded within six minutes. The blaze began on the fourth floor and spread to the top with a velocity and intensity that stunned 250 firefighters is on fight. 81 people died in this disaster. As a result of the fire, Grenfell Tower's displaced residents are now without a home. This disaster has happened because of the failure of newly renovated cladding system which catches fire. The cladding material should resist fire, and as per the norms of Fire Protection Association (FPA). This case study is helpful in studying the fire resistance concrete structures.

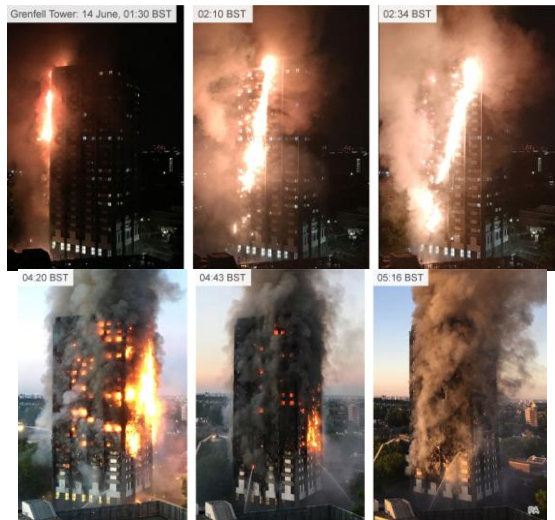
Figure 4: Fire growth scenario

The explosion of an electrical appliance may cause the fire, from fourth floor but nothing has been confirmed in NEWS. And the fire appears to have spread via recently-installed cladding to the block. Actually Grenfell Tower's management company carried out an overhaul of the fire safety system, considering it is a model for many properties and in view of same approach will be applied for all major projects.

On 14 June 2017 Wednesday the fire was first reported at 12:54 a.m. Firefighters responded within six minutes. The blaze began on the fourth floor and spread to the top (Fig. 4) with a velocity and intensity that stunned 250 firefighters responded as in Fig.5. Pockets of fire are still blazing on next day morning. Then the fire broke out more than 24 hours after.

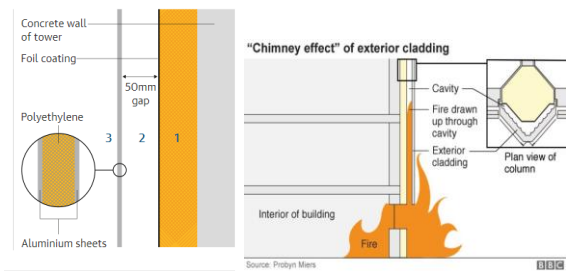
Figure 6: Cladding System

Reynobond panels were used for cladding on Grenfell Tower. This is a layer of sandwich polyethylene between two aluminum sheets. The panels are flammable and official building regulations recommend that only panels with non-

combustible cores be used on buildings taller than 18 m. The cladding had a metal outer coating and an expanded foam interior.

Chartered surveyor and fire expert Arnold Tarling, from Hindwoods, said that the renovating process could create a 25mm-30mm cavity between the cladding and the insulation. It produces a wind tunnel and also traps any burning material between the rain cladding and the building. All insulation used in the process is not sustained. So basically the tower got a cavity with a fire spreading behind it. Although the building met all the fire regulations, required and health and safety standards nevertheless the fire attacked the building. The material of the cladding could fire retardant, it should not catch fire easily, but the temperatures are raised to 900, to 1,000<sup>o</sup> c, and subsequent situations, somewhat material will burn. So the insulation material burnt and left thick black smoke.

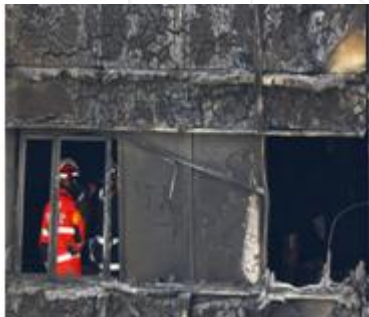
The damage is more on the North-West and south faces of the Grenfell, whereas the East face is partially damaged as shown in fig.8. The damage is insignificant for the lower floors.

The window frames were deflected sagged due to exposure of high temperatures. And it seems cladding sheets become over burnt lot of visible cracks appeared on the façade.

- 1) Through inspection of buildings are required regularly.
- 2) Inspections of buildings with respect of man-made disasters are required annually.
- 3) The material of the helmets of the fire fighters to be enhanced.
- 4) Use cladding material, which should be fire resistant and fire proof as per standards and specifications.
- 5) Residents are to be thoroughly trained for fire safety regulations, securities.
