Practical Case Study of Electrical Safety Issues within an Imbalanced Three-Phase Power System

KABONGO, Monga Chriss¹, ILUNGA, Kalenga David²

¹ Engineering Department, Frontier Mine, Eurasian Resources Group, 238, Route Likasi, Commune Annexe, Lubumbashi, DR Congo

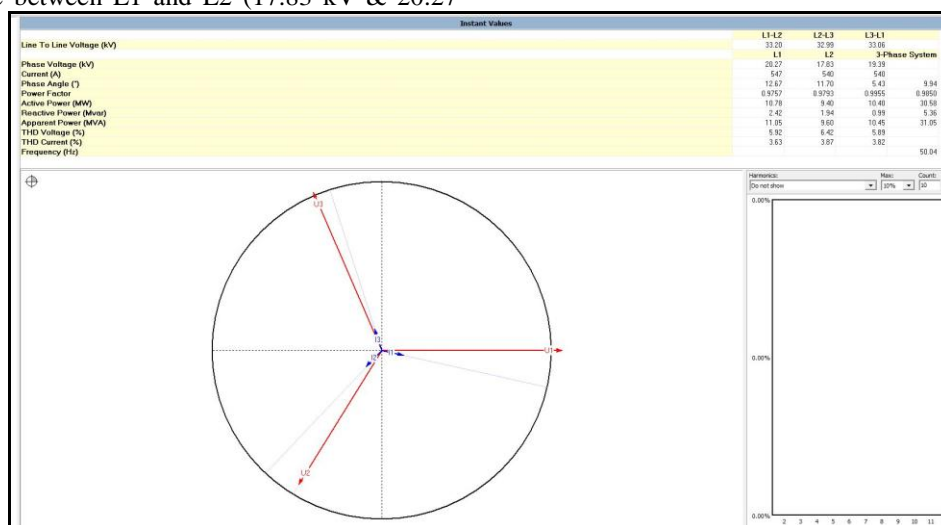
Figure 1: Initial System performance

Following recorded disturbances, the system figures were monitored using Cewe Config in order to discover any abnormality. Two concerns could be noticed: a 12% phase voltage imbalance between L1 and L2 (17.83 kV & 20.27

kV). In addition, phase angle was found to be much lower between L1 and L3, compared to the others hence a higher phase power factor for L3 as well. Figure 1 displays the phase angles as well as different readings at a particular point in time.

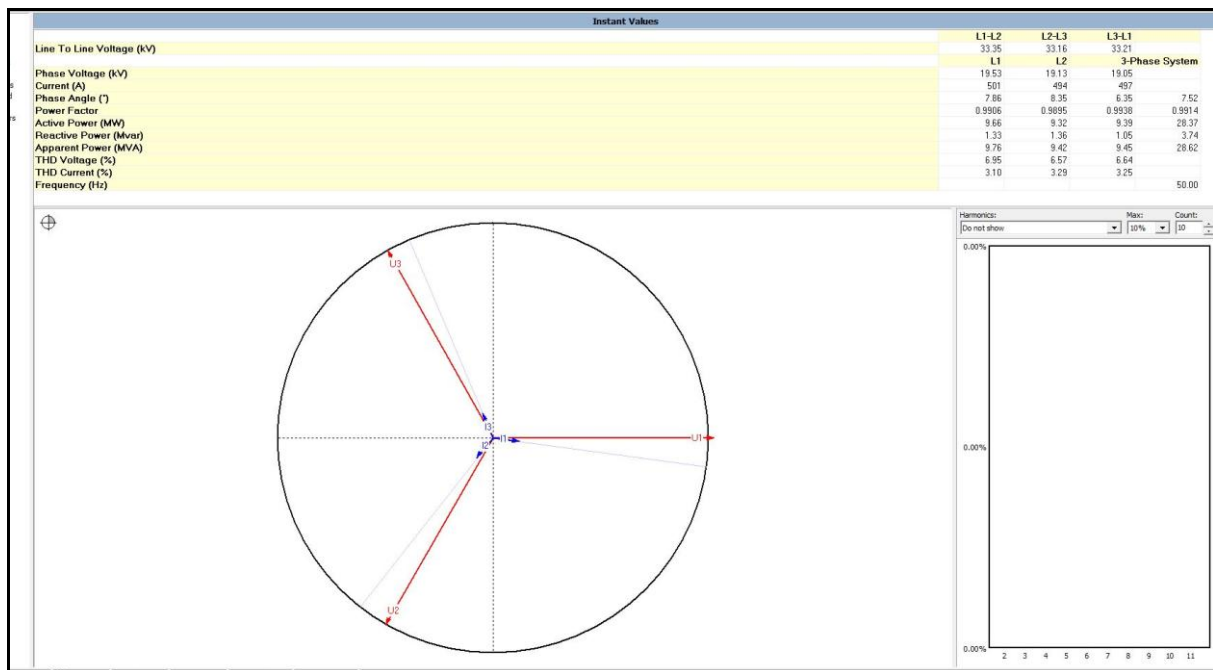
Figure 2: System status prior to sequential monitoring at low voltage and angle difference

From observations, it was seen that the imbalanced varied with time in an uncontrolled manner. Getting from quite severe, as for Figure 1 to a bit better as per Figure 2 which describes the initial status on the test and monitoring date.

At this stage the voltage ratio by considering the extremes (L3 divided by L1) is 97.5% hence a 2.5% imbalance. However, the angles differences taken from the extremes

(third divided by second) is 76% which implies a 24% difference.

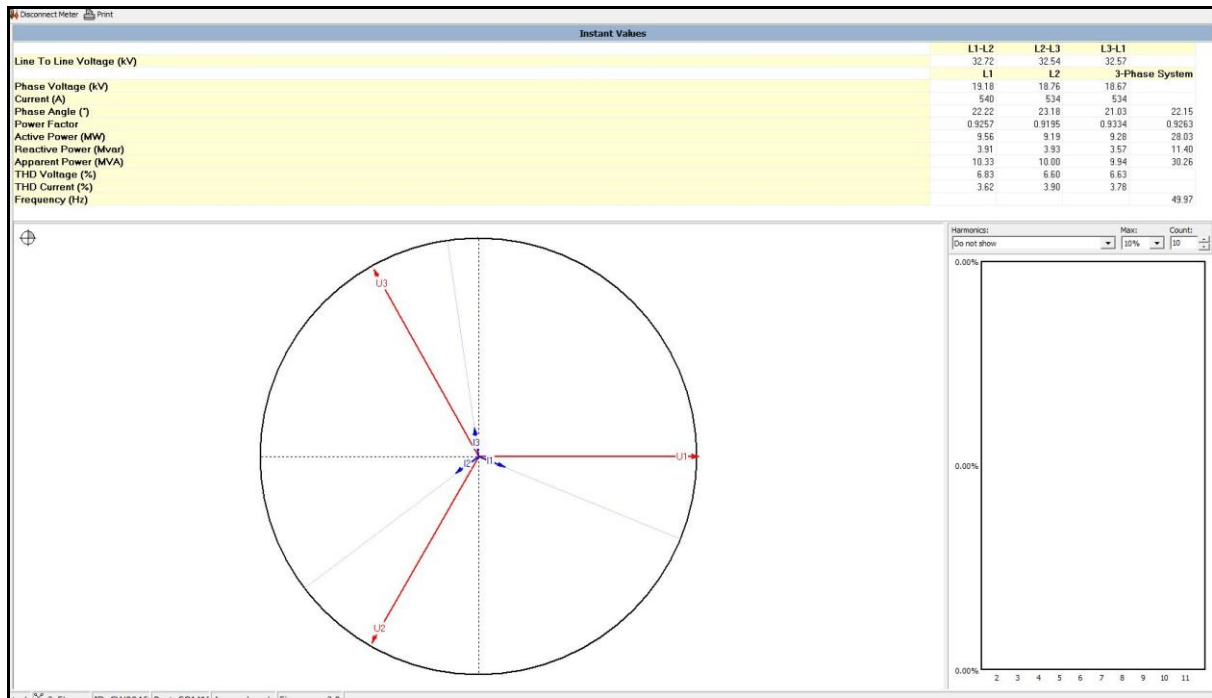
Figure 3: Power factor correction units isolated

This logically resulted in a power factor fall from an average of 0.9914 to 0.9263 with an improvement in voltage angle ratio by comparing the extremes from about 76% to 90%.

This could lead to believe that the power factor correction unit have a negative impact on voltage angles.

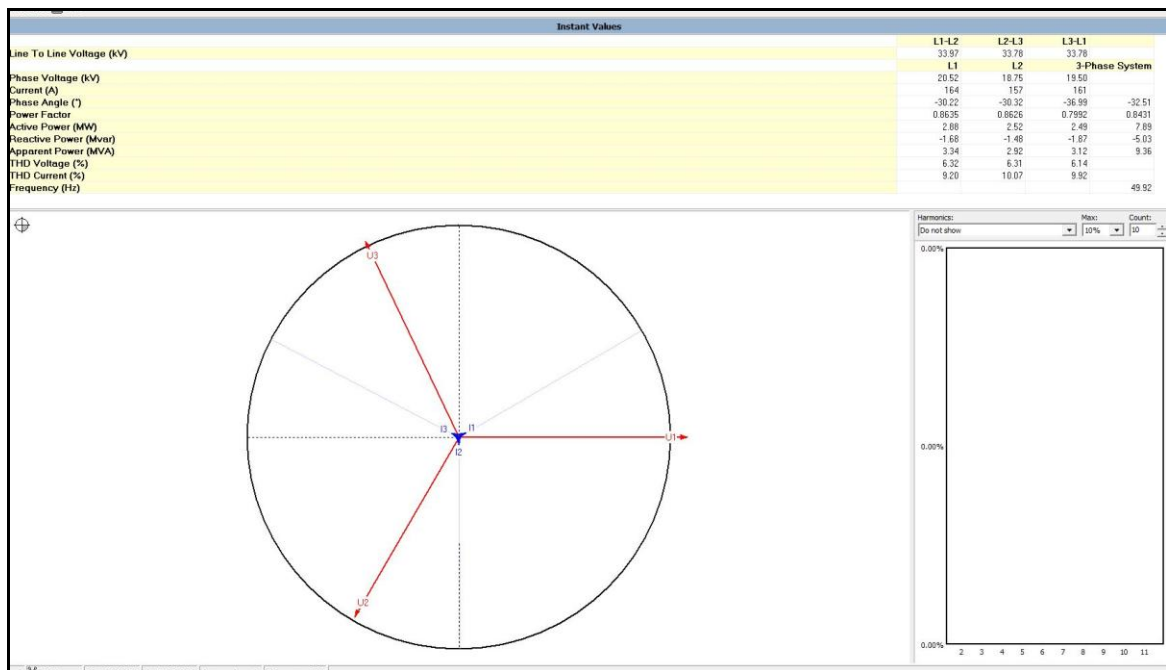
Figure 4: Major plant load shedding (Feeder#2 isolated)

At this stage, the voltage ratio slightly reduced to 95% and angle ratio to 82% with a 72% reduction in load (from 28.03

to 7.89 MW). This reveals that the plant load is a factor of equilibrium.

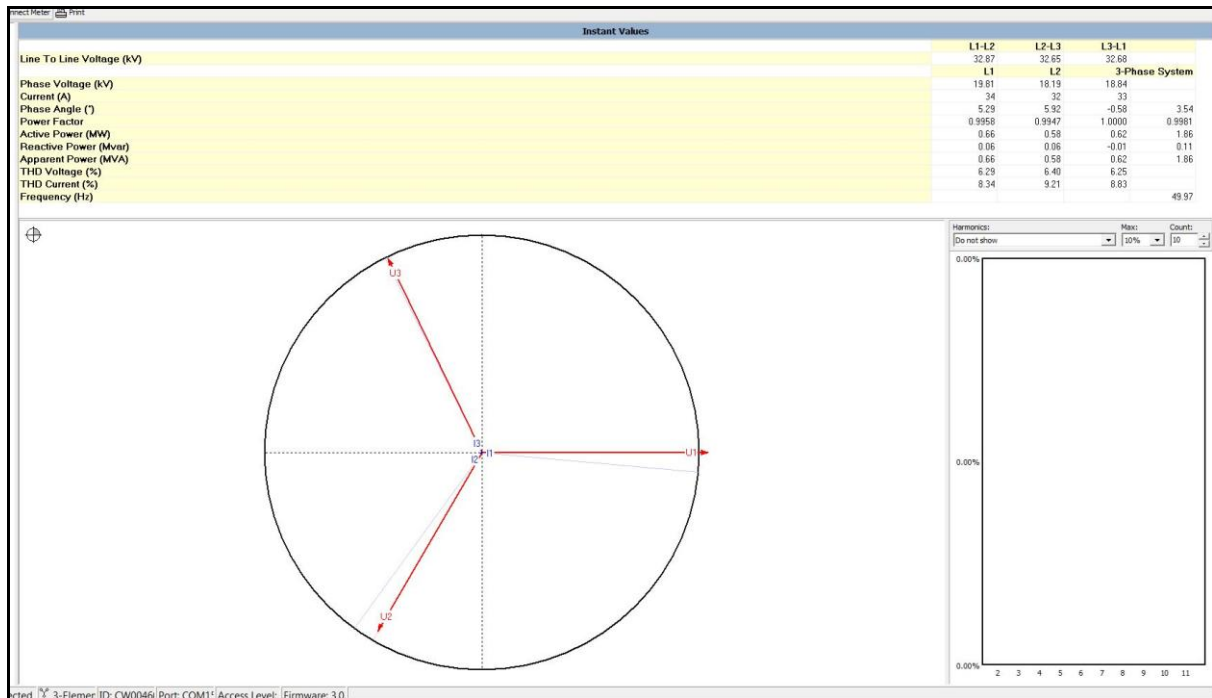
Figure 5: Pit dewatering load shedding (part of Feeder #3 isolated)

A further 21% reduction in load maintained the voltage ratio (now L2/L1) dropped to 92% while the angle ratio gets lower than 10% from the previous 82%.

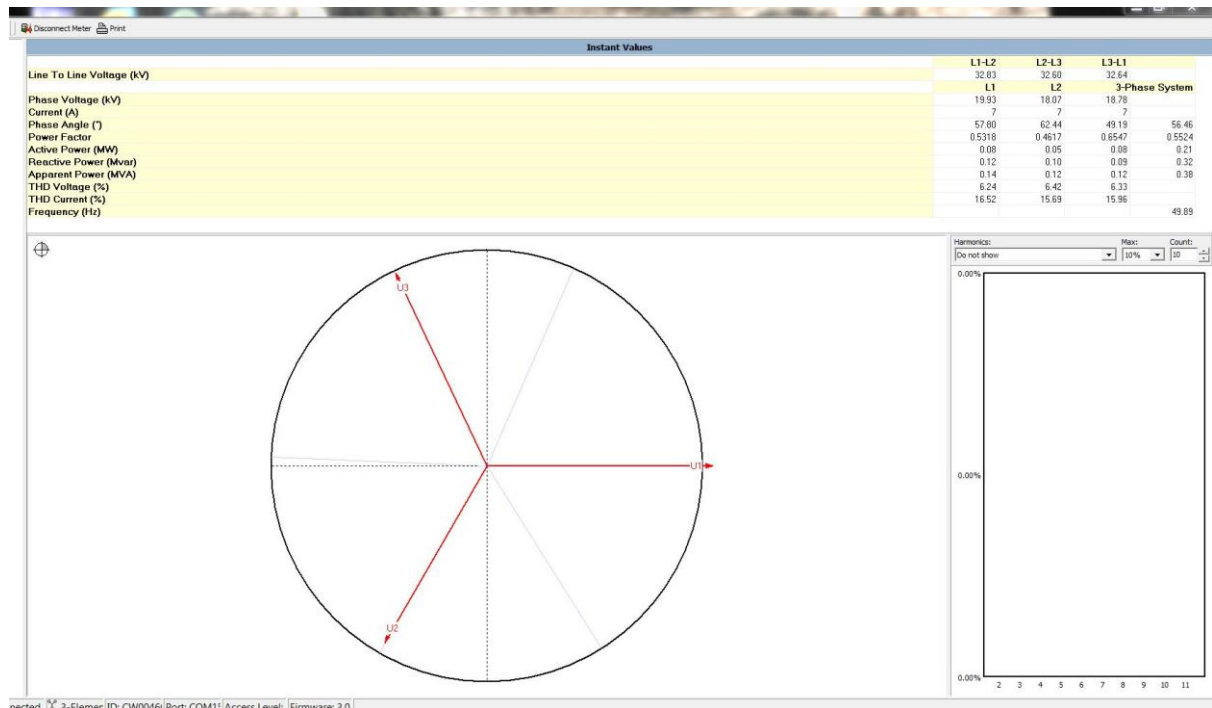
Figure 6: Load shedding of the remaining plant load (Feeder #1)

With only a 0.75% load, the voltage ratio reduced further to 91% while the angle ratio jumped to 79%.

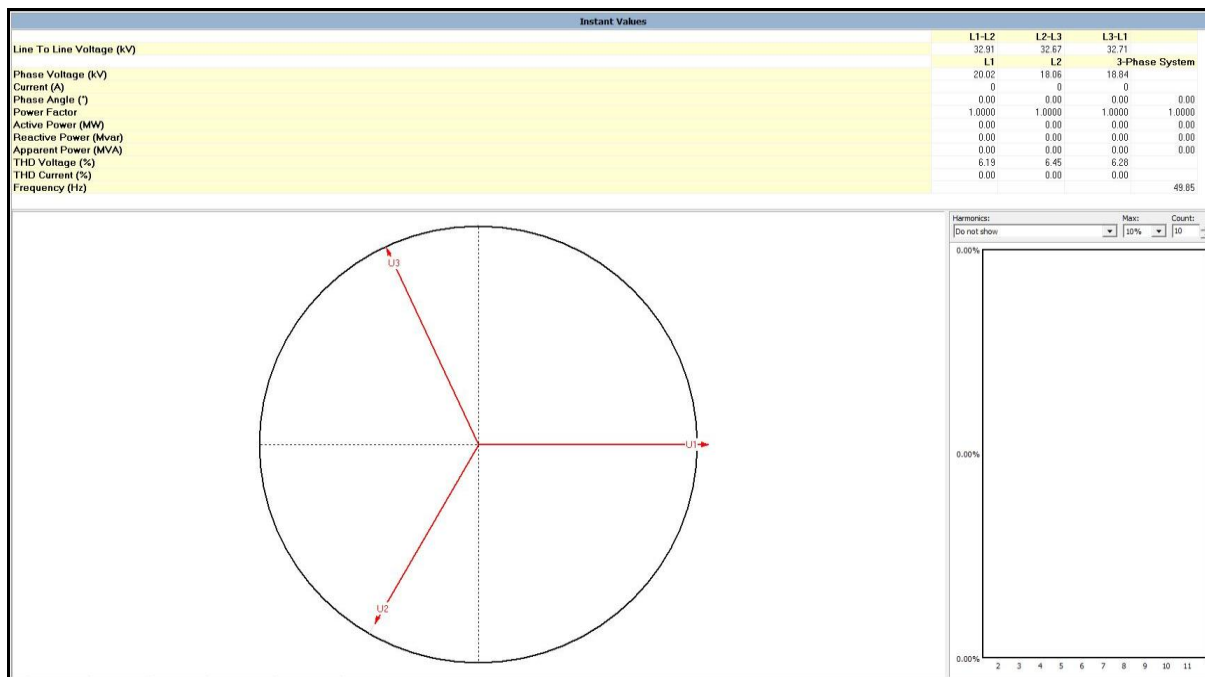
Figure 7: Full site outage

At no load, voltage ratio drops further to 90% hence a 10% imbalance and display the high voltage grid actual performance. All three phases' angles become null due to no load hence no current flowing on the feeder.

In summary, the system performance tends to become worse when the load reduces up to reaching a voltage imbalance of 10% at no load. This is specifically for the phase-to-neutral voltage, while phase-to-phase voltage is somewhat balanced. Looking at it, this is similar to what was measured on the low voltage transformers' terminals using a multimeter, means a different measuring tool. Therefore, we should comfortably argue that the presence of a voltage between the transformer secondary star point and the earth is the consequence of an imbalance at the high voltage level. Consequently, the issue lies on the supplier side and is independent from the site equipment.
