Investing the Cause of Premature Tyre Failure of Open Pit Mine Dump Trucks: A Case of ABC Mine, Northeast Africa

Dr. Dyson Galatia, PhD

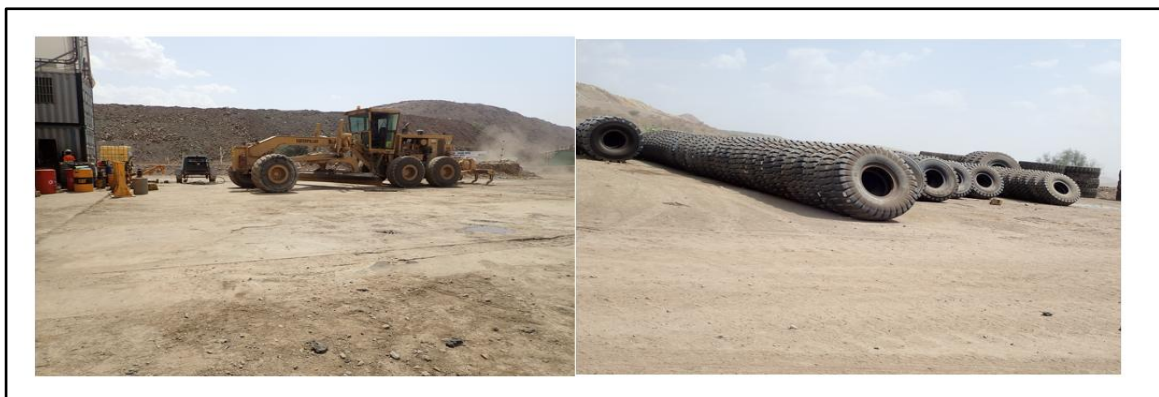
Figure 11: Tyre Work Area and Storage Yard

The storage of tyres was not adequate, the tyres were placed in an open space exposed to various environmental

Further, the tyres were not segregated according to their condition, there were only two areas of new tyres and failed or worn-out tyres. Figure 12 shows the tyre and components

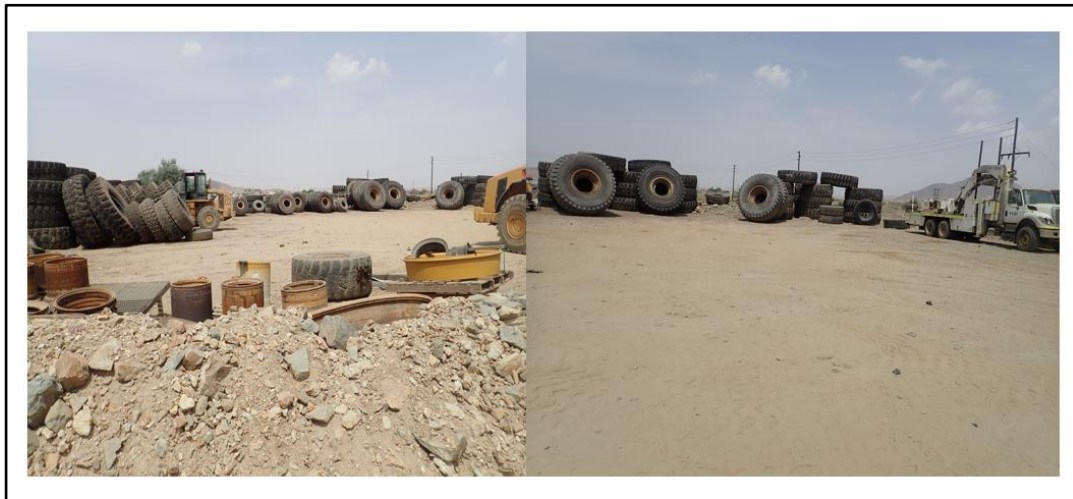
Figure 12: Tyre and Components Storage Area

storage areas. These are assembled, worn-out and damaged tyres as well as tyre components.

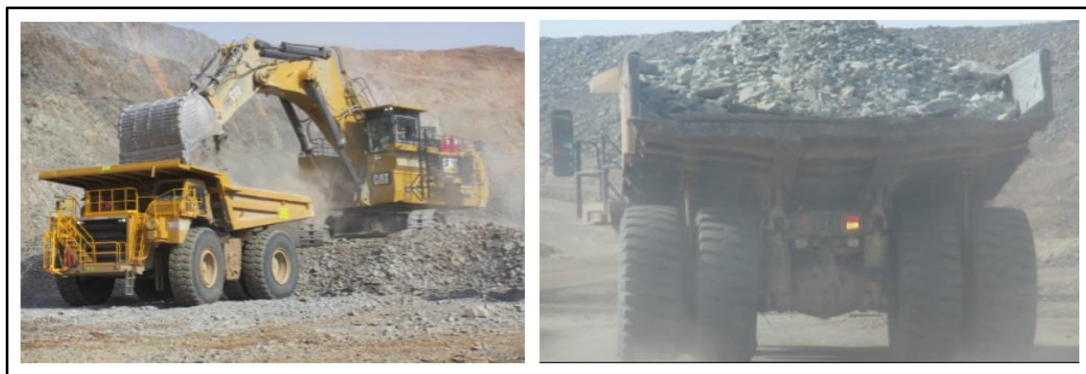
Figure 13: Truck Loading

- a) Spillage – loose gravel ranging from 5mm to 35mm
- b) Undulation – active undulated ground
- c) Payload distribution – load along center of the machine and concentrated to the front of the machine

d) Loading point layout – moderately wide loading area. However, it requires the machine to reverse and maneuver

- e) Surface condition – dry
 - f) Size of surface material – aggregate 5 – 50mm
- Figure 13 shows the loading area with a Dump Truck being loaded and a Loaded Truck heading for the tipping point.

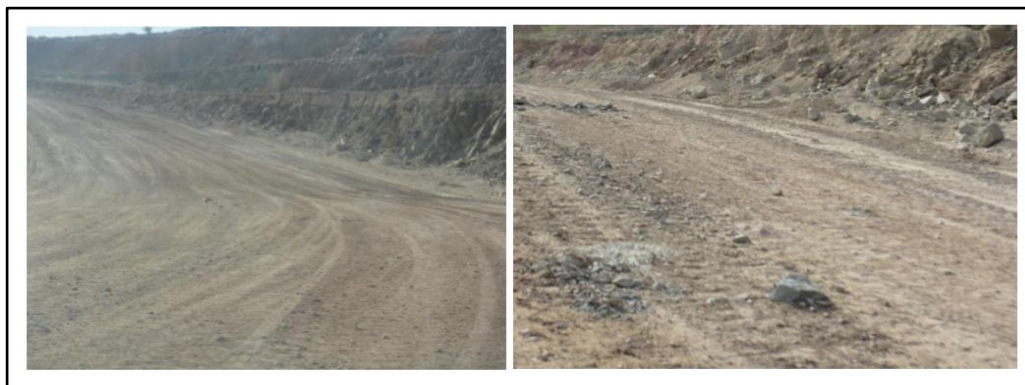
Figure 14: Road condition

- 1) Width – the majority of the roads were wide with few tight corners
- 2) Spillage – noted, moderate to high risk of tyre cuts and aggression
- 3) Undulation – low to moderate

- 4) Sharp turns – two (2) sharp turns were observed on the road
- 5) Water – not significant, reasonably dry
- 6) Size of surface material 5 – 50mm

Figure 14 shows the condition of the roadways.

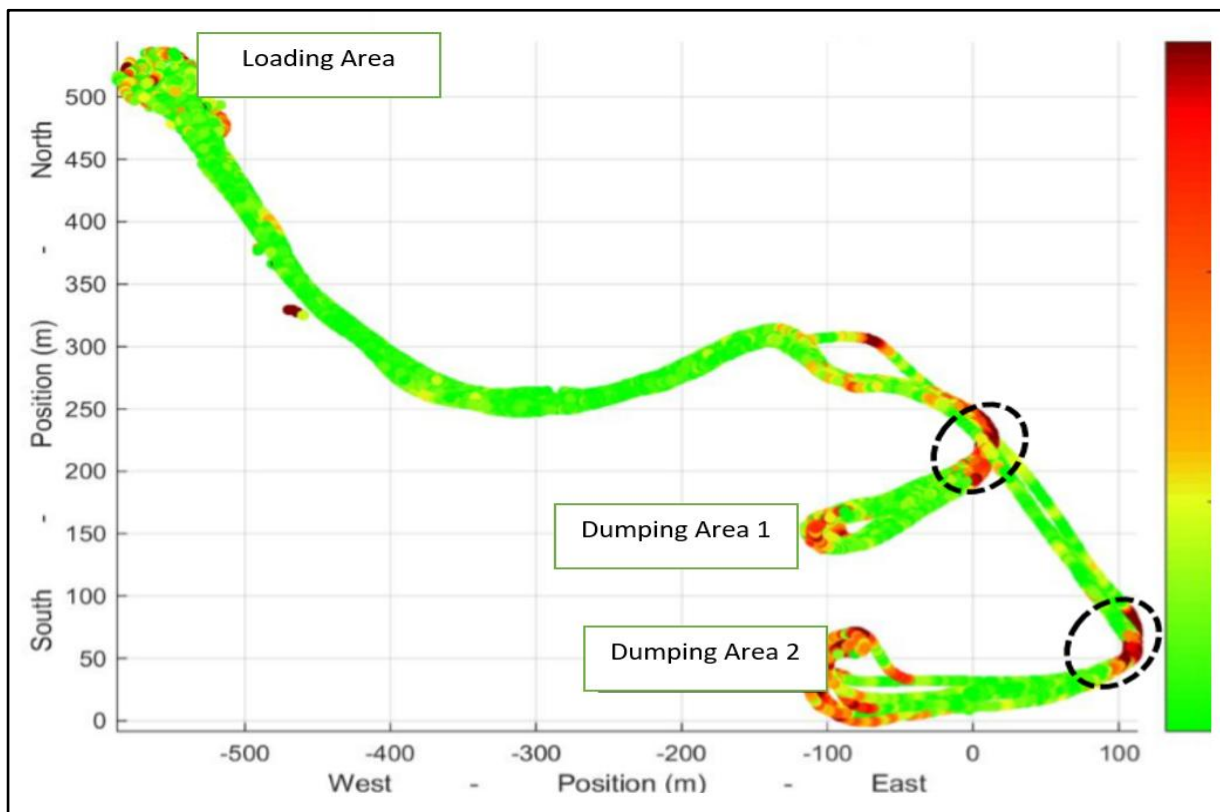
Figure 15: Haulage Route

The two tight turns were observed near the two dumping points, however, operators were encouraged to reduce speed

as they approached these two areas. Figure 15 shows the location of the two sharp turns.

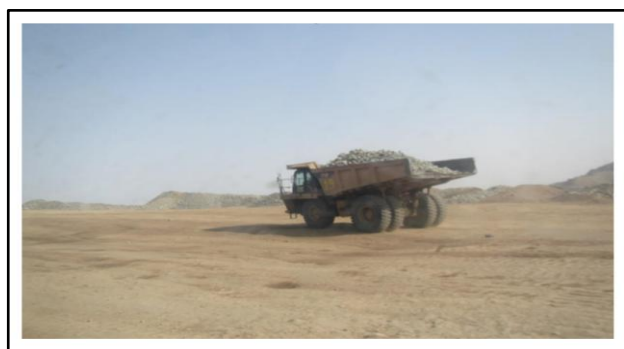
Figure 16: Dumping Area

- a) Spillage – low to moderate
- b) Undulation – frequent undulation, hard compacted surface
- c) Water – dry surface

Figure 16 shows a loaded Truck around the unloading area.

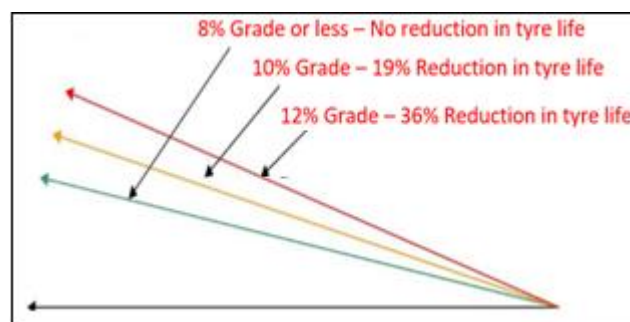
Figure 17: Tyre Wear Rate

The route did not have major slopes, though in certain areas the maximum downhill reached 10%. Figure 17 shows the deterioration of a tyre due to slope effect.

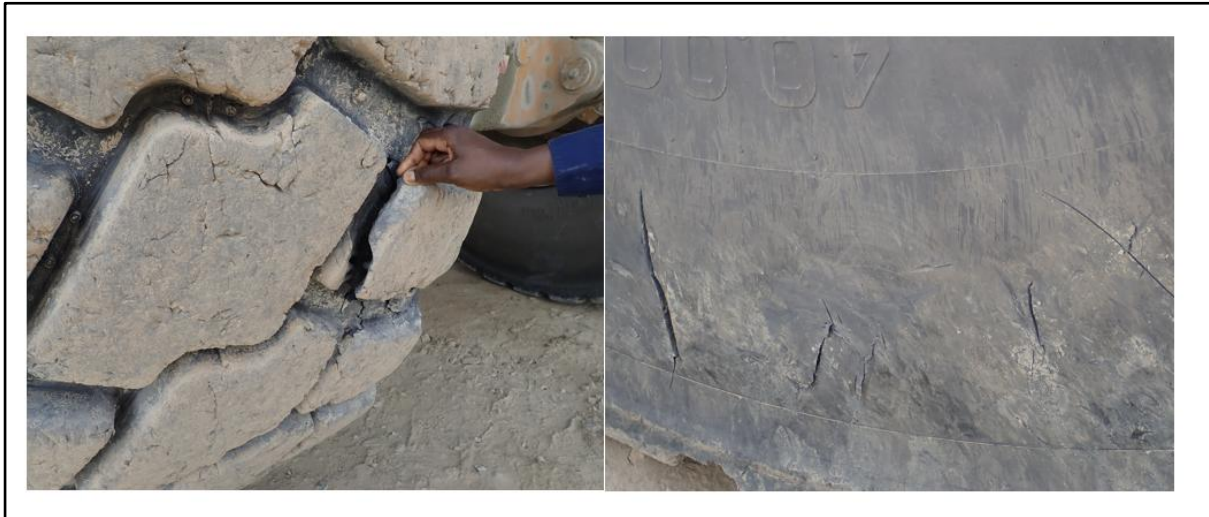
Figure 18: Tyres on a Dump Truck

The condition of tyres, both on the machine and dismantled were observed to determine the nature of failure and the possible failure cause. Figure 18 shows the condition of two separate tyres on a Truck.

The cracks were not sustained from any sharp object, but developed while the machine was in service. This was common to all CAT789B Trucks investigated and a lot of rubber pieces from tyres were noted along the haulage route. Figure 19 shows some of the failed tyres with respective operated hours.

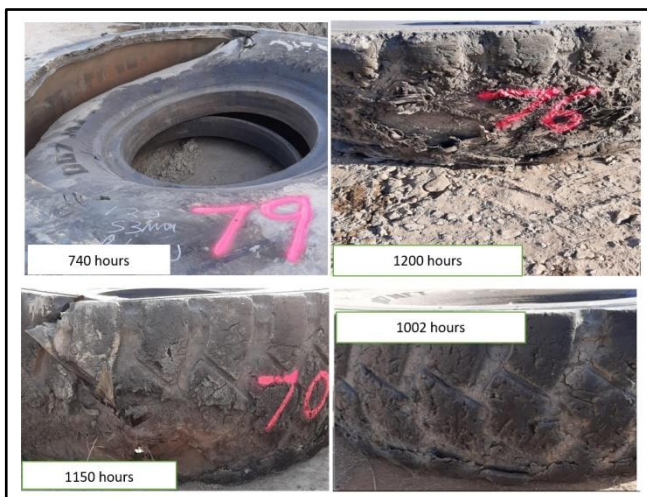
Figure 19: Tyres Failure Modes

Figure 19 shows some of the failure modes observed, a number of tyres failed in a similar ways at low operating hours. Three (3) blow outs were experienced with no injury to personnel, however, from two incidents, nearby equipment was damaged, a Dozer and an Excavator, both lost side windows.
