# A Study on the Crash of Boeing 737 MAX

Vijay Kumar Shrivastava

**Keywords:** Project Management Failure, Aviation, Boeing 737 MAX groundings, Air crash, Aircraft manufacturers

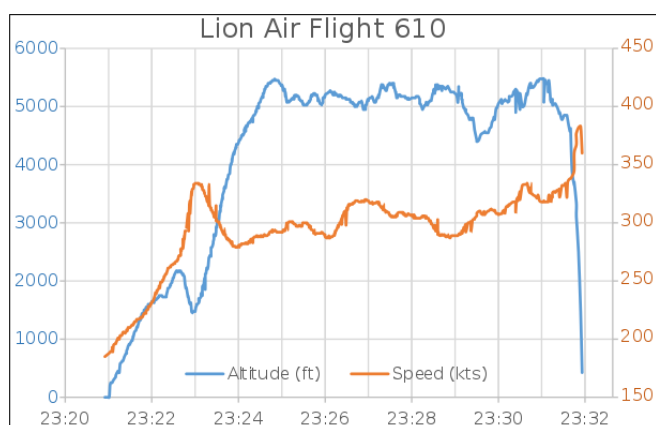
flight control software that adjusts the horizontal stabilizer trim to push the nose downwards, when the aircraft is operating in manual flight, with flaps up (Boeing Statement on Lion Air Flight 610 Preliminary Report, Nov, 2018). MCAS takes input from one of the two angle of attack (AOA) sensors, making it susceptible to single point of failure. The MCAS got automatically activated for 10 seconds ON and 5 seconds OFF, which made it difficult for pilots to figure out as to why the plane's nose was pitching downwards automatically. The plane was losing 600 feet of altitude within seconds. The captain asked the ATC (Air Traffic Controller) to return back to the airport as they could not figure out a solution to problem and was struggling to maintain a stable cruising altitude. While returning to the airport, the pilot asked for 3000 feet altitude to be locked, as they lost control of the actual altitude and wanted to refrain from causing a trouble to other aircrafts in the airspace. While returning, pilots mentioned that most of the systems and equipment were not working properly. MCAS got activated every 10 seconds and switched OFF for 5 seconds which resulted in loss of altitude with nose pitched downwards for 10 seconds and pilots tried to regain the altitude in the remaining 5 seconds. This cycle kept on repeating itself and as it was happening rapidly, without prior information to pilots about MCAS, pilots were not able to understand the reason behind sudden loss of altitude of the plane. The plane was experiencing a steep descent for 10 seconds (when MCAS is ON). A sudden shift in altitude and airspeed can be observed from the graph given below. Pilots had to adjust the pitch trim every few seconds. It was a nightmare in the cockpit as the pilots did not even had sufficient time to consult the Boeing checklist. At 11:32 UTC, the Lion Air Flight 610 crashed in the Jawa Ocean with 40-degree steep nose downwards with system repeatedly announcing "PULL UP TERRAIN PULL UP TERRAIN" killing all 189 crew and passengers onboard. (Indonesian National Transport Safety Committee)

Figure 1: Altitude and speed of Lion Air Flight 610

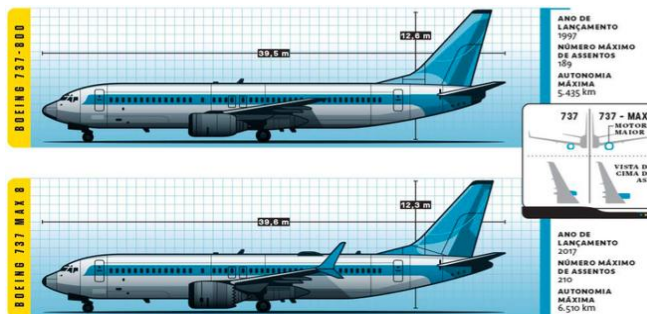
According to Carnot efficiency and Laws of Thermodynamics, larger the size of engines, better will be the efficiency. To deal with larger size of engines and to have better ground clearance, Boeing tried to change the mounting point of the engines, placing them forward and much higher on the wings. The engine’s position on the wings forced the nose of the plane to go up, creating a stall possibility (if the angle of attack is too high). To prevent the plane from going into stall position, Boeing installed MCAS software, which automatically turns ON (for 10 seconds) and OFF (for 5 seconds). The purpose of MCAS is to bring the nose of the plane downwards as a counteract to the automatic lift in the nose of the plane in upward direction (due to placement of the engines) so as to nullify the whole effect and to prevent the plane from going into stall position.

**Figure 2:** Altitude and speed of Lion Air Flight 610
