# Complications during Multi-Level Basement / Deep Foundation Construction Projects

Jaspreet Singh<sup>1</sup>, Prof. V. Srinivas Raghavan<sup>2</sup>

<sup>1</sup>Student, M. Tech, Construction Engineering & Management, Manipal Institute of Technology

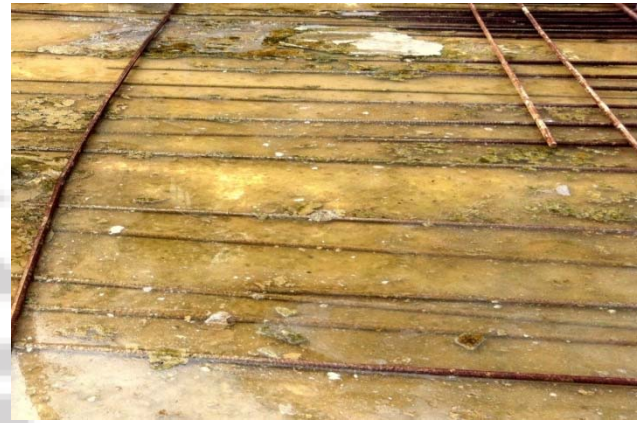
It was reviewed that poor workmanship in reinforcement placement is common in raft (foundation), and columns. Generally as there is no proper spacing maintained between rebars. Problem is evident when the de-shuttering reveals the bars exposed, without concrete cover. Clearly, such structures are less capable of accommodating proper strength and are susceptible to premature deterioration. In many cases the rebars get exposed to water, resulting in rusting. Such a problem is shown in Fig. 6.

**Figure 6:** Rebars Placed Get Exposed to Water, Resulting in Rusting

The common problem in the construction of deep foundation is the poor reinforcing steel placement. Such placement requires accuracy, particularly when the foundation is deep. Often the steel gets exposed to water in these kind of construction projects prior to concreting. The effect of exposure of steel can be diminished by coating steel with cement slurry coating. This will make a protective layer around rebars and will diminish rusting of rebars.
