Structural Characterisation of the Failed Manafwa Historic Bridge in Uganda

Dan Iga¹, Dr. (Eng.) Timothy Nyomboi², (Eng.) Richard Ocharo Onchiri³

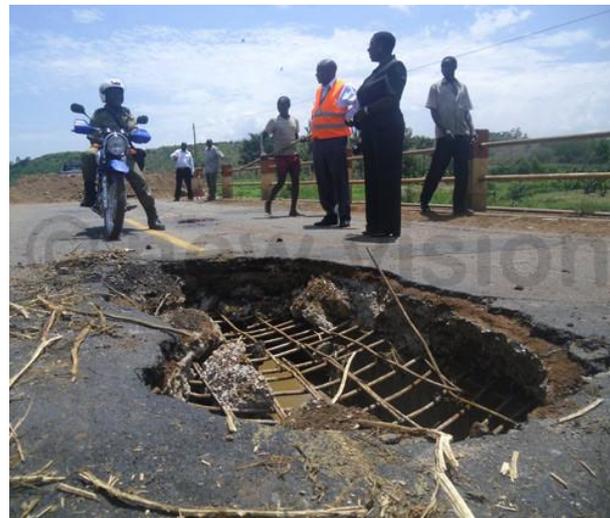
Figure 1: Cracks in the Manafa bridge (The slab may not have been connected to the steel girder using studs)

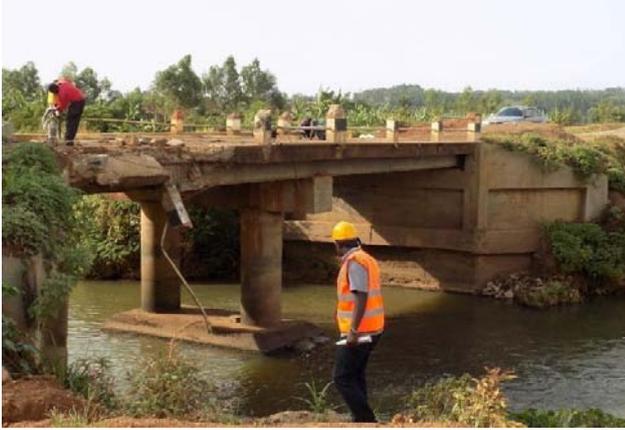
2.1.2 Bridge Superstructure Slab

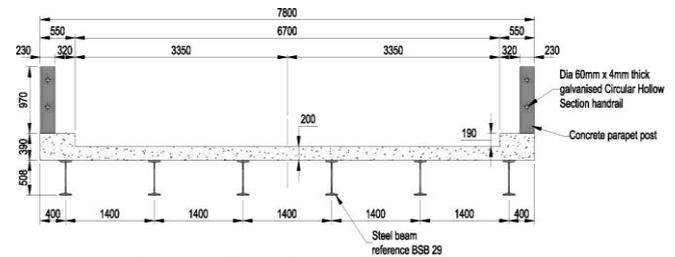
Figure 4: Manafwa River Bridge superstructure cross section

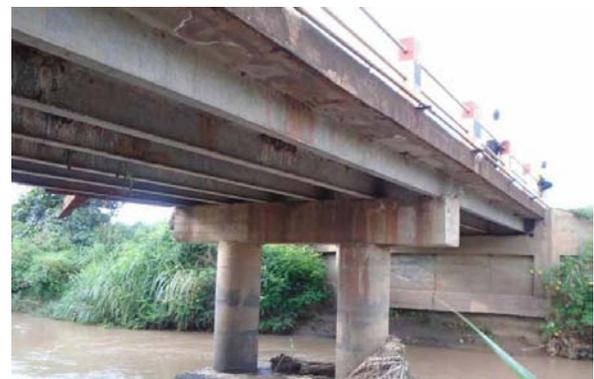
Figure 5: Bridge underside showing steel beams and pier.

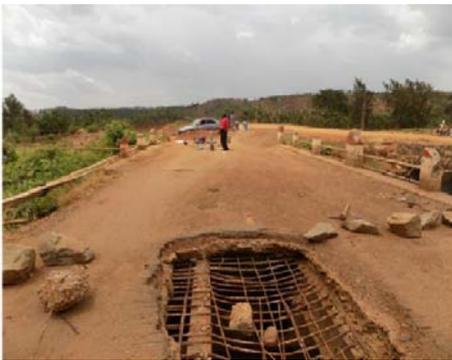
Figure 7: Manafwa River Bridge superstructure cross section immediately after the failure and before the visual inspection on the bridge (L-R).

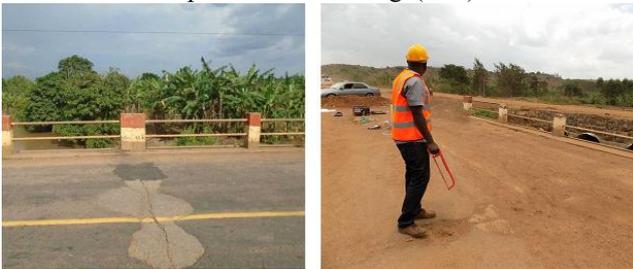
Figure 8: Transverse crack in deck surfacing and concrete patching. There is no transverse joint in the concrete slab on the underside

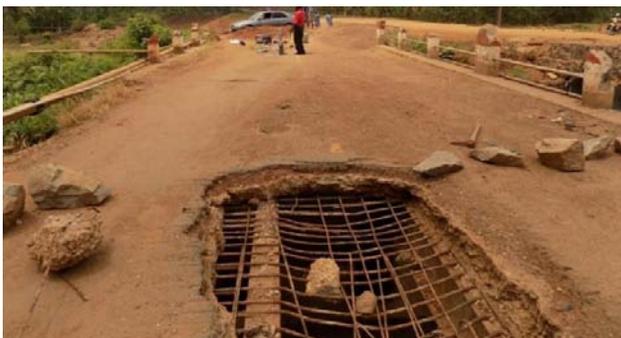
Figure 9: Opening in superstructure slab. Maximum length of opening parallel to traffic flow direction is 2530mm and it is 1350mm in the normal direction

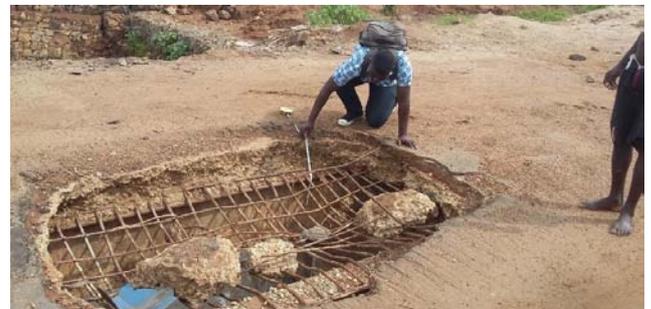
Figure 12: Bottom reinforcement at failed slab location. The reinforcement is diameter 16mm round bars at 100mm centres

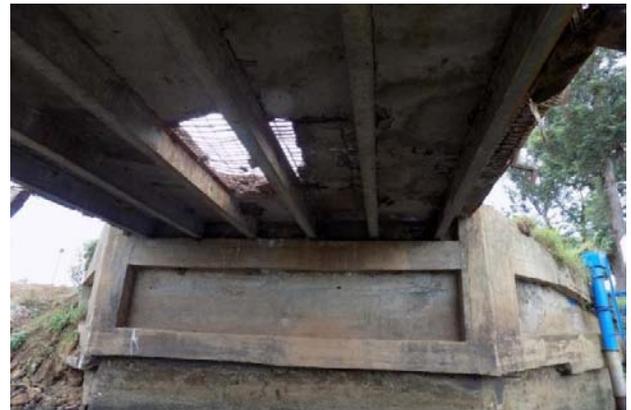
Figure 14: Falling off of the plastered underside of the superstructure slab aimed at concealing the exposed reinforcement bars

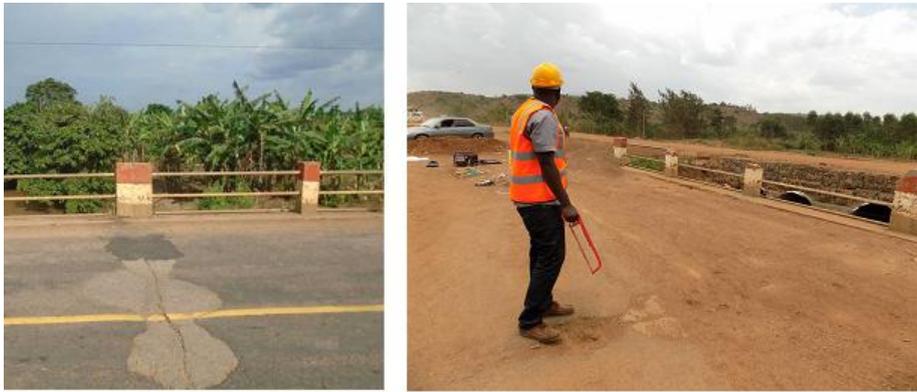
Figure 15: Transverse crack in the slab running to the bottom of the layer
