Survey and Evaluation of flexible Pavement Failures

Magdi M.E. Zumrawi¹

¹University of Khartoum, Department of Civil Engineering, Khartoum, Sudan

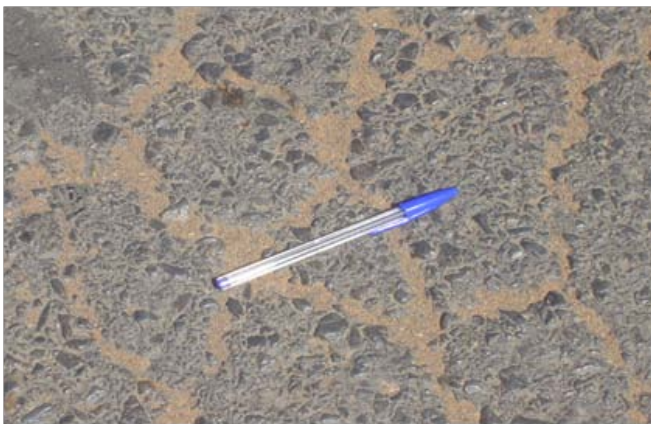
The Cracking consists of visible discontinuities in surface and can be an indication of the pavement's structural condition and serious, [5]. The main problem with cracks is that they allow moisture into pavement, giving accelerated deterioration of pavement. Cracks can occur in a wide variety of patterns (see Plate 1). They may result from a large number of causes, but generally are the result of either ageing and embrittlement of surfacing, environmental conditions, structural or fatigue failure of the pavement, or any other causes, [5]. The formation of cracks in the pavement surface causes numerous problems such as discomfort to the users, reduction of safety, etc. In addition to the above, intrusion of water causing reduction of the strength in lower layers as well as lowering of bearing capacity of subgrade soil by pumping of soil particles through the cracks is also a major problem associated with the pavements, [6]. This leads to the progressive degradation of the road pavement structure in the neighborhood of the cracks. The origin of cracks differs by their shapes, configuration, amplitude of loading, movement of traffic and rate of deformation.

Plate 1: Alligator cracking of high severity level

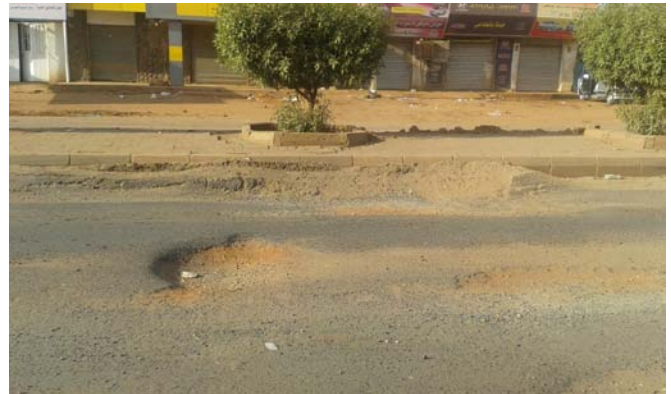
According to Ahmed [6], potholes are an indication of structural surface failure and they result from growth of a break in the surfacing, often as a result of severe alligator cracking as shown in Plate 2. Once water enters pavement layers, the base and/or subgrade become wet and unstable, and the resultant degradation leads to rapid growth of pothole area and depth. Sikdar et al [7] reported that if the potholes are numerous or frequent, it may indicate underlying problem such as inadequate pavement or aged surfacing requiring

rehabilitation or replacement. Water entering pavement is often the cause, and could be caused by a cracked surface, high shoulders or pavement depressions ponding water on pavement, porous or open surface, or clogged side ditches.

Plate 2: Severe potholes on pavement surface, [6]

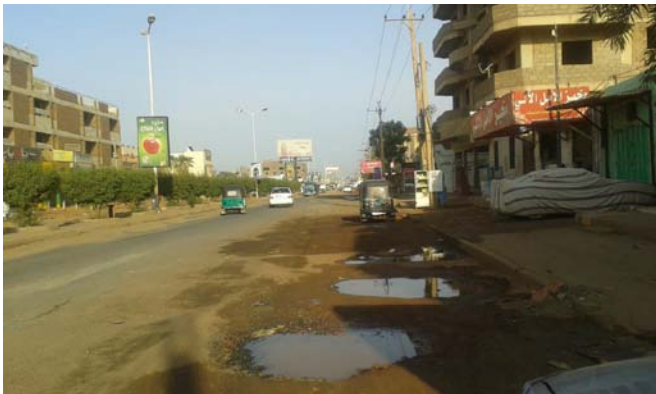
It can be seen that for nearly all types of pavement failure, moisture is often the primary or a contributing cause of failure. As clearly seen in Plate 3, moisture entry through the surface may be caused by inadequate pavement surface drainage during construction, exposure of surface to rain during construction, or porous or open graded asphalt, [11]. He found moisture entry from the side may be caused by pondage in pits or poorly constructed surface drainage, and lateral movement of water into pavement. Other factors affecting the moisture in a pavement include the general drainage condition, such as the effectiveness of drainage structures, shoulder cross-fall and condition, longitudinal grade, and whether the pavement is constructed on cut or fill.

Plate 3: Ponding water on potholes
