Assessment of the Extent of Land Degradation in the River Lobo Watershed of Baringo County, Kenya

Abstract: Increased human population pressure and climate change constitute the global underlying root causes of accelerated and devastating land degradation processes in the Arid and Semi-Arid Lands (ASALs). River Lobo watershed, located at the lower part of the Lake Baringo Catchment, is not an exception. The area is characterized by severe vegetation degradation that has resulted in extreme soil deterioration. This study aimed to determine the extent of land degradation in the watershed with specific objectives of determining the vegetation cover and composition, observing signs of accelerated soil erosion as well as assessing the socio-economic status of the inhabitants in the watershed. Tools for data collection included structured questionnaire, observation schedules and oral histories. The measured variables were analysed using a one-way ANOVA ($\alpha = 0.05$) and correlation analysis. The results indicated that the whole watershed is degraded with 87.5% of the watershed being highly degraded and the remaining 12.5% moderately degraded. The overall vegetation cover was 59.6%.

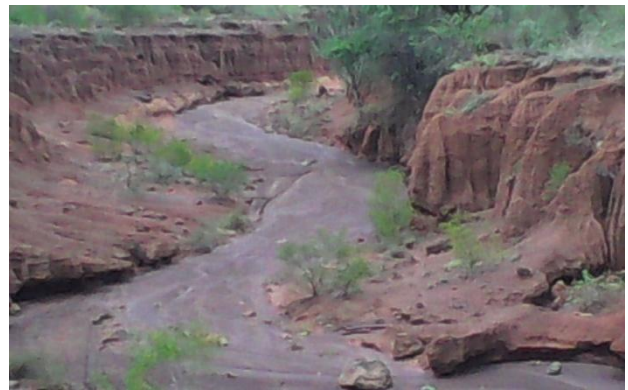
Plate 1: Riverbank erosion along the Lobo river (March, 2013)

The overall vegetation cover estimate was established to be 59.6±2.3%. The results also depicted a gradual increase in rock cover downstream; from 3.75% upstream to 40.8% downstream. Vegetation cover estimates for Kapkechui location and Koibos location did not differ statistically. Similarly, cover estimates in Simotwe and Koibos locations were not significantly different. However, vegetation cover in the middle section of the river Lobo watershed is significantly different with that in the upper section of the watershed. Baringo County is described as one of the most dependable sources of grain with water and grass available all year round (Sanyu, 2001), implying cover was significantly sufficient in the early 1900's. By analysis of satellite images, Johansson and Svensson in 2002 recorded a bush cover of 77% for the Semi-Arid catchment of Lake Baringo, of which river Lobo watershed is part. This illustrates that within a decade, vegetation cover has declined by 17.4% while bare ground has increased from 13% to 16.3%. It was also observed that there was no riparian cover along the Lobo river hence the river bank is prone to serious soil erosion. Bossio and Geheb (2008) indicate that such riverbank erosion eats into productive land while increasing incidences of siltation and flooding downstream. During the rain season, flooding is a common phenomenon downstream especially near Kiborgoch swamp.

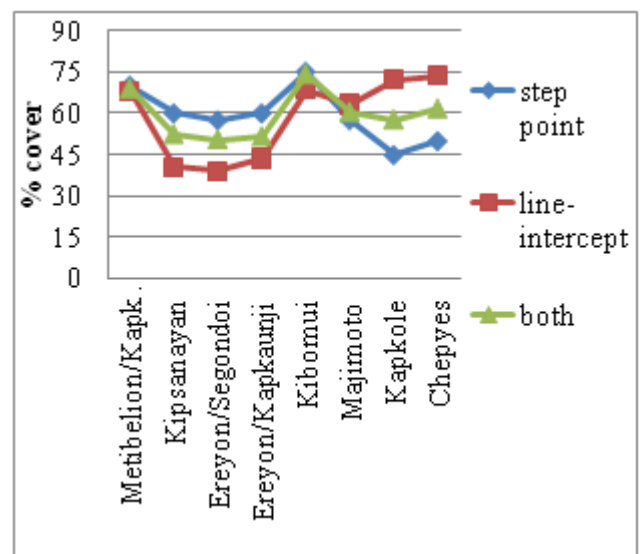
Figure 2 below illustrate the general trend for vegetation cover in the river Lobo watershed. The upper section (Kapkechui location) of the watershed recorded the highest cover of 71.5% (Metibelion/ Kapkundul and Kibomui villages). The cover seemed sufficient in providing adequate protection to the soil in the area. There were few incidences of visible erosion in the location and of great environmental significance was the seasonal spring at Chepchukuko. People fetch water from the spring. The spring is almost 3km from the main source of river Lobo where the locals hold that there was once a spring. As is the case with most water sources, such as lakes Baringo, Bogoria and Nakuru, in the rift valley, quantity of water in the spring has increased in the last three years.

Figure 2: Cover along each transect/ village

Stoddart *et al.* (1975) indicated that a >70% basal cover provides an adequate protection to the soil in the rangelands and forage for livestock production. Based on field observations and cover results of Kapkechui location, this study affirms the figure for river Lobo watershed. Cover is a key factor in combating land degradation. The middle section (Simotwe location) of the watershed was found to be most hit in terms of cover degradation. The location recorded the least cover of 51.4%. Transect 3 and 4 (Ereyon/Segondoi and Kapkaunji villages) recorded the least covers (50.36% and 51.54%, respectfully). The two transects constitute the priority areas for future vegetation cover

rehabilitation. Cover in lower section of the watershed (Koibos location) was 59.8%. Koibos location is rocky and it was observed that the rocks were so large that at some points there was no vegetation at all. More crown cover was recorded in the location compared to the middle section and upper section. The high crown cover can be attributed to the many trees recorded in the location especially the *Acacia species*.
