Analysis of Flash Floods Behaviors in Sentani, Jayapura Regency, Papua

Abstract: *Flash floods are flows in very large numbers and occur suddenly, flowing from the upstream to the downstream at a very high speed. This study aims to analyze the parameters that influence the occurrence of flash floods in Sentani and to analyze flood behavior Kemiri river and Flafouw river. Hydrological analysis based on maximum daily rainfall data for the last 10 years (2009-2019), and hydraulic analysis on secondary and primary tertiary channels (S. Kemiri) on river geometry then simulated by modeling using HEC-RAS software to calculate one-dimensional water level profiles, in each section of the Kemiri river. The planned flood discharge using the Nakayasu method obtained $Q_{10th} = 51.798 \text{ m}^3/\text{s}$ kemiri river with $t = 1.615$ hours while the Flafouw $Q_{10th} = 94.804 \text{ m}^3/\text{s}$ and $t = 1.669$ hours. The flood inundation when the disaster occurred was 1.00 - 4.00 meters with inundation time <24 hours, but the sediment (sand, stone, and logs) rose until it reached the roof of the house. The results of field observations of the classification of flood hazard levels in seve

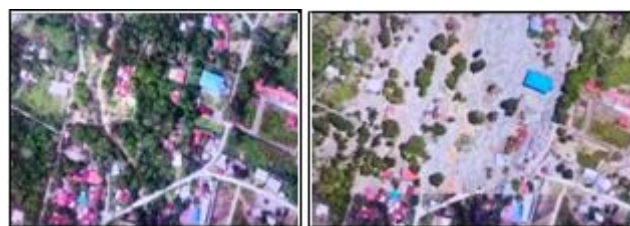
Figure 7: Location of the Kemiri river (a) before, (b) after Table 2. Identification of depth at several points

Analysis of the Sentani flash flood behavior 2019, apart from the flow conditions in the Kemiri river, the impact of the flash flood that occurred in Sentani also resulted in settlements and other infrastructure being affected. The behavior of the flash floods that swept through residential areas as seen in the image below, indicates how powerful the flow rate in the Kemiri river is. The results of field observations in locations affected by the flood showed very large sand and stones up to the middle area of the settlement.
