Identifying the Factors Leading to Mismanagement of Floodplains in Kelani River Basin; Particular Reference to Kaduwela Divisional Secretariat of Colombo District in Sri Lanka

Kanchana Rajapaksha¹, Weththige Varunika Nishani Fernando²

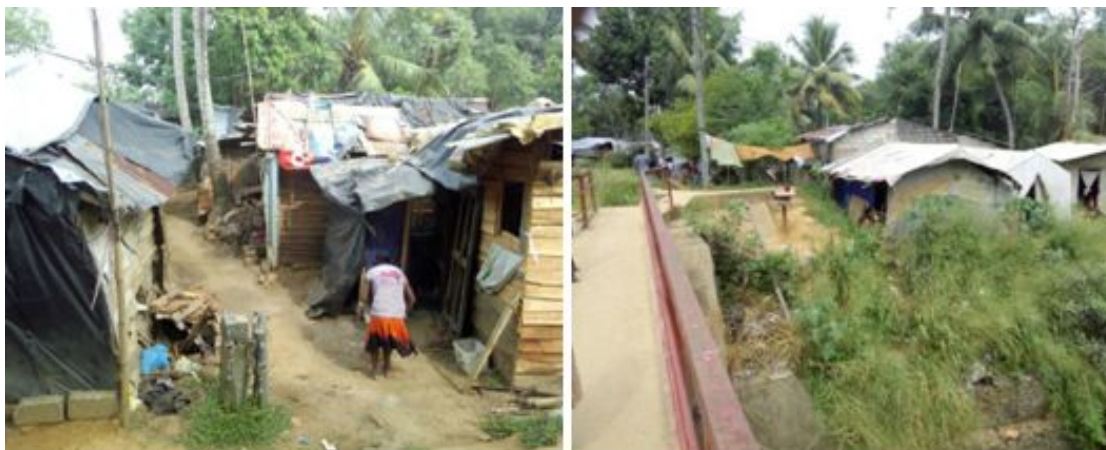
Figure 3: Unauthorised occupants in Pahala Bomiriya A, Field survey 2016

Figure 3 and 4 shows the houses of the unauthorised occupants. It was observed that approximately 30 families live as unauthorised occupants in the river reserve and canal reserve areas. Figure 4 shows the houses of the unauthorised

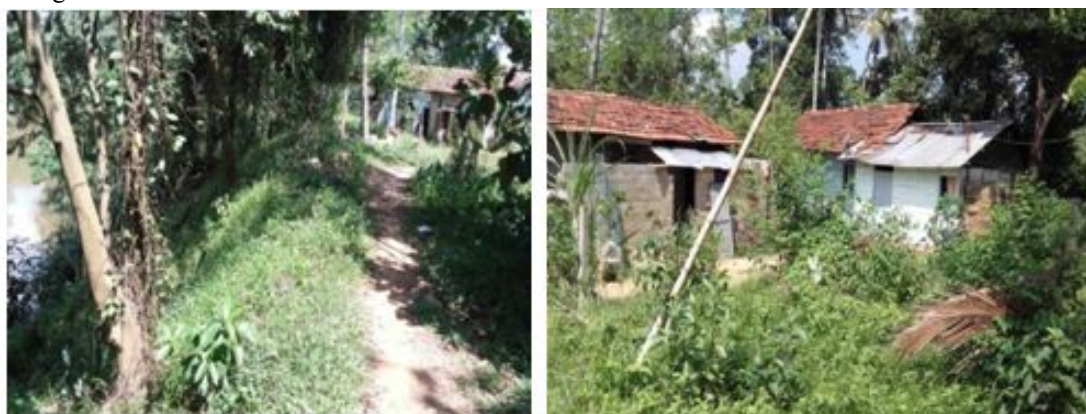
Figure 4: Unauthorised occupants of Kaduwela A GN division, Field survey 2016

occupants in Kaduwela A GN division. It was found out that approximately eight families are living in the Kelani river reserve area and canal reserve area.

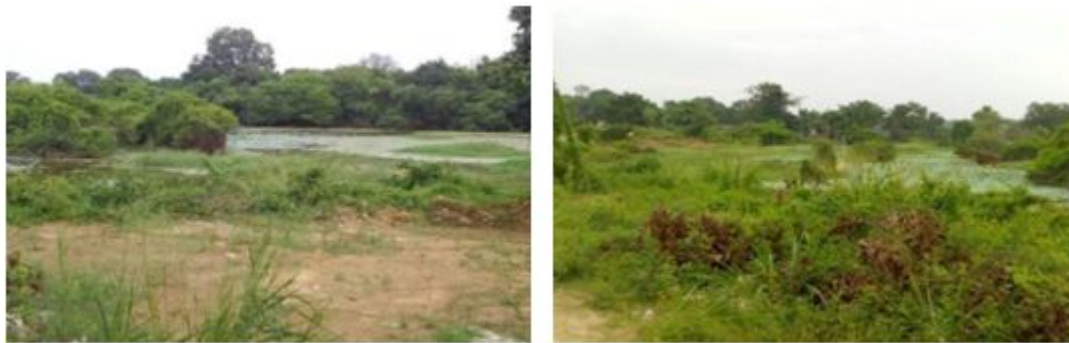
Figure 5: A marshy land Pahala Bomiriya A GN division, Field survey 2016

The sample area where this study was conducted has historically been a marshy land. However, by the time of the study in the GN division of Pahala Bomiriya A (See figure 5), only one marshy land was not reclaimed. The rest of the surrounding marshy lands were reclaimed, and industrial buildings were constructed in these areas. Thus, the presence of human activities is apparent in the low-lying lands as well as marshy lands.

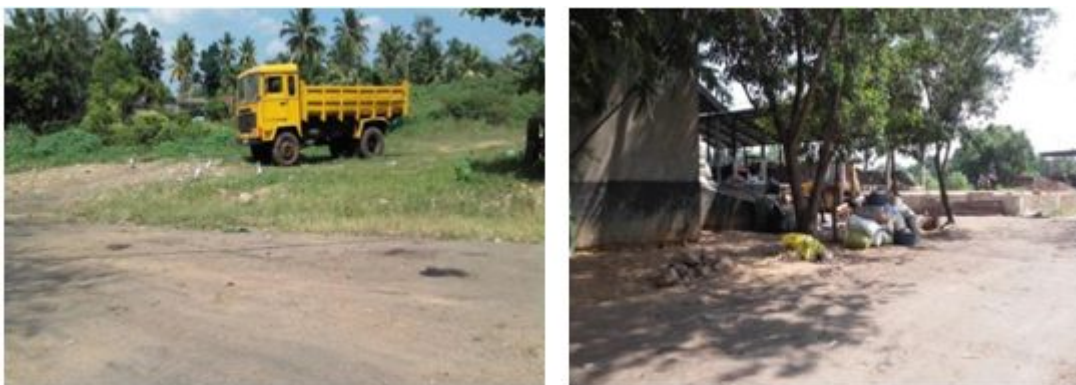
Figure 6: How marshy lands and low-lying lands appear after landfill, Field survey 2016

Figure 6 illustrates how the low-lying lands and the marshy lands appear at present after being reclaimed and further shows the compost plant used for compost recycling constructed on reclaimed land. Before the constructions, this area has been a sizable marshy land.

Further to that, these areas with an ecological value are being used as rubbish disposal sites. These marshy lands are being

filled using industrial and residential garbage.

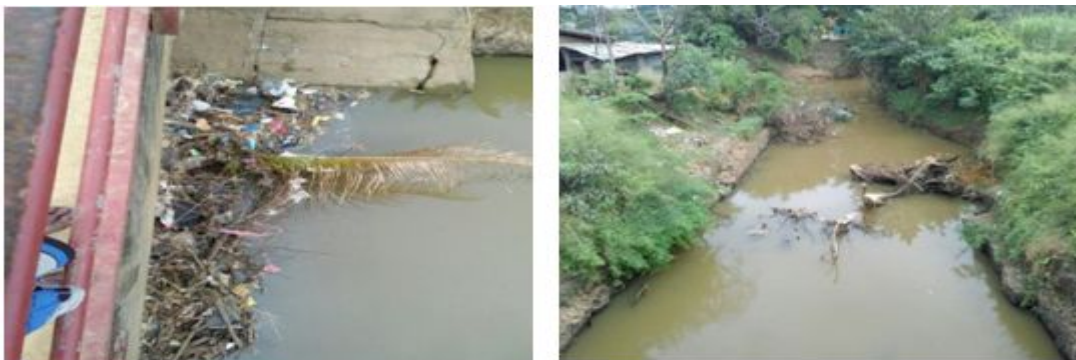
Figure 7: The pollution in Hettige Ela, Field survey 2016

are poorly maintained. The canals, Hettige ela (See figure 7), Medilla ela, Meda ela, and Maha ela in Kaduwela A GN division are blocked due to the rubbish deposited. The obstruction of the canal system that does not allow rainwater flowing has impacted to intensify the flooding. As per the families' information in the Kaduwela A GN division, Kadugam Medilla ela is not being cleaned. Thus the mismanagement of canals in the area could be identified as a significant factor for the destitute flood plains.

The obstruction of the canals by rubbish disposal is one of the main factors for worsening the flash floods that occur due to intense rainfall. This obstruction delays the water flow from the canal to the river. Consequently, flooding has become more severe and lasts for an extended period.

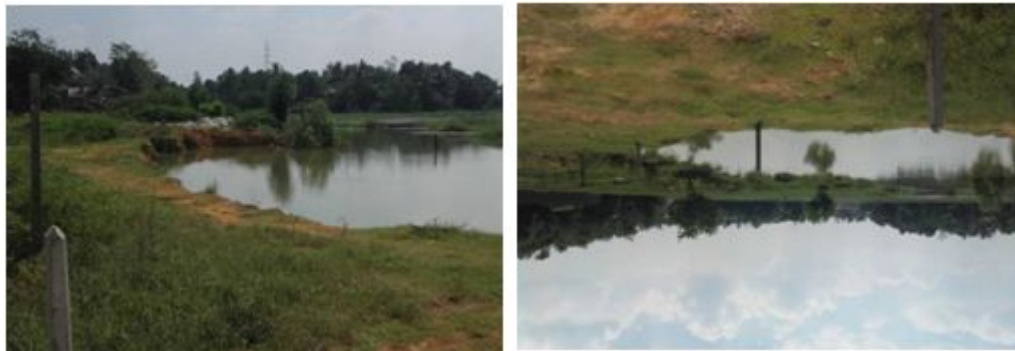
Figure 8: Clay pits created by digging of clay for pottery, Field survey 2016

Another reason for poor floodplains management is digging clay for the pottery industry (See figure 8). Historically, the brick and tile industry has been massive in the GN divisions of Pahala Bomiriya A and Kaduwela A. The clay needed for the sector was dug out from the low lying areas of the floodplains. Deforestation has occurred due to this digging,

and several clay pits have been created.

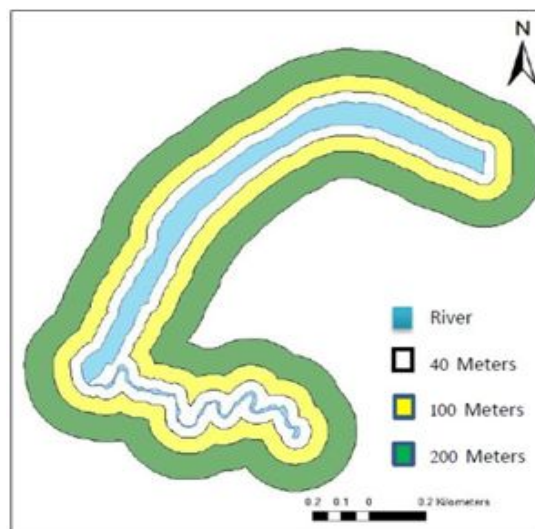
Figure 10: Zoning of Riverside floodplains, Drafted by the author using geographical information technology

The author recommends a system for zoning of riverside floodplains (Sivakumar, 2015). The land consumption activities in the area need to be prohibited by implementing strict laws. 100m zone is known as the limited zone. As the water flow is considerably slow, this area is ideal for farming and animal husbandry. Engaging in and consumption in this area is not appropriate. The 200m zone is known as the danger zone. As this area is less likely to get flooded, land consumption activities can be carried out in this zone, creating flood plain zoning to keep the natural balance of overflow of water from the channels of rivers and streams.
