Comparative Evaluation of the Shear Bond Strength and Mode of Fracture of Different Core Materials - An in Vitro Study

Hence, the aim of this study was to determine shear bond strength and mode of fracture of different core materials using Universal Testing machine and SEM.

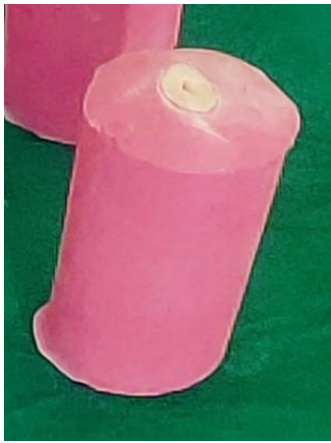
Samples decoronated at level of CEJ

A total of 20 human molars were selected and were decoronated at the level of CEJ. They were randomly divided into 4 groups (n=5) and embedded in acrylic cylinders. Core build up was done with all groups according to the manufacturer's instructions.

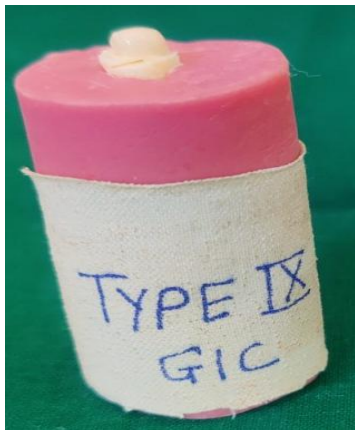
Core build up done

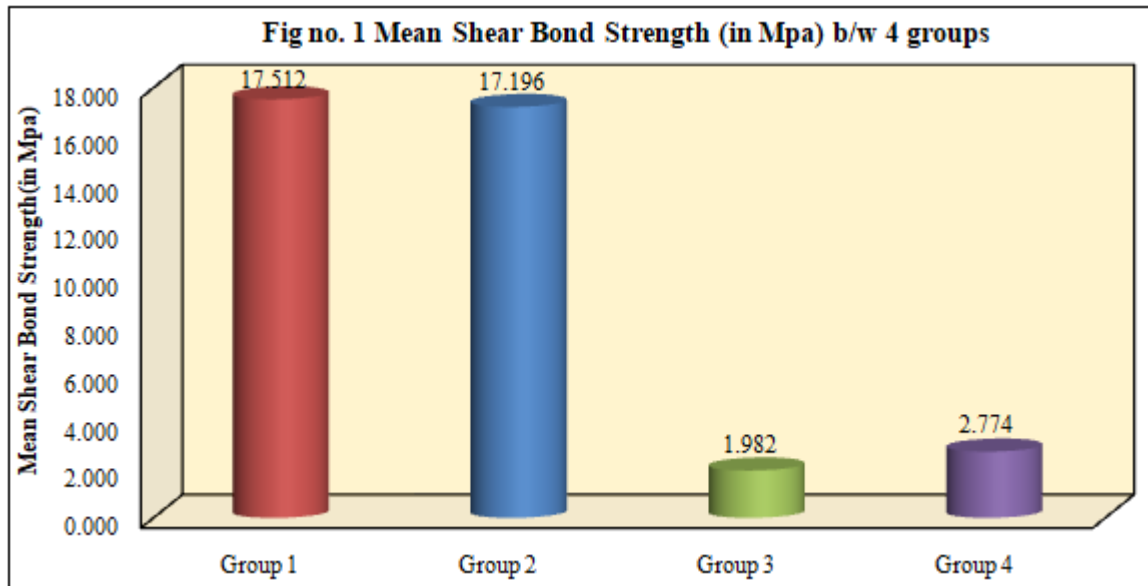
Graph 1

The test result showed the mean Shear Bond Strength for Group 1 was 17.512 ± 2.785 , Group 2 was 17.196 ± 2.164 , Group 3 was 1.982 ± 0.627 and Group 4 was 2.774 ± 1.129 . The difference in the mean Shear Bond Strength between 4 groups was statistically significant at $P < 0.001$.

Multiple comparison of mean differences between groups showed that both Group 1 showed significantly higher mean Shear Bond Strength as compared to Group 3 & Group 4 at $P < 0.001$. This was then followed next with Group 2 showing significantly higher mean Shear Bond Strength as compared to Group 3 & Group 4 at $P < 0.001$. However, Group 1 showed a relatively higher mean shear bond strength as compared to Group 2 and similarly, Group 4 showed a relatively higher mean shear bond strength as compared to Group 3, there was no significant difference between Group 1 & Group 2 [$P = 0.92$] and between Group 3 & Group 4 [$P = 0.25$].

The mean shear bond strength of MultiCore Flow and Rebilda DC showed the highest values with 17.51 MPa and 17.19 MPa respectively. The highest mean SBS of MultiCore & Rebilda DC can be attributed to the presence of nanofillers, flourides and silicone dioxide (approximate 5 wt%) in adhesive used. They also have the added advantage of being esthetic materials.
