# Fungal Involvement in Bio Weathering of Historical Monument with Reference to Gopinath Temple at Gopeshwar Town, Chamoli, Uttarakhand, India

**Abstract:** *Fungi are complex communities of microorganisms that damage historic monuments. The present study was made to examine the diversity of fungi associated with deteriorated monument sites. In the present investigation, 10 samples were collected from various portions of deteriorating sites of Gopinath temple at Gopeshwar Town of Chamoli district, Uttarakhand. Five fungal species isolated from deteriorated monument sites are reported in this paper. The most frequent isolated fungal species from the historic monument sites are Aspergillus niger. Present biological and mycological investigations focused on bio-deterioration of said monument by various fungal species.*

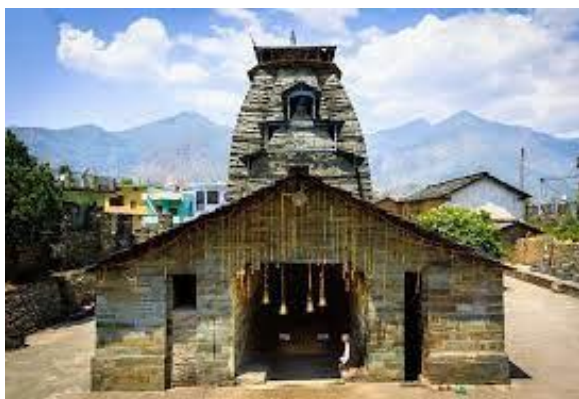
The Gopinath temple is built of sand stone, which is porous in nature. The surface deposits seem to be very old due to the formation of secondary dull green pale white lichens, which are present all over the stone surface. Due to these growths of microbes, the aesthetic beauty of the temple is seriously affected (Fig:1-3). From a scientific point of view these growth of microbes are very harmful for the health of the stone surface, because these micro organisms secrete an acid that dissolves the sand stone<sup>11</sup>.

Figure 3: Showing micro-organism growth on the monuments
