# Abnormal Bone Thickening along an Intramedullary Nail away from Fracture Site Could Be a Broken Nail

**Abstract:** *A Broken Implant was almost evident in a radiograph. In few cases there is no evidence of IM nail rupture or break in radiographs but intraoperatively found broken. Inadequate planning and preparation for removal of broken IM nail leads to complicated surgery and non - retrieval of implants was a major concern for patient satisfaction. During elective implant removal of a 6 years old short PFN for united intertrochanteric fracture, we unexpectedly found Implant breakage distally during surgery which successfully removed through a retrograde reamer from distal femur entry. On retrospective examination of radiographs, it shows characteristic abnormal bone thickening at the same site of Implant rupture. This sign was also observed in another similar case and other four cases from literature. From these observations, we conclude abnormal bone thickening away from a fracture site along an IM nail with an united primary fracture as a strong predictor of Implant breakage or rupture at that site.*

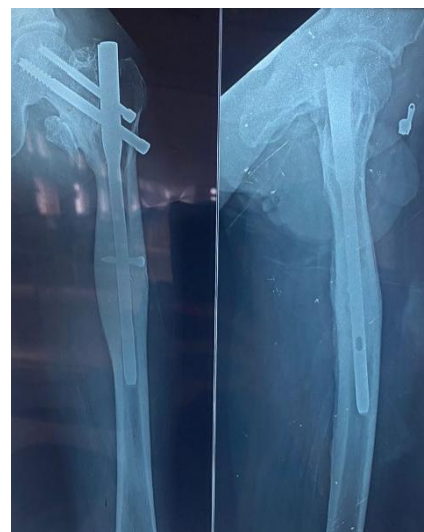
**Figure 1:** Preoperative radiograph showing united fracture, intact implant with no signs of rupture and abnormal spindle shaped bone thickening around distal screw

On examination there was healed scars over left hip and thigh region. Deep tenderness present over the mid thigh region. Rest of the examination is normal with normal hip range of motion. A preoperative radiograph shows a well united left trochanteric fracture with short proximal femoral nail Insitu with two screws proximally and single static screw

distally. There is abnormal bone thickening at level of distal screw. Post operative radiograph 6 years before shows an intertrochanteric fracture with short PFN, no fracture is seen at level of distal shaft. No further radiological investigations performed due to financial constraints of the patient.

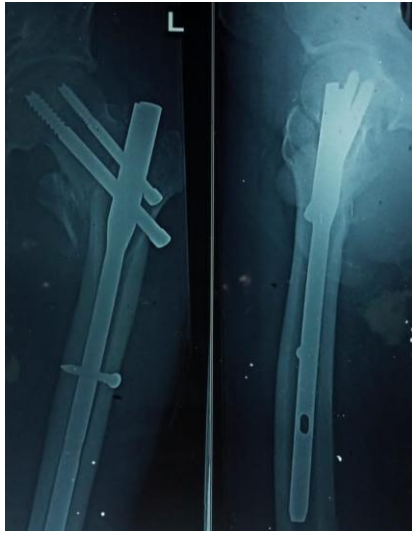
**Figure 2:** Immediate post operative x ray six years before showing No bone fracture distally, no bone thickening distally and intact implant (PFN)

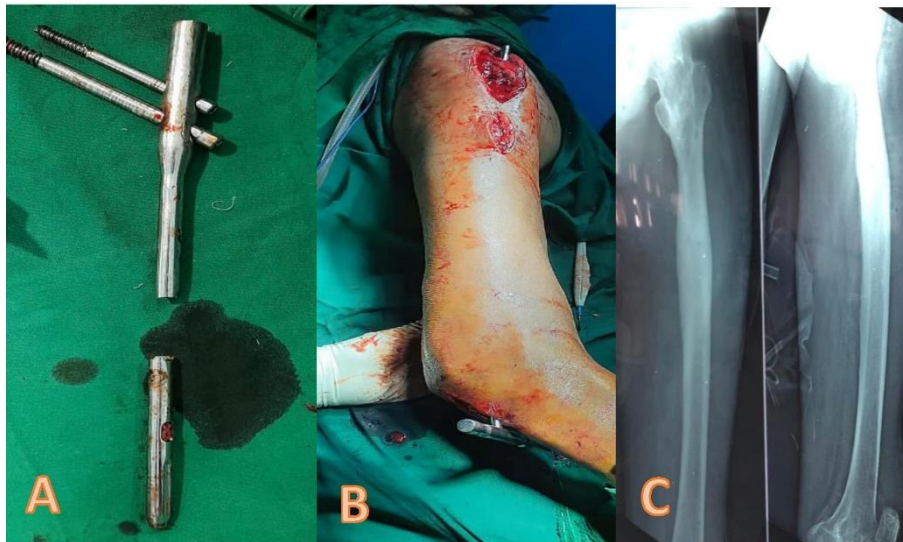
**Figure 3:** (A) retrieved implant, screws intact but nail broken at distal screw site. (B) removing distal broken nail part through retrograde reamer from distal femur. (C) post operative x ray showing well united fracture with no implant retained in bone.

Patient is posted for elective implant removal. Intraoperatively the buried proximal and distal screws removed with difficulty but all the screws were Intact. While retrieving nail with proximal jig, only half of nail came out. We found break of nail at level of distal screw. By taking an informed consent from patient attenders, The remaining portion of distal nail removed through retrograde reamer from distal femur. Bone biopsy taken from thickened portion of bone distally found normal on histopathology.

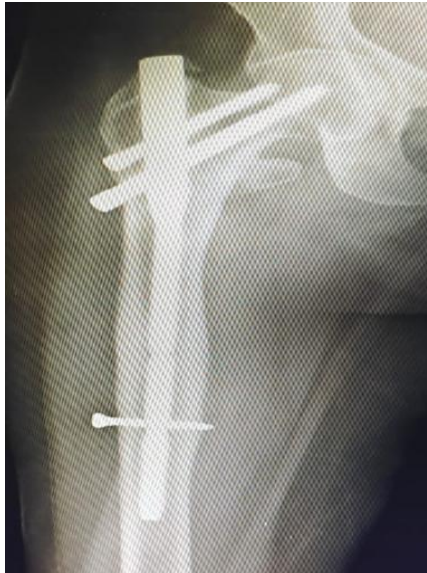
**Figure 4:** Another case of united trochanteric fracture with short PFN. Nail was broken proximal to shaft and there was bone thickening around it.

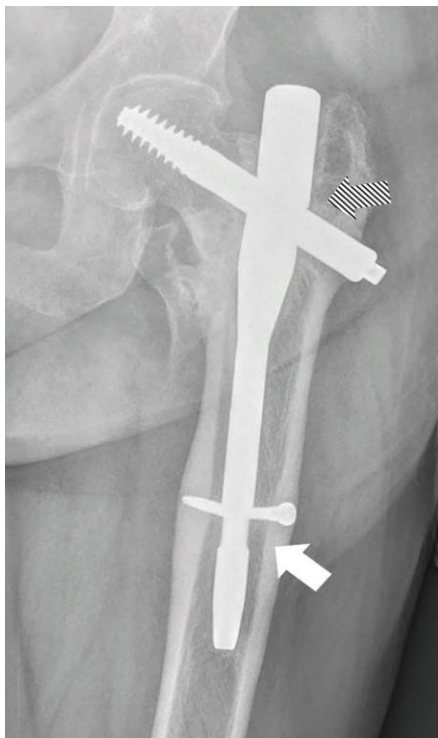
**Figure 5:** The white arrow showing bone thickening around implant rupture site distally. Also nail was broken at proximal aperture.

perthrochanteric fractures”, also shows this abnormal bone thickening at nail break site distally away from united fracture site (figure 5). In a case report by yoshino et al., named - “Implant failure of long gamma nail in a patient with intertrochanteric - subtrochanteric fracture“, preoperatively they suspected distal nail breakage but unexpectedly they found nail broken proximally and no break distally. There is no sign of bone thickening at distal part of nail where they initially expected an implant breakage.
