# Debunking a False Gunfire Allegation Through Forensic Crime Scene Investigation: A Case Report

Tanmoy Kumar Mukherjee<sup>1</sup>, Annwesh Mazumdar<sup>2</sup>

<sup>1</sup>Scientific Officer, State Forensic Science Laboratory, Kolkata, West Bengal, India

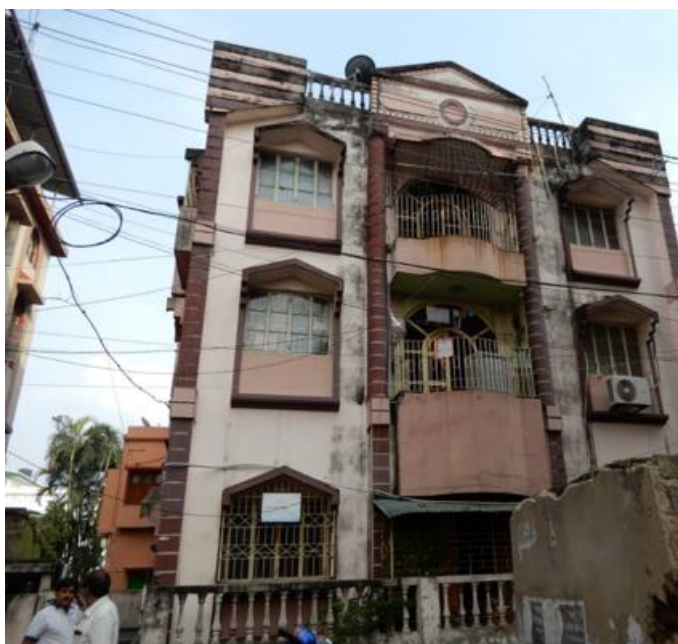
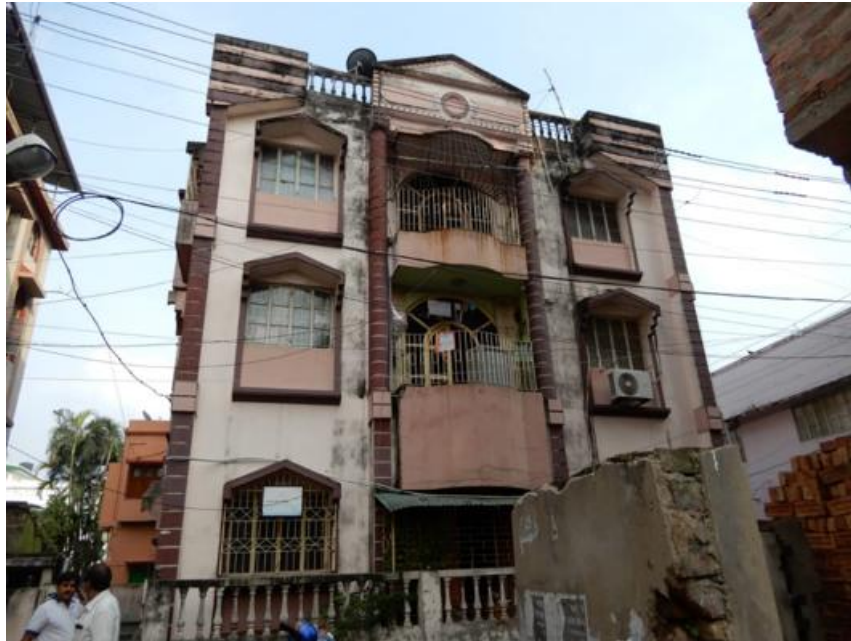
individual presented two empty shell casings found just beneath the sunshade, highlighting the severity of the situation. Moreover, they pointed out a shattered glass pane in their window, which was a direct result of the gunfire. In response to the urgency of this incident, the forensic team was dispatched the next day to investigate the matter officially. They meticulously examined the room on the second floor of the three-story building (

**Figure 1:** 3-story building where gunshot penetration was reported in the window of the 2nd floor.

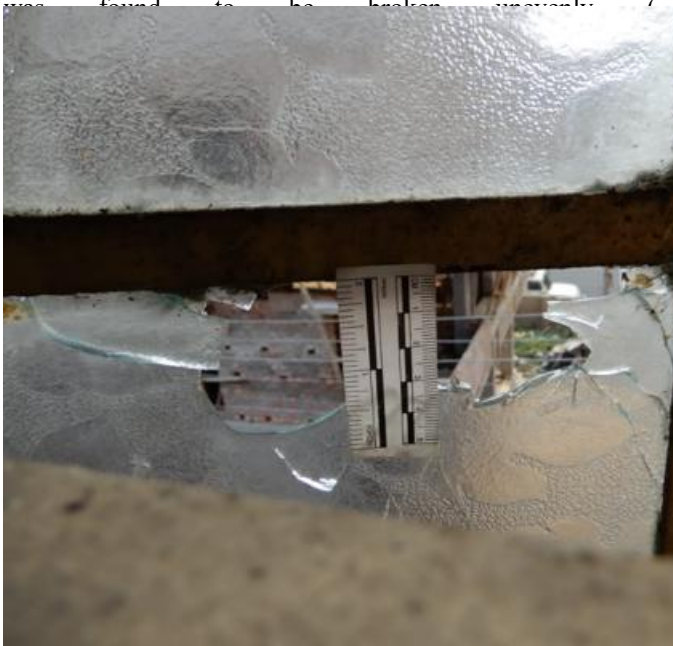
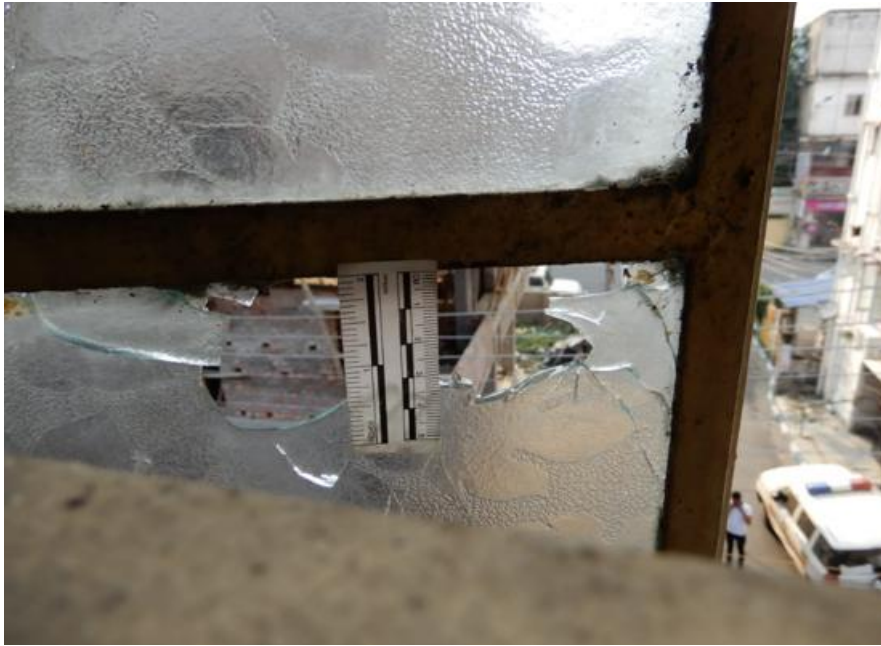
The forensic team carried out a scientific examination of the crime scene in the presence of police personnel and the complainant. The dimensions of the room were approximately 11 feet 2 inches long from east to west and 9 feet 9 inches wide from north to south. The room had one door and two metal-framed glass windows, one on the northern side and one on the western side. The western-side window was found to be broken approximately 4

*Figure 2*), with a maximum length of 10 inches and a minimum width of 15 inches. The bottom of the window was approximately 4 feet 3 inches above the floor. A metal wardrobe, with two trolley bags atop it, stood directly across from the broken window pane. Additionally, a study table and a wooden chair were placed on the eastern side of the room. No other furniture or household items were observed inside the room.

**Figure 2:** Glass penetration initially reported as bullet impact.

The FSL (Forensic Science Laboratory) investigator placed a tripod on the road surface in front of the window and sent laser rays through the broken portion of the western side glass pane at different angles. One team member marked the points where the rays touched the ceiling and walls of the room. No evidence of projectile penetration or flaking/peeling plaster was detected at the marked points inside the room. The authors examined the ability of broken glass pane to propagate cracks. Considering the radial cracks, concentric cracks, ridges, Wallner lines, etc., the investigator opined that the window glass pane was broken from the inside by a blunt instrument. A pink curtain was hung in front of the window in the room. There were no signs of burning or any holes on the curtain, especially near the area where the glass pane was broken. This confirmed the curtain remained undisturbed. The complainant reported that empty cartridges were found on the ground directly below the sunshade. This location was directly under the sunshade on the ground floor. All the window sunshades on every floor were in the same position. If an object had ricocheted from the window, it would have likely bounced onto the road. This indicates that the cartridges were not found in the reported area.

Following a detailed scene examination, forensic experts concluded that a blunt object from within the room had broken the glass pane, eliminating the possibility of an external projectile. The presence of Wallner lines provided additional evidence supporting the conclusion of an internal blunt force impact. To substantiate this conclusion, the investigator collected swabs from the broken window pane and fractured glass, adhering to standard procedures. These were then sent to the forensic science laboratory for testing to confirm the presence of gunshot residue and determine the cause of the glass breakage. Ballistics experts concluded the glass pane was shattered from within by a blunt object, with no gunshot residue (G.S.R.) detected at the scene. Upon receiving the forensic report, after thorough investigation and interrogation of the complainant, the police filed a
