Cyclone-Driven Coastal Erosion and Land Use-Land Cover Changes in the Talsari-Shankarpur Coastal Tract, West Bengal, India: Impacts of Amphan and Yaas

Abstract: *The Talsari–Shankarpur coastal tract, along the Bay of Bengal, has witnessed accelerated environmental and socio-economic changes due to Cyclones Amphan (2020) and Yaas (2021). This study examines the impacts of these cyclones on shoreline stability, land use, and community livelihoods through satellite imagery, field surveys, and socio-economic assessments. Results indicate severe coastal erosion, saltwater intrusion into agricultural lands, contamination of freshwater sources, and extensive damage to infrastructure and coastal establishments. Land Use and Land Cover (LULC) analysis between 2010 and 2022 shows a marked decline in paddy fields, vegetation cover, and sand deposits, with simultaneous increases in fallow lands, betel cultivation, marshlands, and built-up areas. These transformations highlight both ecological stress and a shift in livelihood practices. The findings call for integrated coastal management, disaster-resilient infrastructure, and sustainable land-use planning to mitigate long-term risks and enhan

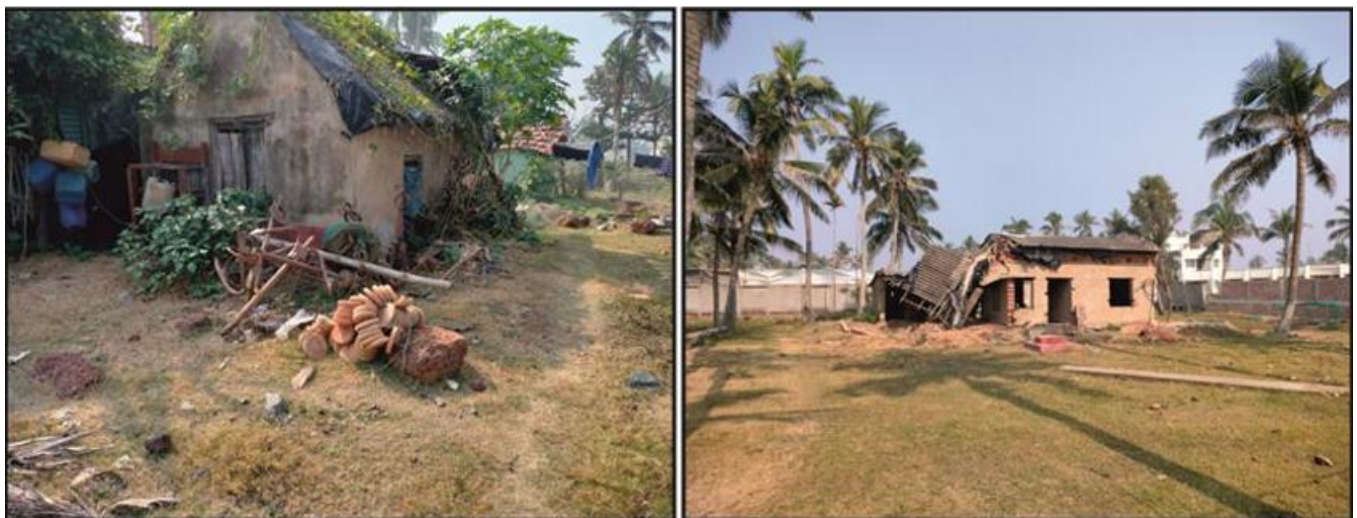
Figure 4: The figure shows field photographs of cyclone-induced damage to local houses in coastal areas. (A) Partially damaged mud house with scattered household items and overgrown vegetation indicating neglect. (B) Severely damaged brick house with collapsed roof structure, highlighting structural vulnerability to extreme weather events.

Housing damage was most extensive in Old Digha, where older, non-engineered structures bore the brunt of high-velocity winds and tidal inundation (Fig. 4). The lack of robust embankments and dense construction close to the shoreline heightened structural vulnerability (Hazra et al., 2021). Shankarpur, with a concentration of temporary fishing settlements, also witnessed widespread damage (Patra et al., 2022). New Digha sustained moderate losses due to stronger building materials and improved urban design, while Udaipur and Talsari, with lower settlement density and natural vegetation buffers, showed comparatively limited destruction (Sahoo & Bhaskaran, 2021; World Bank, 2021).

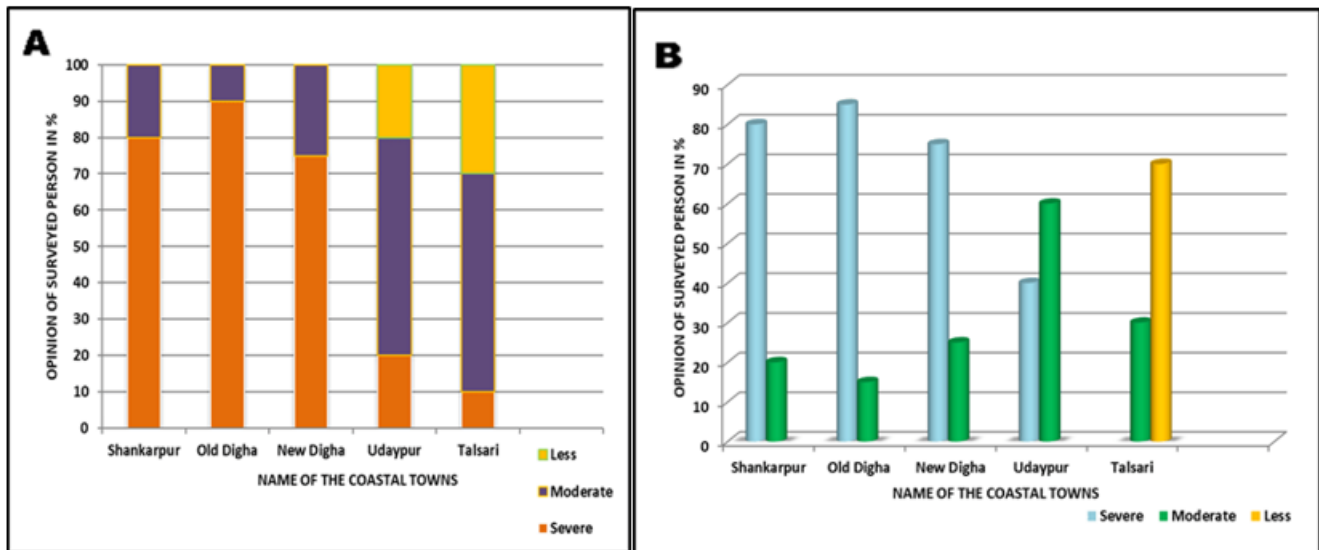
Figure 5: The figure shows the percentage distribution of respondents' views on the severity of impact (*severe, moderate, less*) on (A) transport and communication infrastructure and (B) shoreline-based commercial establishments such as shops, hotels, and restaurants, following Cyclones Amphan and Yaas. **Source:** Field survey data, compiled during post-cyclone assessment (2020–2021).

Cyclonic impacts on roads and communication infrastructure were most severe in Shankarpur and Old Digha, where prolonged inundation, drainage failure, and direct wind exposure damaged over 40% of essential infrastructure (Fig. 5) (IMD, 2020; CWC, 2021). Electrical poles, mobile towers, and road surfaces were destroyed, disrupting emergency response and post-disaster recovery. New Digha reported moderate impact due to planned tourism infrastructure and partial protection from embankments (Hazra et al., 2021). Udaipur and Talsari, aided by natural topography and lower developmental pressure, showed limited disruption.

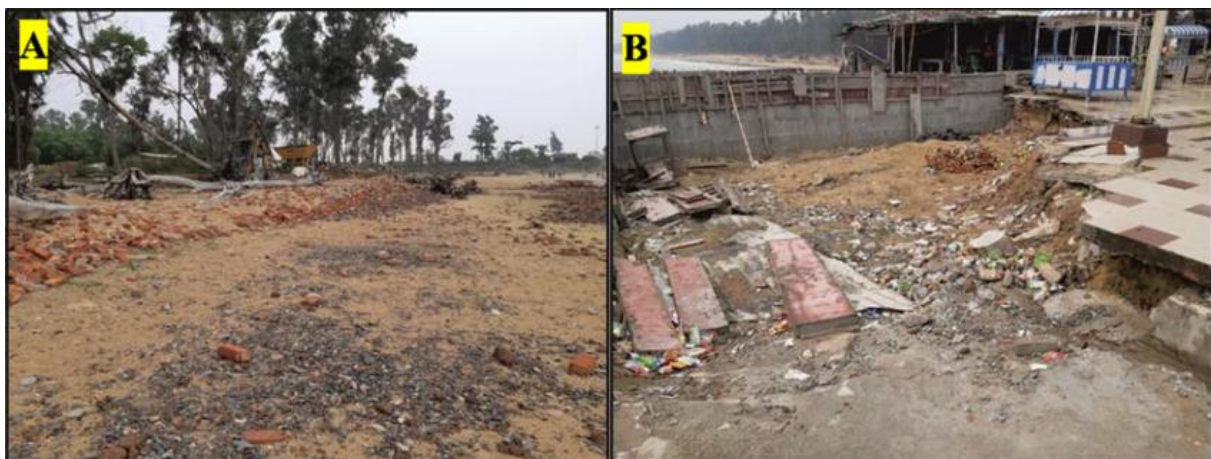
Figure 6: The figure shows field photographs of cyclone-induced structural damages (A) Erosion damage near commercial structures at Shankarpur; (B) Scattered debris along the beachfront at Digha, indicating severe erosional pressure on natural and built environments

More than 50 % of coastal protection structures in Digha and Shankarpur sustained severe damage, indicating their inability to withstand cyclone-induced stresses (Fig. 6) (Hazra et al., 2021; CWC, 2021). These failures exposed adjacent settlements to direct wave energy and flooding. Udaipur

showed mixed levels of structural impact, likely moderated by natural features such as dunes and vegetation (Sahu et al., 2022). Talsari recorded the least damage, benefiting from lower development intensity and estuarine protection (Panigrahi & Sahoo, 2022).
