Applied Geomorphology for Identifying Landslide Prone Area in Brebes, Central Java, Indonesia

Nana Sulaksana¹, Pradnya Paramarta Raditya Rendra²

^{1,2}Laboratory of Geomorphology and Remote Sensing, Faculty of Geological Engineering, Padjadjaran University, Jalan Raya Bandung-Sumedang Km.21, Jatinangor, Indonesia

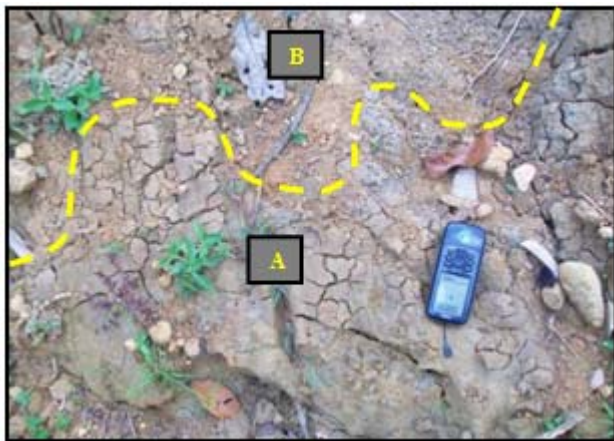
Figure 7: Claystone (A) mixed with landslide material (B) that comes from top of the slopes

Research area affected by landslide hazard is influenced by exogenous process such as weathering, erosion, and transportation of rocks and soil materials. In addition, the landslide hazard occurred are influenced by claystone which contain clay minerals (Figure 7). This clay mineral has specific characteristic that is swells and shrinks. This characteristic is influenced by water content of rocks. When water content of rock is increased, clay mineral will quickly swell but when the water content of rock is decreased, clay mineral will quickly shrink. These conditions resulted in soils on the slope of research area are easily expanded and shrink so the hill of research area become unstable and susceptible to landslide.

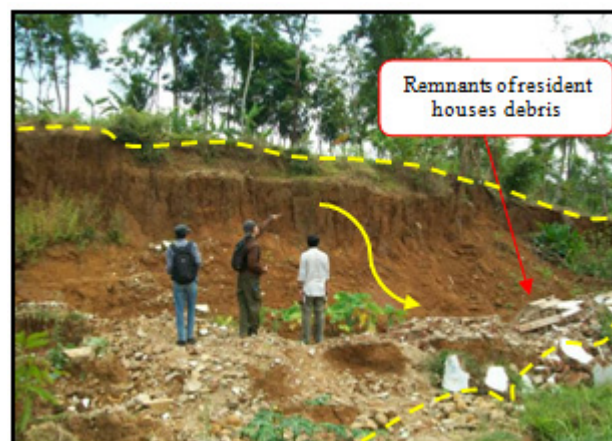
Figure 9: Remnants of resident houses debris that have been affected by landslide (yellow arrow represent direction of landslide)

This landslide movement was relatively slow. However, this landslide can cause heavily damage to resident houses, public buildings or facilities, and it can be life-threatening to local residents. Most of the local resident houses suffered severe damage due to landslide disaster in research area (Figure 9). A lot of local residents had to evacuate to a safer place due to landslide disaster. Local government has been trying as much as possible to resolve this problem immediately by encouraged local residents to reduce their activities in the area that had been prone to landslide disaster and always be aware during the rainy season. However the landslide disaster still occurs almost every year in this area.

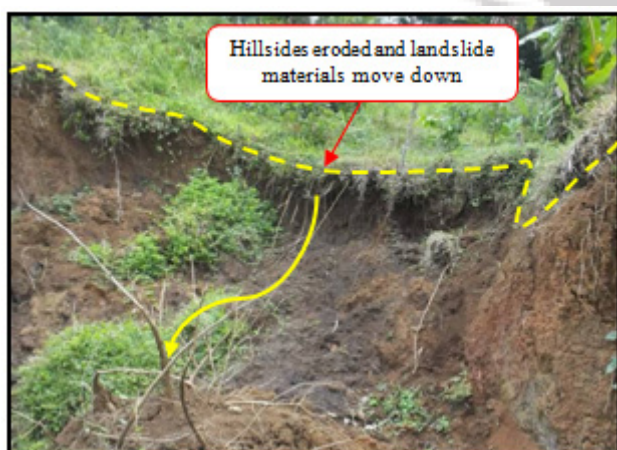
Figure 8: Landslide materials move down along relatively planar surface (yellow arrow represent direction of landslide)

Field observation was carried out in several areas that have been proved affected by landslide disaster. Field observation evidences suggest that landslide occurred in research area can be classified into translational landslide. The mass in a translational landslide moves down along relatively planar surface with little rotational movement (Figure 8). The landslide materials range from loose, unconsolidated soils to compacted rocks. Many plantations and agricultural area were severely damaged. In addition, this landslide can occur due to intense rainfall that fell continuously in research area.
