Applied Geomorphology for Identifying Landslide Prone Area in Brebes, Central Java, Indonesia

Nana Sulaksana¹, Pradnya Paramarta Raditya Rendra²

^{1,2} Laboratory of Geomorphology and Remote Sensing, Faculty of Geological Engineering, Padjadjaran University,
Jalan Raya Bandung-Sumedang Km.21, Jatinangor, Indonesia

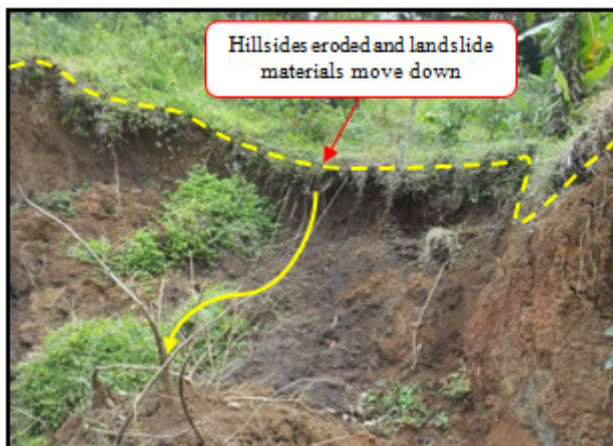
Figure 8: Landslide materials move down along relatively planar surface (yellow arrow represent direction of landslide)

Field observation was carried out in several areas that have been proved affected by landslide disaster. Field observation evidences suggest that landslide occurred in research area can be classified into translational landslide. The mass in a translational landslide moves down along relatively planar surface with little rotational movement (Figure 8). The landslide materials range from loose, unconsolidated soils to compacted rocks. Many plantations and agricultural area were severely damaged. In addition, this landslide can occur due to intense rainfall that fell continuously in research area.

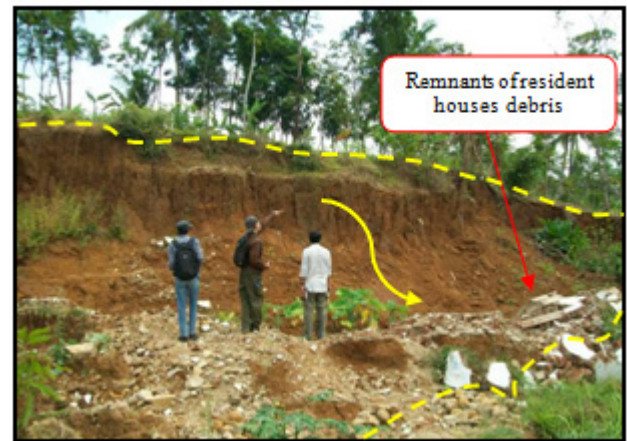
Figure 9: Remnants of resident houses debris that have been affected by landslide (yellow arrow represent direction of landslide)

This landslide movement was relatively slow. However, this landslide can cause heavily damage to resident houses, public buildings or facilities, and it can be life-threatening to local residents. Most of the local resident houses suffered severe damage due to landslide disaster in research area (Figure 9). A lot of local residents had to evacuate to a safer place due to landslide disaster. Local government has been trying as much as possible to resolve this problem immediately by encouraged local residents to reduce their activities in the area that had been prone to landslide disaster and always be aware during the rainy season. However the landslide disaster still occurs almost every year in this area.
