Rockfall Hazard Analysis of Ellora Cave, Aurangabad, Maharashtra, India

Abstract: The Ellora caves are located in Deccan Trap lava flows of upper Cretaceous to lower Eocene age. The terrain preserved one of the most historical places near Aurangabad city of Maharashtra, India. The Kailashnath temple is one of the most attractive caves and anticipated damage due to rockfall activity. The rockfall problem around the temple could be related to weathering, jointing and human intervention or a combination. In this study, rockfall hazard at Kailashnath temple is evaluated by 2D rockfall analysis. Different sizes of blocks are taken into consideration in the analysis based on visual observation at the site. The impact of fallen blocks on the Mandapa (Nandi Mandapa) structure is evaluated. The kinetic energy and velocity of the impacted blocks and damage caused by this impact on Nandi Mandapa has been evaluated. The obtained data are used to define the possible damage to Nandi Mandapa and based on the evaluation of the data; protection measures such as net fences are suggested with suitable height considering different sizes of the rock blocks. The height of the net fences has been figure

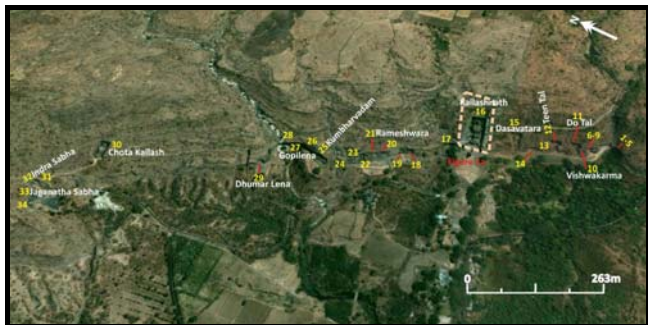
Figure 2 Arrangement of the Ellora caves with increasing number from East to West. Study area is marked as rectangular blocks and shown in Figure 3a. (Source: [http://en.wikipedia.org/wiki/Kailashnath Temple, Ellora](http://en.wikipedia.org/wiki/Kailashnath_Temple,_Ellora))

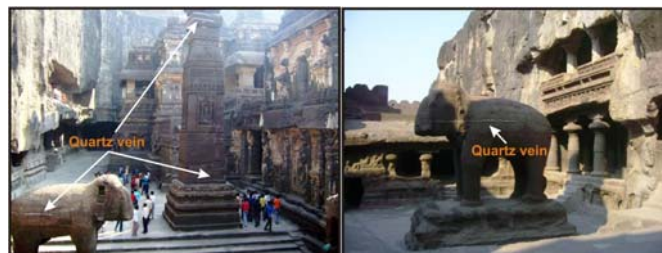
Figure 4 Quartz vein in Basalt at the Kailashnath temple in Ellora cave

Ellora and its surroundings are located in a relatively flatter region of the mountain ranges well known as Western Ghats. The southern Indian plains suffer intense volcanic activities for many million years. The mineral rich rocky crust has been fetched out on to the surface due to these volcanic activities. However, in some other part of the flat plane, volcano erupted and formed abrupt hilly formations. One of the lava heads is located very close to the Ellora caves near to the cave 32 through which lava once flowed. Several flows have been identified in the study area by researchers [3]. These are marked by an alternating sequence of ‘Aa’ and ‘Pahoehoe’ in which ‘Pahoehoe’ flows are relatively more homogeneous in nature without any clear-cut divisions except for the glassy crust at the top of the flow [3]. It is characterized by alternate massive and vesicular units. Quartz veins with thickness varying from 0.5 cm to 2.0 cm were recorded in the field (Figure 4) and these quartz veins lie near the lineaments [4].

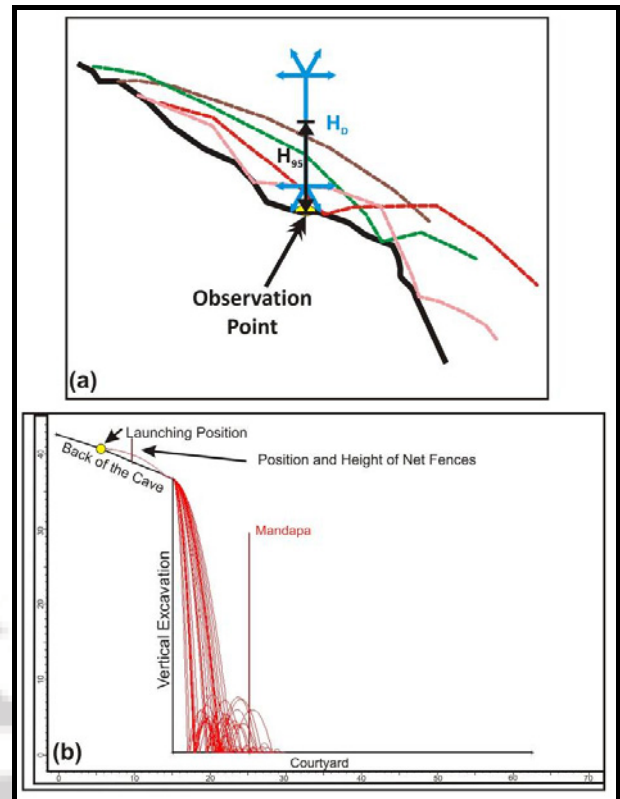
Figure 7: (a) Schematic diagram for the design height of net fences (b) location and height of proposed net fences at Kailashnath temple.

The schematic diagram for the net fences is shown in figure 7a and the data for the analysis is mentioned in Table-3. Also location of the net fences is shown in figure 7b and using the method proposed by Peila and Ronco [28], height of the net fences has been identified and mentioned in Table-3. The value of height of the net fences is found to be 1.49 m to protect the miss-happening at the site.
