First Pass Yield Improvement by Eliminating Base Plug Leakage in Feed Pump Manufacturing

Abstract: Base plug leakage caused by the inefficient tightening of the base plug in the feed pump of a diesel engine is the common problem in the field. The leakage of fuel is mainly due to the inefficient sealing of copper washer which is used to seal base plug and feed pump housing. A case study has been done in the industry to reduce the rejection of feed pump due to leakage of fuel through base plug in diesel engine. In this paper an effort is made to identify the factors which cause the leakage of fuel by using why-why analysis. It is found that some significant factors are the main cause in the feed pump assembly causing the major problem. Hence a trial on the present design is made and suggested the improved design by providing an undercut in copper washer landing area of the base plug.

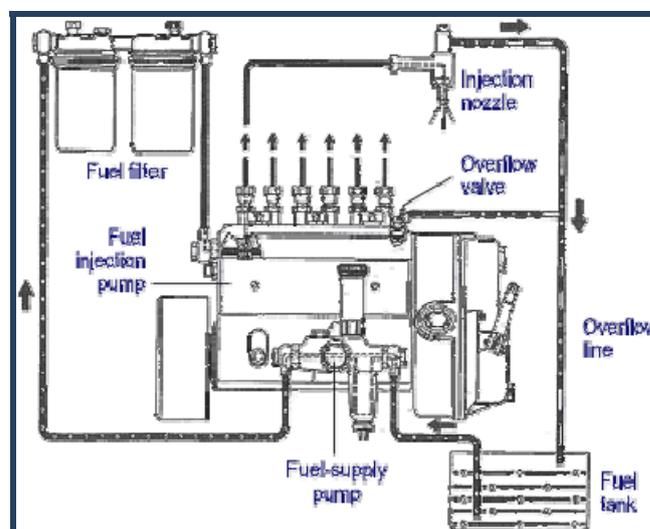
Figure 1: System Overview

This is normally flange mounted on the in-line fuel-injection pump. Depending on the conditions in which the engine is to be used and the specifics of the engine design, various fuel line arrangements are required. Feed pump is normally flange mounted on the in-line fuel-injection pump. Depending on the conditions in which the engine is to be used and the specifics of the engine design, various fuel line arrangements are required. If the fuel filter is located in the immediate vicinity of the engine, the heat radiated from the engine can cause bubbles to form in the fuel lines. In order to prevent this, the fuel is made to circulate through the fuel-injection pump's fuel gallery so as to cool the pump. With this line arrangement, the excess fuel flows through the overflow valve and the return line back to the fuel tank.

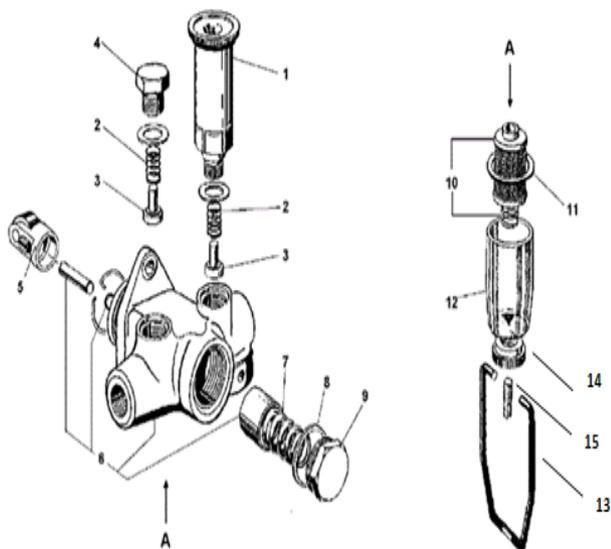
Figure 2: Exploded view of feed pump

Components of feed pump

- | | |

| 1. Hand primer | 9. Base plug |
| 2. Spring | 10. Plastic filter mesh |
| 3. Nylon valve | 11. Rubber Gasket |
| 4. Fitting nut | 12. Filter bowl |
| 5. Roller tappet body | 13. Wire clip |
| 6. Sliding pin | 14. Round nut |
| 7. Compression spring | 15. Headless screw |
| 8. Copper washer | |

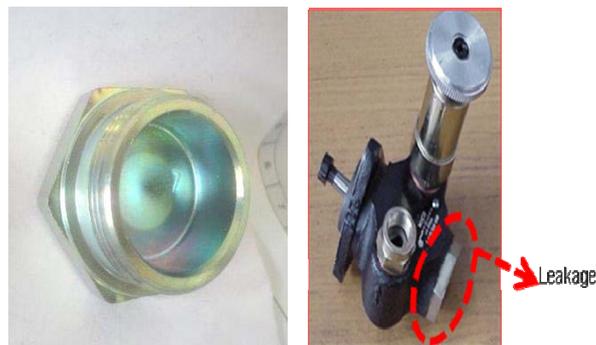
The Base plug leakage mainly happens due to the improper tightening of the base plug. Copper washer plays an important role in sealing between base plug and feed pump housing. Without proper tightening of the base plug it leads to fuel leakage which affects the performance of the vehicle.

Figure 3: Base plug & Base plug leakage

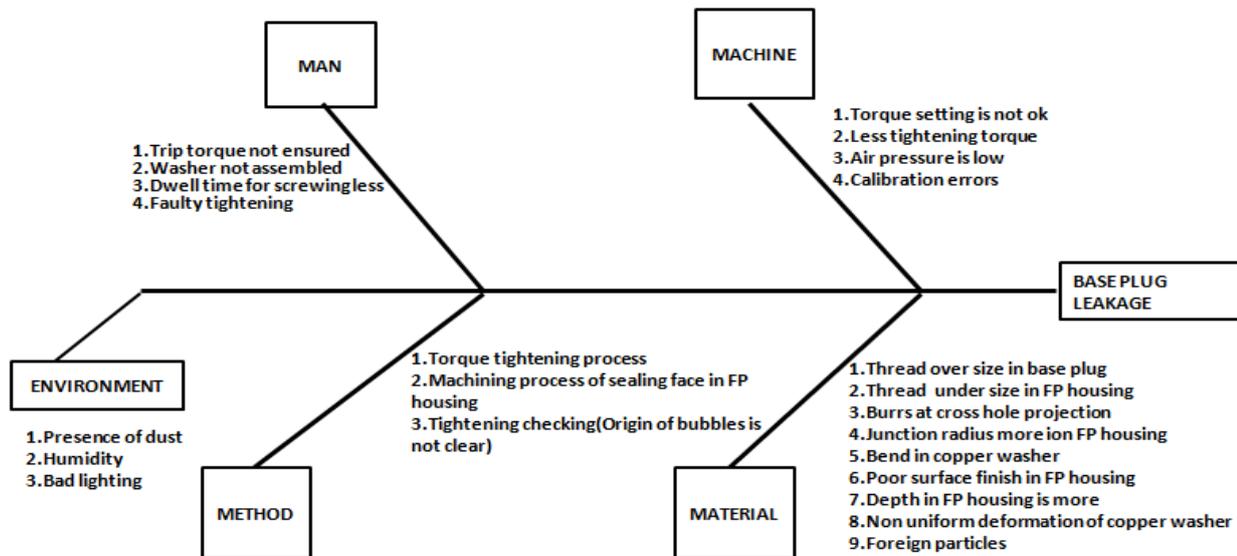
The Fish bone diagram, designed after observation as well as hands on experience at the plant depicting the major and minor causes for current problem at hand (Base plug leakage) is as shown below.

Figure 4: Fish bone diagram for base plug leakage

The Fishbone diagram has been of immense help and a very important tool used to reach to the root causes of the problems have at hand. The causes were easily found upon observation which not only helped me to reach to the conclusion as to what the causes were but which were the major causes and which were the minor causes.

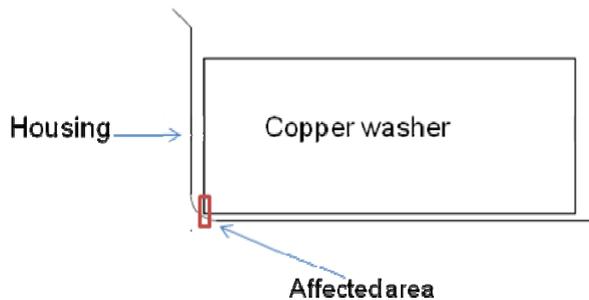
Figure 6: Copper washer alignment with FP housing

- **WHY? Washer seating at the area R0.3 does not provide effective sealing**

The feed pump corner radius is 0.3mm. The radius induces a gap when the copper washer is assembled to the feed pump. The gap created leads to ineffective sealing at the junction.

- **WHY? R0.3 creates uneven holding of Cu washer**

The uneven holding of Cu washer is mainly due to the fabrication specifications that have been over a period of time. The Cu washer dimensions are a standard therefore, need to validate the corner radius of the feed pump as a cause for the ineffective sealing.

- **WHY? Chances of R0.3 exceeding due to radius tool wear out**

The manufacturing specification with a tool tip of 0.3 mm is used. The amount of feed pumps manufactured with this tool in a day is 1500. There is a very high probability that over the course of manufacturing the pumps in a day the tool tip may become blunt and fall outside the specifications required. This will further increase the corner radius to a value greater than 0.3 mm causing ineffective sealing.

- a) **Root Cause:** FP housing corner radius tip used is R0.15
- b) **Corrective Action:** Using a tool radius tip of 0.10mm against 0.15mm
- c) **Reason:** A tool tip radius of 0.10mm will decrease the area at the washer seating location at the feed pump. The decreased area will ensure no air gaps are induced when the Cu washer is assembled. On supplying pressure to the torque meter a complete deformation of Cu washer is achieved. This seals the assembly by closing all the air gaps at the base plug region that are present when a tool tip radius of 0.15mm is used. Therefore, a tight seal is obtained eliminating all possible leakages.
- d) **Type of Action:** Design and manufacturing change at supplier (SS industries).

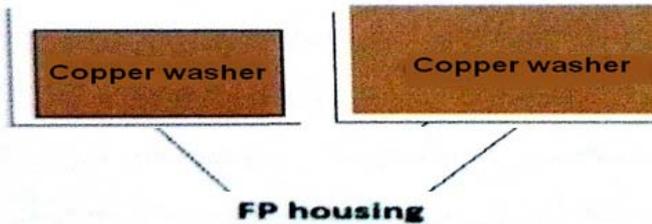
- **WHY? Cu washer thickness is 1+-0.1 (i.e., 1 to 1.1mm) where as FP housing dimension is 1.2mm leads to ineffective sealing**

The height of Cu washer is 1.1mm. When the depth of feed pump at the washer seating area is maintained at 1.2mm, it implies that the Cu washer will lie below the feed pump and when the torque is applied it directly falls on the feed pump instead of the washer thereby causing air gaps in the region resulting in leakage.

Figure 7: Change in height of copper washer

- a) **Root Cause:** Copper washer thickness is $1+0.1$ (i.e., 1 to 1.5mm) where as FP housing dimension is 1.2mm needs to ineffective sealing
- b) **Corrective Action:** Change depth in feed pump at Cu washer area to less than 1mm
- c) **Reason:** To ensure torque is applied completely on the copper washer and not on feed pump thereby ensuring uniform deformation of Cu washer. At the start of the manufacturing process the feed pump depth is maintained at 1.2mm. But over the course of manufacturing the depth may increase due to tool wear to a value above 1.2mm. When such a case is evident, the torque directly rests on the feed pump instead of the washer causing damage to the region. To avoid this damage, the feed pump depth should

be reduced to value below 1.1mm so that Cu washer is always at a height above that of the feed pump.
d) **Type of Action:** Design and manufacturing at supplier

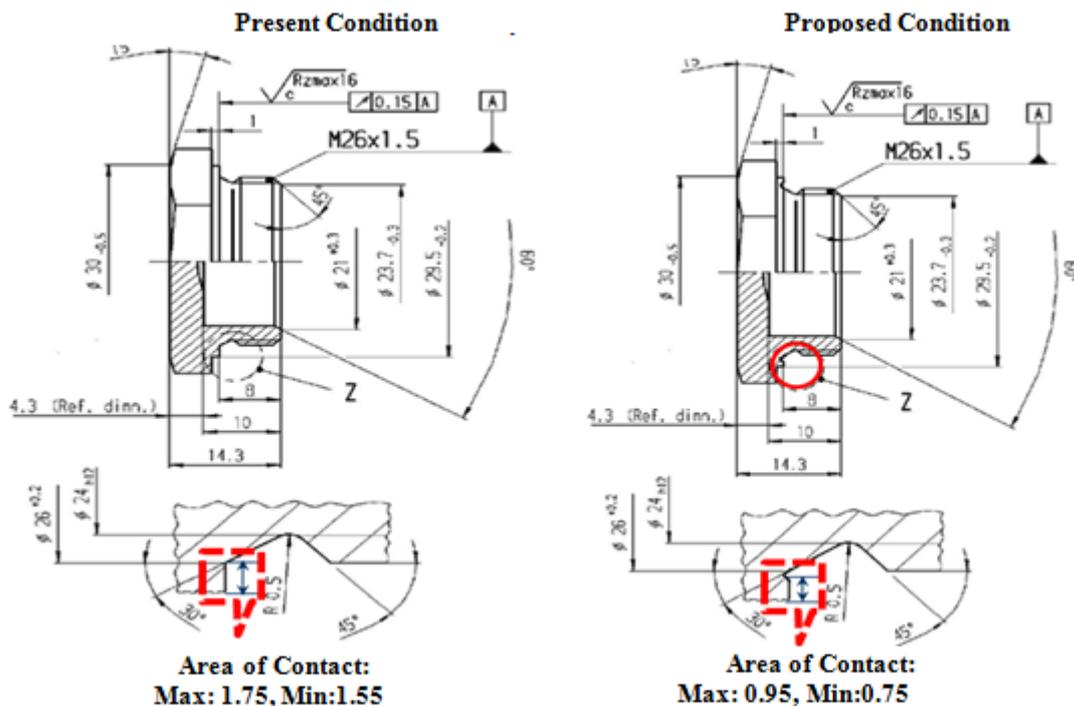
By doing all the above continuous improvement process using Why-Why analysis, the copper washer deformation caused by the base plug is observed. The deformation which made on the copper washer was not uniformly distributed and we cannot tighten the base plug more than $80+20$ N-m, because it may leads to housing breakage or damage if it tightened further. So under these boundary conditions change in the design of copper washer landing area in the base plug to give a better and uniformly distributed deformation is made. Hence by doing this, the same amount of tightening torque is applied on copper washer, such that the reduced land area in base plug giving a cutting action on the copper washer and with more pressure making the copper washer to get bulged at the inner side of bore and getting uniformly sealed at the outer circumference area.

In the present design the area of contact is more so pressure is not uniformly get distributed on the copper washer, whereas in the proposed design by reducing the land area with the same amount of torque, pressure got uniformly distributed with a better sealing effect. So design change in copper washer landing area in the base plug is made and reduced the copper washer landing area by providing an undercut of 0.8mm.

Figure 8: Present & Proposed base plug design

The above figure showing the present and proposed design changes in base plug, where in the proposed design an undercut of 0.8mm is made to give better deformation and to obtain good sealing effect by the copper washer.

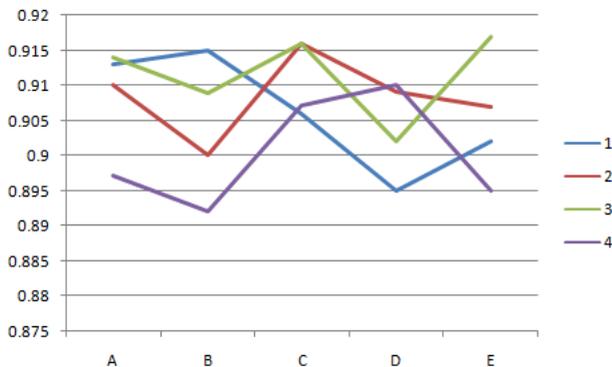
Deformation observed at five respective points of four Copper washers by using Present base plug design, measured by dial stand.

Graph 10: Deformation distribution

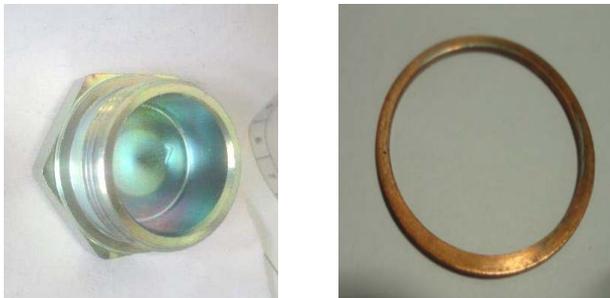
Table 11: Deformation values of proposed design showing present base plug & deformed Cu washer

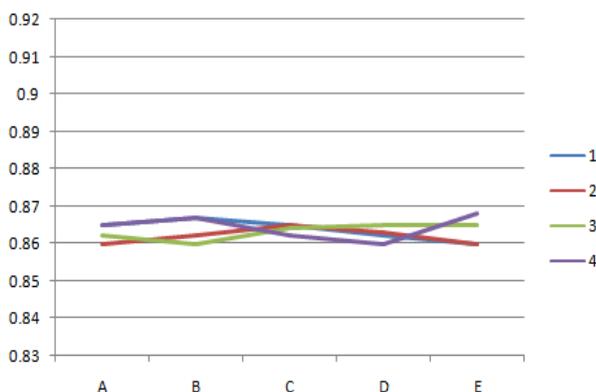
Deformation observed at five respective points of four Copper washers by using proposed base plug design, measured by dial stand.

Figure 13: Deformation distribution

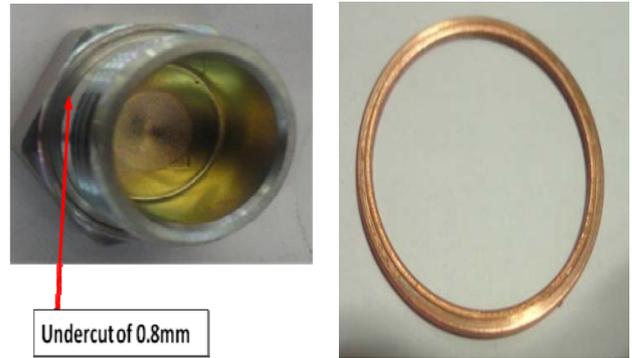
Figure 14: Showing proposed base plug & deformed Cu washer

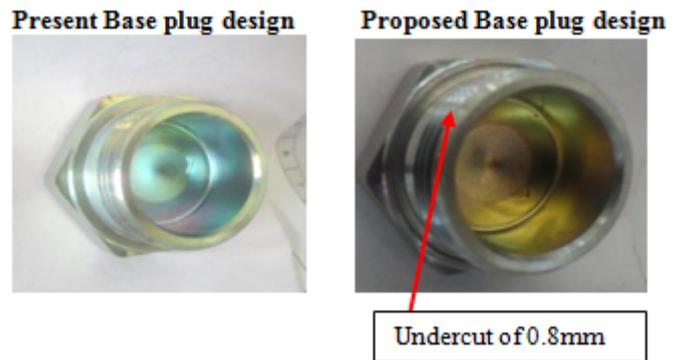
The design change in base plug made the copper washer to deform uniformly and resulted in a better sealing effect. The undercut of 0.8mm on the copper washer landing area with the same 80+20 N-m tightening torque, gives uniform deformation on the copper washer.

Figure 15: Present & Proposed base plug design

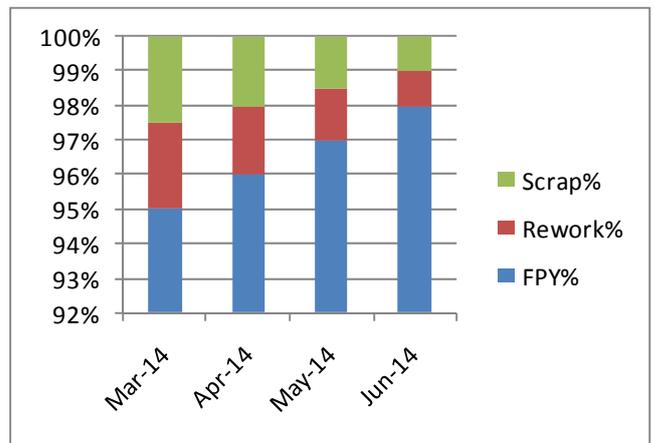
On implementing the proposed base plug design, the first pass yield is improved from 95% to 98% where scrap and rework is also reduced. Also base plug leakage is resolved with the better sealing effect.

Figure 16: First pass yield improvement
