Improvement in Machine Performance with the Help of Vibration Analysis of Rotating Machine

Abstract: *In industries excessive vibrations in machines often results in reduced output and hence plant effectiveness is also reduced. Sometimes a simple vibration measurement with limited capability can help in reducing the impact of lost production before getting help of an expert. This is explained with the help of a case study in which the measured vibration spectrum was used to detect the unbalancing in rotor due to deposition of scale on the blades of PH fan in a rotary kiln in a cement industry.*

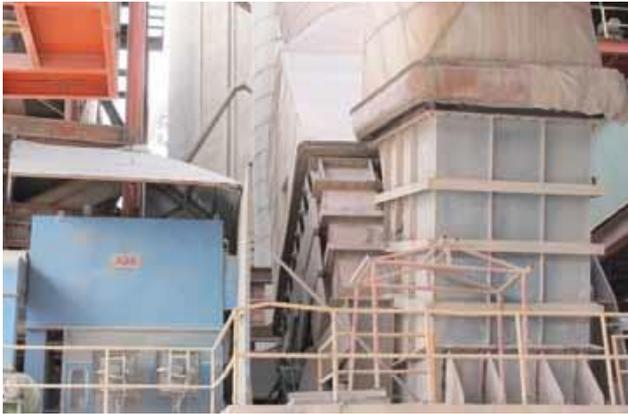
Figure 2: Pre-heater fan

Table 1: Specifications of PH fan

Type	Exhaust fan (centrifugal fan)
Model No.	KZE 250-1400010-252*1.04(DIDW)
Impeller effective diameter	3690 mm
Fan speed	980 rpm
Fan shaft power	3069 KW
Fan capacity	793080 m ³ /H
Weight of impeller with shaft	18000 kg
Fan static weight	52000 kg
Full-load torque	29492 N-m
Fan bearings	22224CC/C3/W33
Lubrication	SH 46

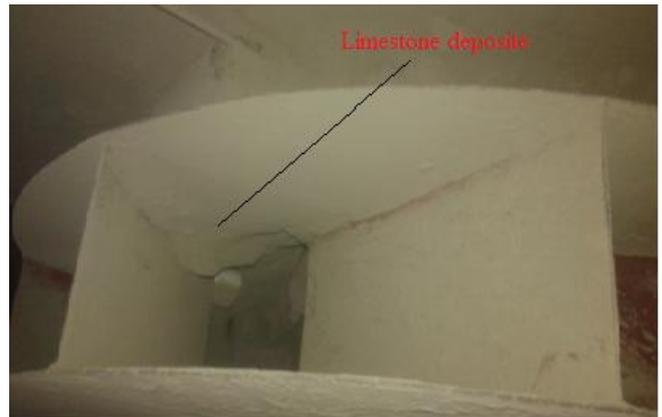
Vibration spectrum was measured at the PH fan and motor bearings. The vibration measurement showed a peak at the rotational speed (1x) as shown in fig 3(a). Primary analysis triggered an suspicion of unbalance in shaft. The reason behind the unbalance could be the deposition of moist

limestone on PH fan impeller blades from the exit of the calciner.

Figure 2: deposition on blades

In order to reduce the further losses, an immediate visual inspection and cleaning of the fan impeller blades was recommended. Upon opening the fan casing, there was found a coating of limestone the blades. The cleaning was performed. After cleaning and restarting the fan, vibration signals were again collected (FIG 3(b)). This showed a significant drop in vibration amplitude even at higher speed.
