Construction Problems of Light Structures Founded on Expansive Soils in Sudan

Magdi M.E. Zumrawi

Abstract: *Expansive soils in Sudan have been contributing to light structures failures and subsequently causing increased annual repair expenditure. The study aims to investigate the foundations problems associated with expansive soils and provides practical and economical solutions for construction on expansive soils in Sudan. The research is mainly concerned with field performance of expansive soils with emphasis on design criteria and construction precautions for structures founded on expansive soils. Some cases of existing light buildings and roads in different regions in Sudan, suffered from severe distresses and damages due to expansive soils, were studied. The results obtained clearly indicated that generation of high swelling pressure, which leads to differential heave of structures, is the main cause of failures. Finally, based on the case study investigation and the previous experiences recommended by researchers, proposed construction guidelines to assist the civil engineers to deal with expansive soils at design and construction stages of foundations is outlined and descr

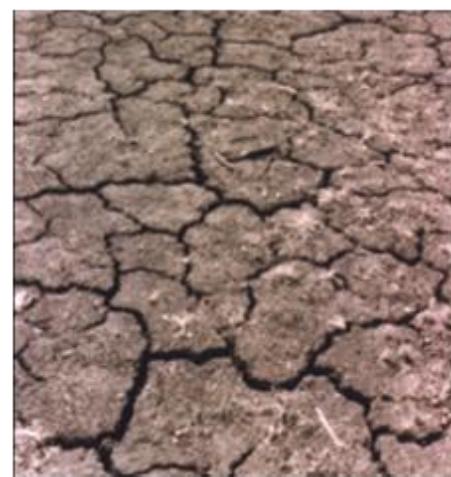
Figure 1: Expansive soil with polygonal patterns cracks

Potentially expansive soils can be recognized in the laboratory by their plastic properties. Clays of high plasticity, generally those with liquid limits exceeding 50 percent and plasticity index over 30, usually have high swelling potential. In the field, expansive clay soils can be easily recognized in the dry season by the deep cracks, in roughly polygonal patterns, in the ground surface (see Figure 1).

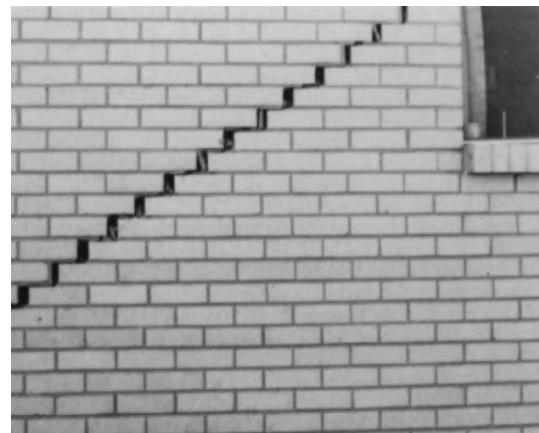
Figure 2: Typical severe diagonal deep crack in the wall

Many one and two storey buildings utilizing shallow foundations have been extensively damaged. It is observed that severe cracks and uplifting of floors are common distresses of most houses throughout the city. Figure 2 shows damage to the room wall on the ground floor. It can be observed from Figure 2 that the wall has developed a severe diagonal crack. It is observed also, most of the damaged walls in the front face of the structure. This is because of plants in the front garden which is subjected to considerable watering continuously throughout the year. Therefore, the subsequent swelling of the soils has exerted an uplift force on the wall resulting in the development of a crack.

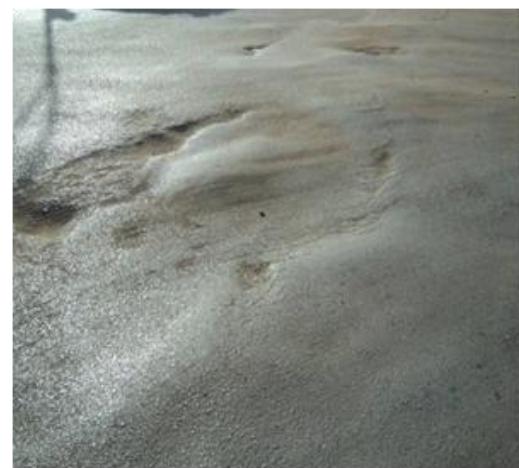
Figure 3: Severe distresses of heave on Alarda road, [13]

Some major roads in Khartoum state such as Obeid Khatim, Alazhari and Alarda roads suffered from severe distresses and damages, [13]. He found that the main causes of these failures due to expansive subgrade soils and poor drainage, leading to severe cracking and heave on road surface. Although these roads were maintained several times during the last 10 years but still suffered from failures (Figure 3).

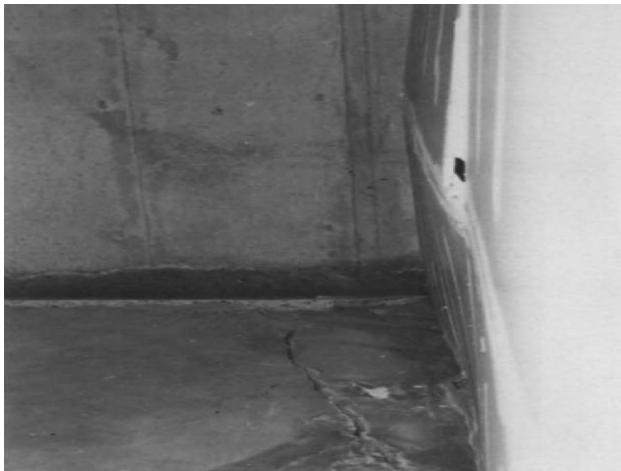
**Figure 4:** A severe cracks of ground floor and inside walls

This case study is typical of what happens when foundations are placed on expansive soil without considering uplift forces. In this instance the study involves many buildings of the university were constructed without benefit of adequate design. The university is situated in Wad Medani in Gezira state, 250km south of Khartoum. Many buildings of the faculty of medicine in Nishaishiba area greatly suffered from expansion. The site is underlain by a 5m thick expansive soil layer. The single and two storey buildings supported by isolated footings, placed at a depth of 2m has experienced significant damages near bathroom areas. Visual inspection by the author indicates that most of the buildings suffered from severe cracking and uplifting of ground floors by soil expansion as shown in Figure 4. As stated in the records of the university that the repairs of these buildings amounted to more than 6% of their initial cost.
