Overview of the Italian architecture in Durrës from 1920 to 1944

Loreta Çapeli¹, Meri Priftuli Semini², Florian Nepravishta³

Abstract: *Durrës is an Albanian coastal city. During the period from 1920 to 1943, Italian architects examined his urban plans and proposed new ones. The architectural heritage of Italian style and its monumental structures built during the '30 s in Albania possess precious architectonic and cultural elements that must be preserved and promoted and to achieve that, we may start by first identifying and presenting them to the wider community of interested professionals. This study identifies these buildings, their location in the city and focuses on the small structures with residential function, highlighting their architectural qualities. Through the study cases on the villa typology the aim is to explain and know the morphology, compositional and stylistic characteristics. Concluding, it has been understood that Durrës city encloses inside its structure a lot of architectonic value that, as an inherited richness must be protected, restored, and evaluated, prior to being damaged from lack of attention. Also, the data of this study will serve for future res

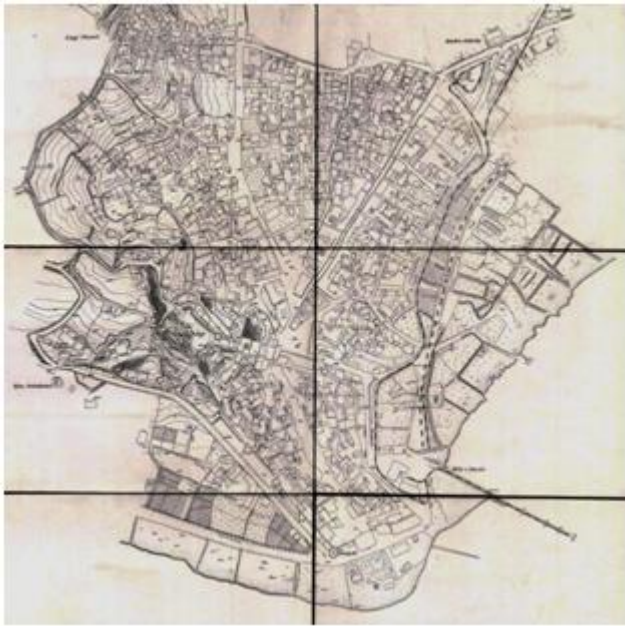
Figure 1, a) Assessment city plan 1928, [3]

That first urban situation came through the assessment city plan of the year 1928 (figure 1.a.) which reflected a medieval urban shape organized. The triple roads that ended at the regular shape square, gave this square the important organizational role for the city, as it was usually the case with all medieval cities which were organized around the religious buildings.

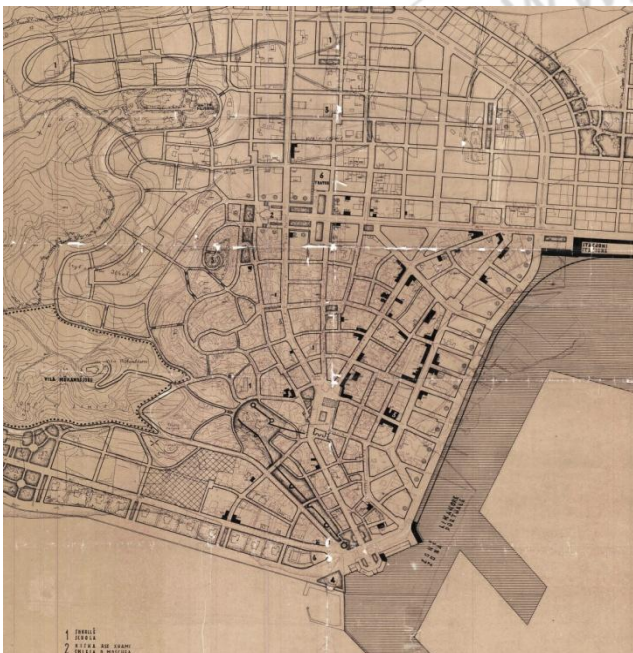
Figure 1: b) Regulatory city plan 1942, [3]

Following this period, another plan was prepared by the Italian architects L. Carmignani and F. Poggi and it was approved in 1942. [4] It preserved the main logical structure of the 1934 plan, and proposed a perpendicular road system mainly for the new northern part, where the development of the city was foreseen. (Figure 1, b)

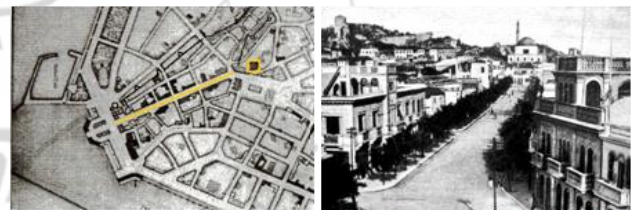
Figure 3. Plan and aerial view of old and new “Mercantile Street”

Note also the trace of the “Mercantile Street” that played a very important part in the network of streets. This street was already well defined in the 1928 and began from the southeast at the gate of the harbor and went straight northwest, up to the City Hall square. (Figure 3)

So the religious building remained an urban focus even for the “Mercantile Street” which, at the end of its perspective, used the Mosque as an architectonic sign: A baroque concept of an open city to be seen in Durrës urban texture.

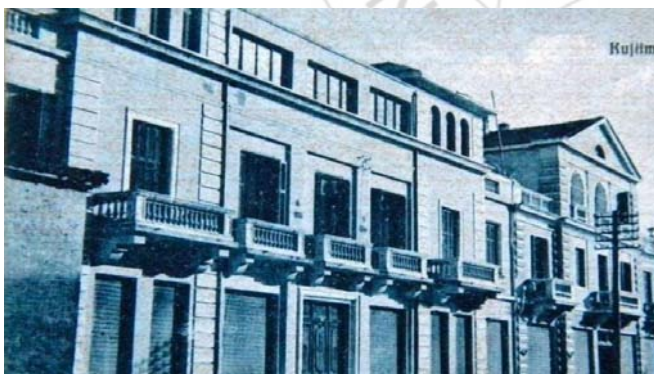
Figure 4: a) Rectangular Openings, [6]

Used for business activity, the ground floors of buildings were rich in architectonic details, mostly in line with a sense of laconic rationalism. We find a sense of play in the frames around doors and windows, mainly of rectangular shape, made of plaster mimicking the carved stone that are combined with the horizontal thick lines on the facades. (Figure 4.a) The architectonic order is rarely used, even where the pylons decorate the spaces between openings; they are only styled capitals or bases

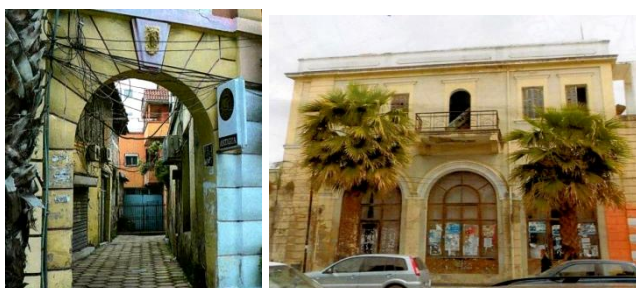
Figure 4: b) Vaulted shape openings, source Authors

The vaulted shape openings in the ground floor are rarely used, but sometimes they are preferred for a street-door opening to connect, access to, or from the main street. (Figure 4.b)

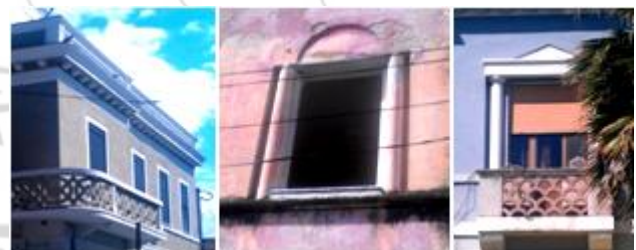
Figure 5: a) Windows details in Durrës [8]

These carved lines will help the framing to be more visible in the whole view of the building facade. There are few arched windows and, when used, are of double and triple aisles, bringing a romantic atmosphere in the building façade. (Figure 5,a)

Another window type is a rectangular one, decorated by two small side columns and a blind arch above the beam, (Figure 5,a) which is strange to the decorating style of the Italian rationalists, but seems more a reminiscence of the local use of painted wooden arches over the windows beam in the traditional house of Gjirokastra. (Figure 5,b)

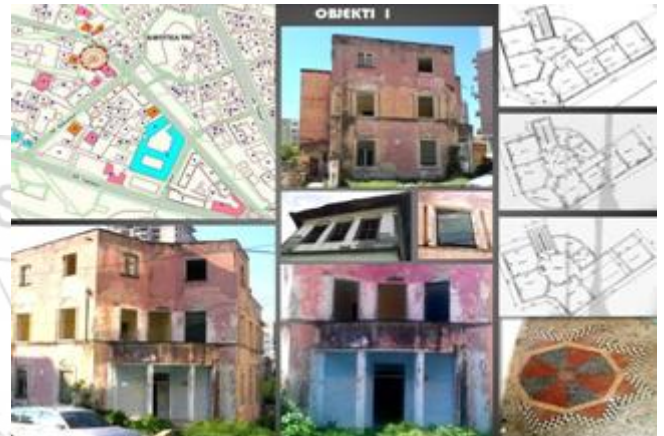
Figure 6: b) Bibliographical Index of building 1 [8]

Building No. 1. (Figure 6, b) Its location at the crossroad has played a significant role and has constrained its layout and its interior partitions. The central access vestibule is of irregular hexagonal shape and will become an organizational focal point for the building.

The rest of the interior partitions are distributed on both wings with a view on the street. A perspective view of the road from the hill could be a very disturbing and repulsing sharp corner, but the architects have „carved“ this sharp corner to make space for a welcoming small „piazza.“ They clearly signal the access point into the building and is covered with the only balcony of the building that is supported by two columns.

The exterior is treated with a clear and concise language. The esthetics of the facade rely on proportional harmony of the principal elements and a few decorative details. The ground floor windows, differentiated from those of the upper floor level, have only decorative frames, while those above have additional small columns on the sides as a replica in miniature of the columns supporting the balcony at the access door and a blind arch above as a decorative supplement. (This detail has been applied in other areas in Durrës).

Following a careful survey of the exterior, we can see that an additional floor has been built on top of the building, being deprived of the upper decorative cornice similar to the one dividing the ground and first floor. In the interior spaces, we can still see the careful work in detail of floors that were equipped with mosaics.

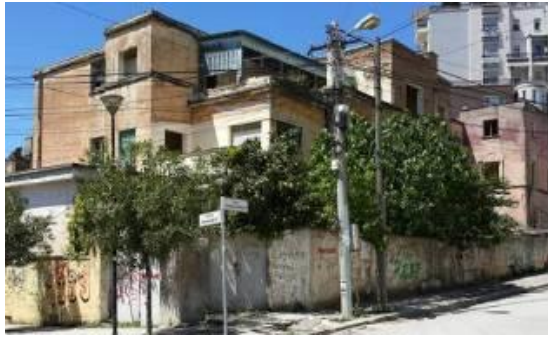
Figure 7: a) Building N°2, [8]

Building, No. 2. (Figure 7,a) Being positioned in the corner of its parcel plot, the building is not constrained by its peculiar position. In its layout composition, it is similar to a two – family villa.

The exterior decoration is essential and limited to the horizontal cornices that limit the window height. The volumetric movement of the building has been lost in time through the usual addition of another upper storey, occupying the space previously reserved to the two panoramic terraces, it once had.

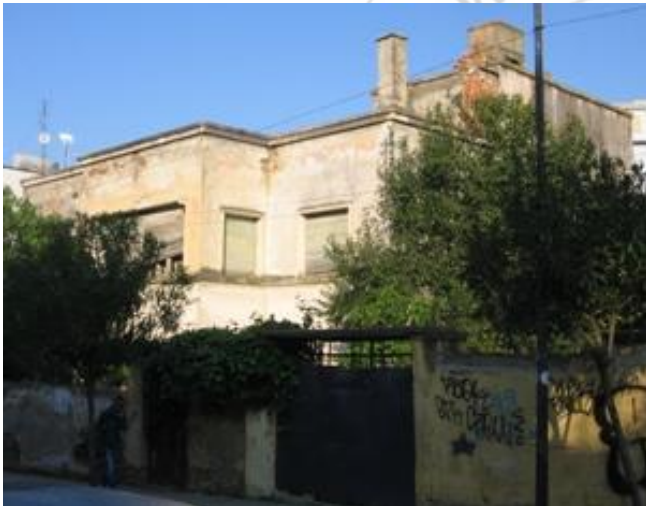
Figure 7: b) Building N°3 [8]

Building, No. 3. (Figure 7,b) It has a simple layout plan and is composed of a half – underground floor and two upper floors, distributing areas on the sides of the linking corridors.

As for the architectonic style, the structure shows a similar approach with the nearby villa replicating the same decoration featuring horizontal cornices and the same movements of volumes and the same terraces with panoramic view. The window openings are significant, thus offering very good sun exposure of the rooms in the south – east side. Long years of neglect and abandonment have taken their toll and the building now is inaccessible and degraded.

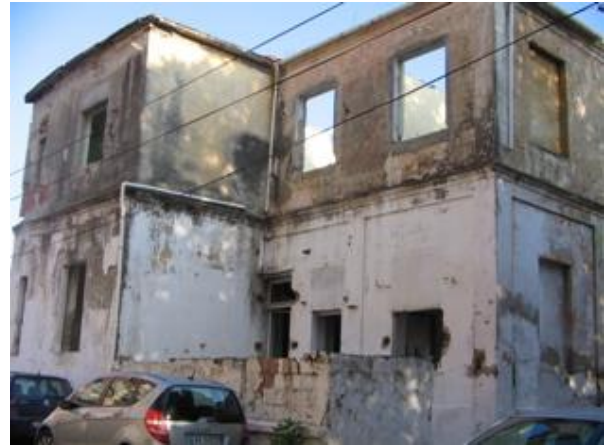
Figure 7: c) Building N°4, [8]

Building, No. 4. (Figure 7,c) In the assessment plan of 1928, it exists as a constructed plot. The architectonic language of the facade and the window proportions are some of the elements that leave a doubt on the time of construction as it has much more in common with the ottoman buildings or to eclectic ones.

Based on the way the plan was composed and how the facade was treated, we think that this building was changed from a single storey building with a pitched roof, to a two storey one.

The presence of an outer staircase that leads to the upper floor is an indication of the new floor extension, together with the detailed cornice that frequently is found just under the pitched roof and now is between the two storeys, or the pilasters that are not replicated in the upper floor.

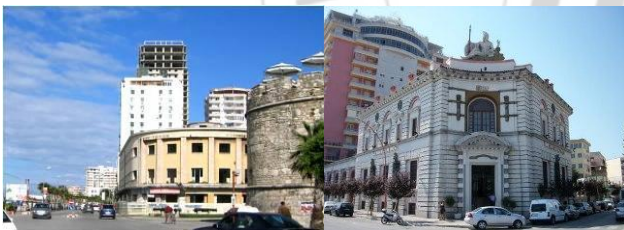
Figure 9: a) Hotel Vollga [8], b) Bank of Albania Building. [8]

The former Hotel "Vollga" shows a remarkable architect's sensibility to replicate the morphologies of the Venetian tower, due to his closer presence. (Figure 9, a) While, the recent structures do not take care to respect these elements, resulting to an architectonic violation of the historic city urban space, and its historic skyline. (Figure 9, b,c,)

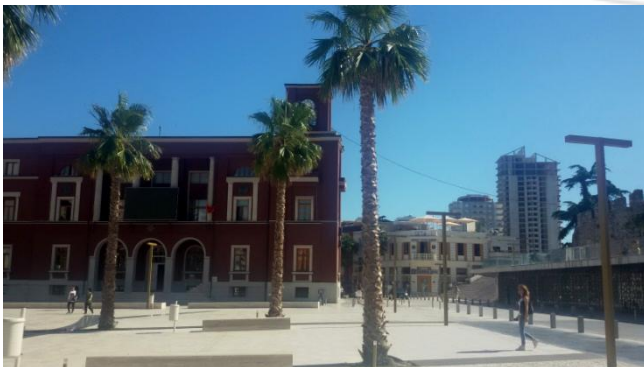
Figure 9 : b) Town Hall Square, central square [8]

Interventions without criteria have violated the architectonic image of historic buildings and squares. In the city history, it is important not only its architectonic image, but also the visual and historic citizen's memory, which must be

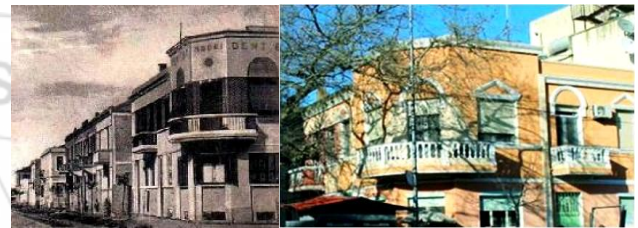
Figure 10, Old view [6] and Details [8] of the same building, mistakenly treated

respected. Important points of the city like „Vollga“ and the Venetian Tower are now cardinal points for the city life. They must continue to play this historical role. The necessity and the actual pressure to build new structures for business or residential purposes should be addressed to the new construction plots, strictly away from historic sites and places. Sometimes, due to the lack of historical studies, the reconstructions have harmed the architectonic language of the buildings they aimed to improve. For those structures, where the intervention is not yet finished, it must be immediately intervened, based on the historical studies, to help with the correct treatment of architectonic details. Attention should be given to buildings in good shape, but that often come with deviations of their architectonic details, which mistakes can be treated as original. (Figure 10,) By studying the old images and the most degraded parts of the building, it should be possible to distinguish the original elements and to intervene to return it in his historic shape.
