Challenges of Urban Drainage System in the Emerging Towns of Ethiopia: The Case Study of Assosa Town

Kokeb Zena Besha

Lecturer, Department of Civil Engineering, College of Engineering, Assosa University, Ethiopia, East Africa

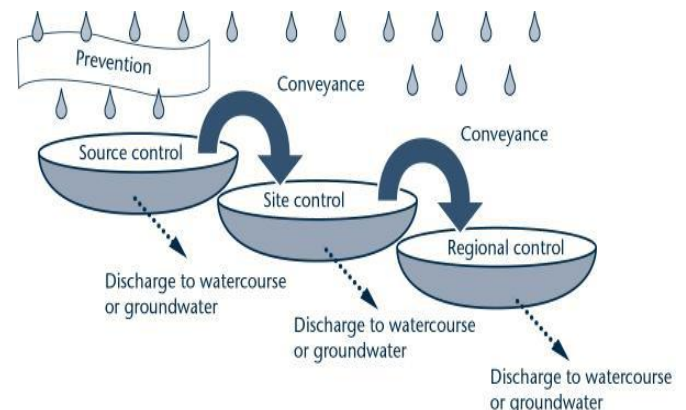
Figure 1: Sustainable Urban Drainage System Management Train (after CIRIA, 2000)

In the above figure, the storm water management system starts with prevention or good housekeeping measures at the household level and progress through local sources control to larger downstream site and regional control. The concept

- 1) **Sources Control:** discharging of storm water to the surface where rainfall lands,
- 2) **Site Control:** discharging of storm water on the surface water run-off from large areas, such as part of housing estate, major roads, or business parks. The run-off from large urban areas can be channelled to a site control measure using swales (shallow drainage channels), and
- 3) **Regional Control:** discharging of storm water with the gathered run-off from a large area at regional level.

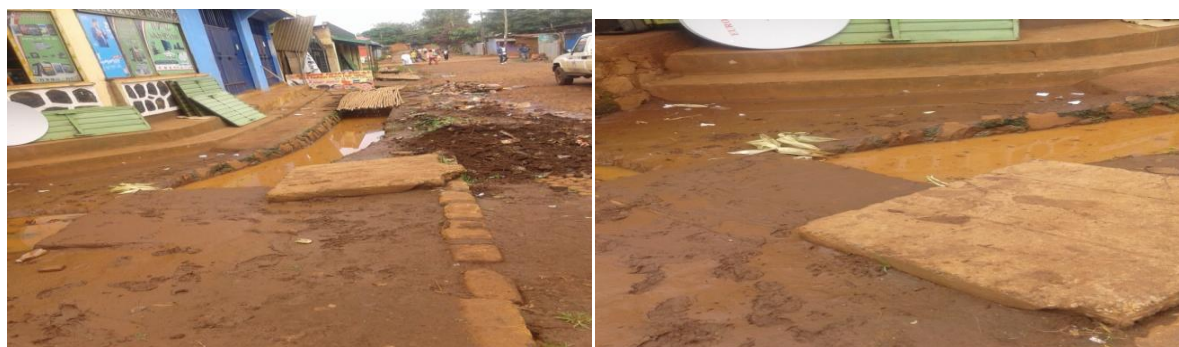
Figure 2: Rectangular Open Drains with poorly defined outlet

As shown in figure 2, a photo was taken by the researcher in May, 2016 during the field work shows that due to poorly defined inlets & outlets stagnant water is formed in the open drains.

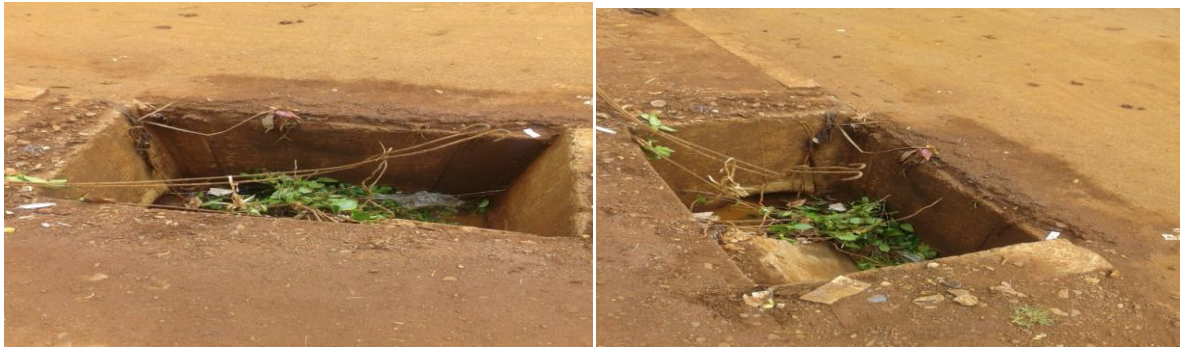
Figure 3: Manholes used as dump place

In figure 3, one thing the drains are left open, the other thing the waste material extracted from different sources dumped in the manholes and blocked the drainage system as seen.

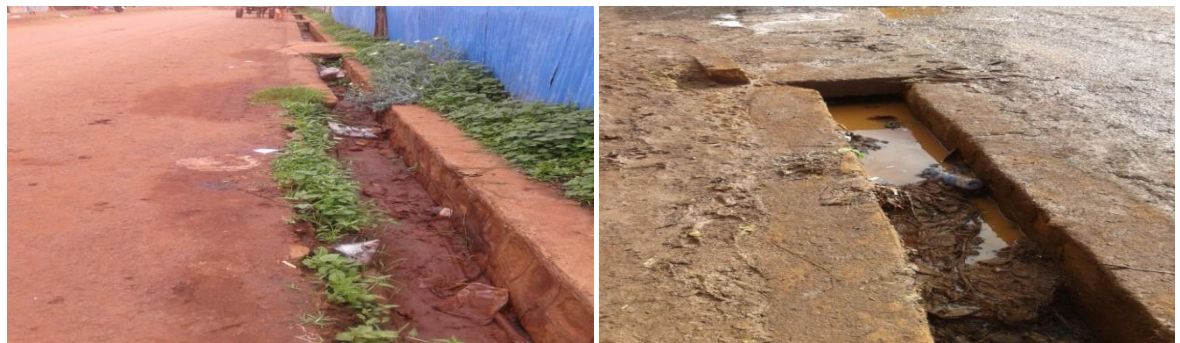
Figure 4: Failed & blocked Side drains

In figure 4, the side drains are failed & blocked by silt sediments due to poor maintenance & lack of timely supervisions by the concerned bodies.

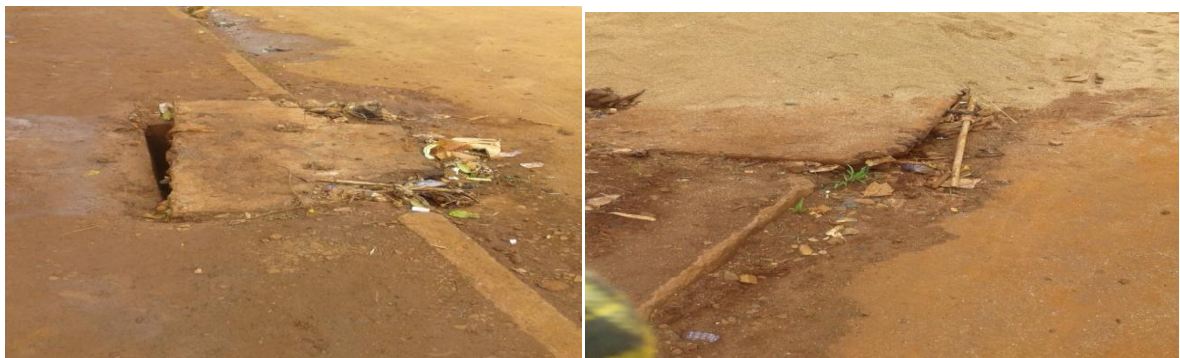
Figure 5: Poorly Executed Manholes

In figure 5, the manhole cover is not properly done and maintained as well due to lack of technical skill & poor supervision during construction time.

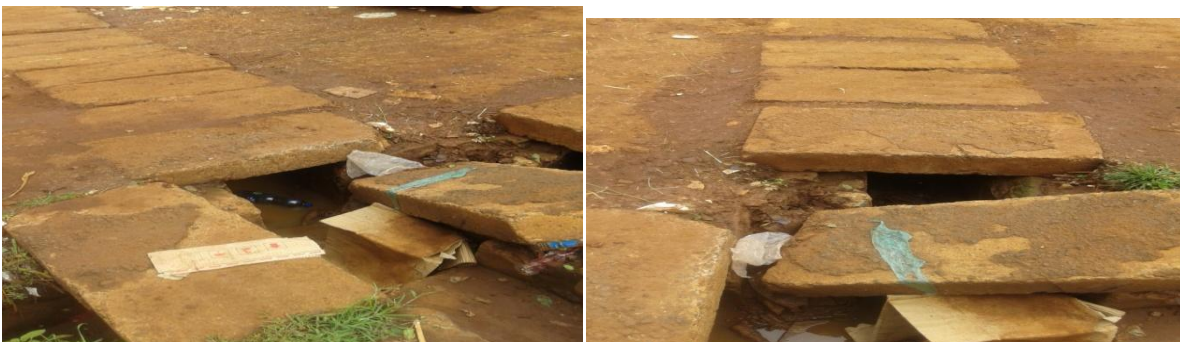
Figure 6: Poorly Covered open drains

Considering figure 6, the concrete block which is used as a cover for open drains is not properly executed; such types of problems are seen here and there at the study area. In general, it is reflected that drainage condition is poor in
